Structural Investigation and Report for the

MILLBROOK ARENA

Township of Cavan Monaghan

AUGUST 7, 2019

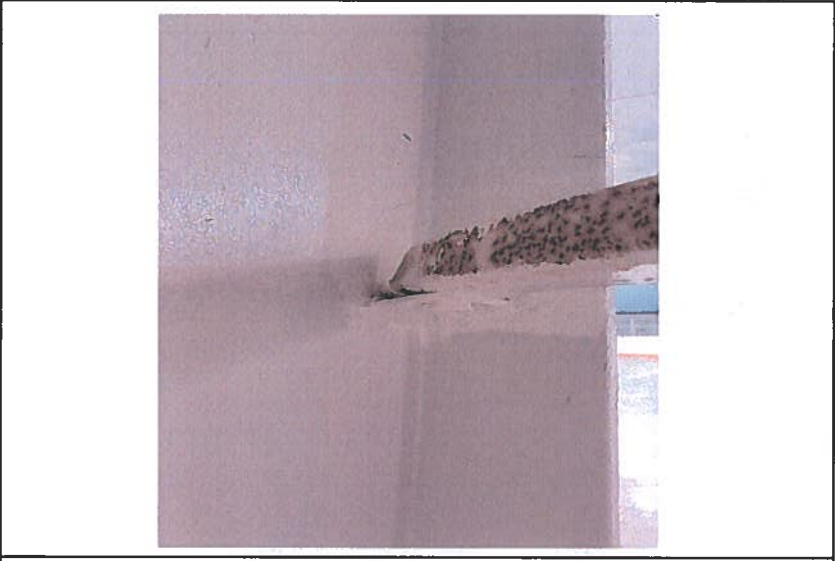
Photo 003 Pre-Engineered Frame

- Minor damage was observed at the surface of the frames resulting from repeated puck impacts (Photo 003). For aesthetics purposes, we recommend that the damaged area is cleaned and painted as required to match original conditions.

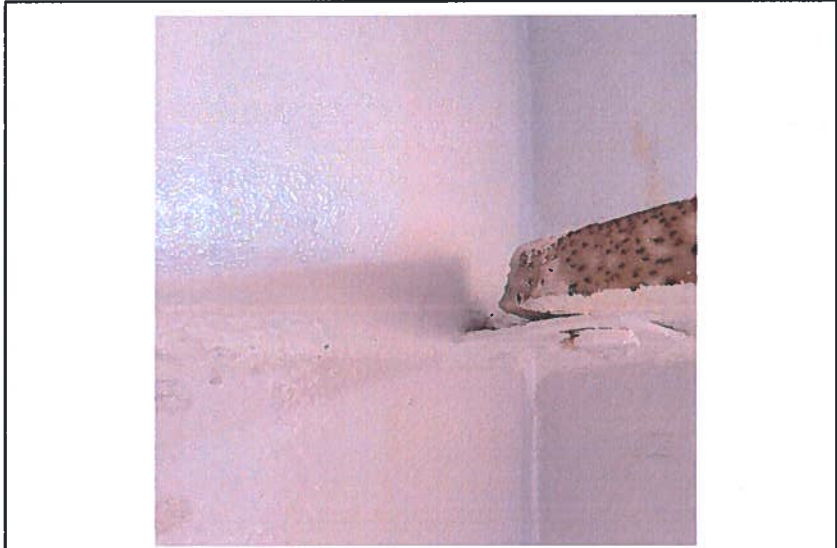
Photo 004 Rust on Frame Brace

- Minor localized surface rusting was observed along several bracing members (Photo 004). This is likely due to condensation and high humidity during occupancy. We recommend for the rusted area to be wire brushed clean to bare metal and an epoxy protective coating is applied.

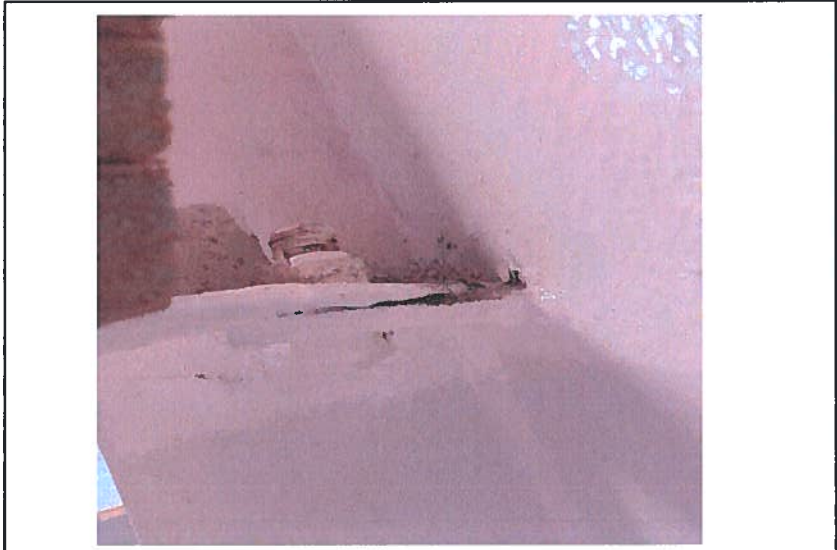
Photo 005 Bent Connection

- Bolted connections at the braces appeared to be bent at several locations, effectively causing the nut to be displaced (Photo 005). This appears to be an original condition from the fabrication of the braced connections. Further, minor surface rusting was observed at several bolted connection locations (Photo 006). We recommend for the rusted areas be wire brushed clean to bare metal and an epoxy protective coating is applied.

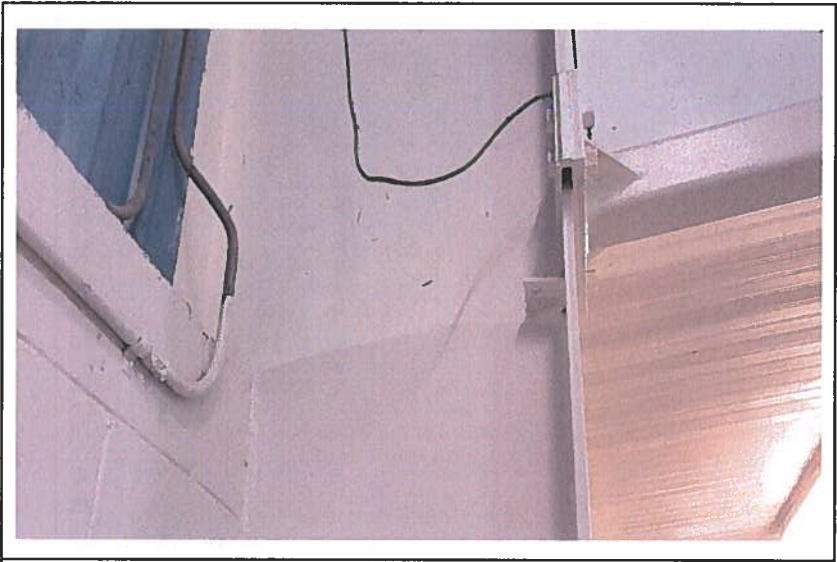
Photo 007 Pre-Eng Frame Base Connections

- Insufficient anchor bolt thread protrusion was observed at several locations. The threads at several bolted connections were not observed to extend past the nuts at the pre-engineered frame base connections (Photo 007). As this condition does not meet the minimum code requirements for thread protrusion past the nut, we recommend that the locations be plug welded to ensure connection to the foundation below is adequate.
- The lower set of braces were observed to be missing along the bleachers (Photo 008). This appears to be an as-built condition as the braces would interfere with the bleacher seating area. A single brace at the south side of the arena appears to be experiencing some deflection, this appears to be an as-built condition (Photo 009).

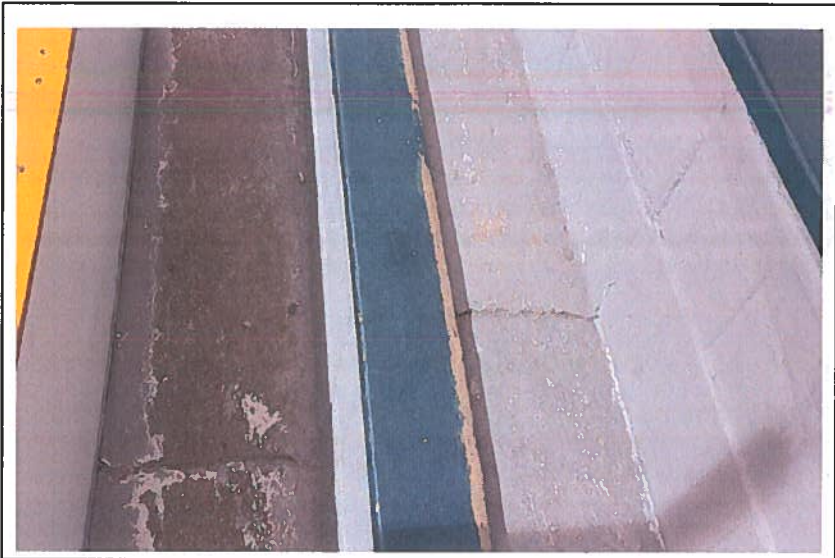
Photo 010 Paint Chipping and Crack on Bleachers

- The concrete topping was observed to experience localized minor cracking and paint chipping at localized locations (Photo 010). We recommend that all loose paint be scraped and repainted to match existing conditions.
- Minor cracking was observed at the precast concrete joint location (Photo 011). This cracking is typical for concrete joint locations and is not a structural concern. We recommend for the joints to be routed out and infilled with a flexible calking material.

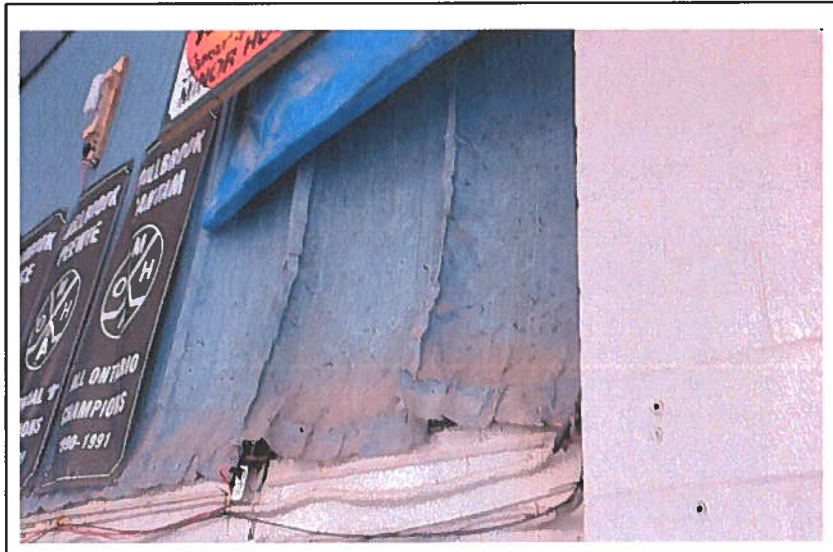
Photo 012 Localized damage to MetalCladding

- Minor damage to the metal siding at the North-East corner was observed (Photo 012). This damage is likely a result of repeated impacts from pucks/balls within the arena. For aesthetics purposes, we recommend that the cladding is cleaned and painted as required to match original conditions.
- Significant damage to the metal cladding at the North Wall was observed (Photo 013). The cause of the damage is unclear. However, we recommend that the cladding be replaced at this location to restore to original conditions.
- The metal cladding at roof level along the North elevation appears to be separating from the adjacent cladding. We recommend that the cladding at the roof level be re-secured to match the existing conditions (Photo 014).

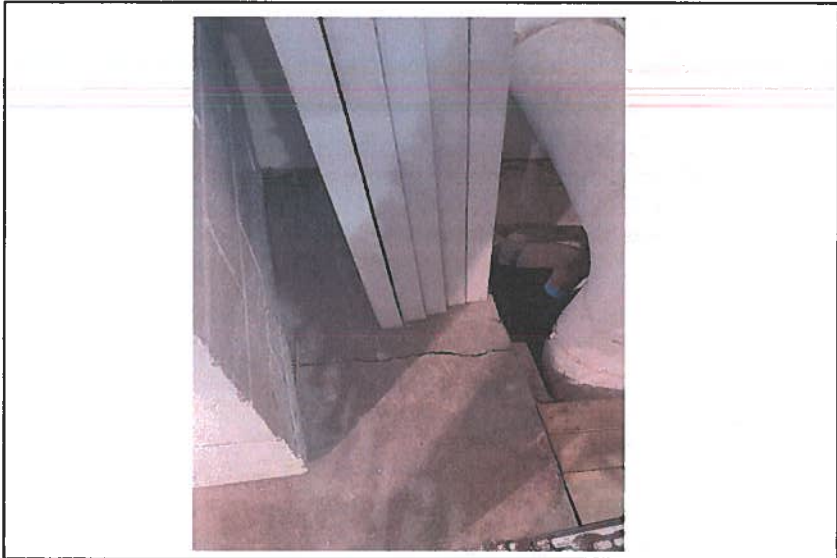
Photo 018 Apron Slab Under Garage Door

- Moderate cracking and spalling were observed underneath the exterior garage door on the East side of the building (Photo 018). We recommend for all loose and unsound concrete to be chipped out and removed and patched with a suitable repair mortar.

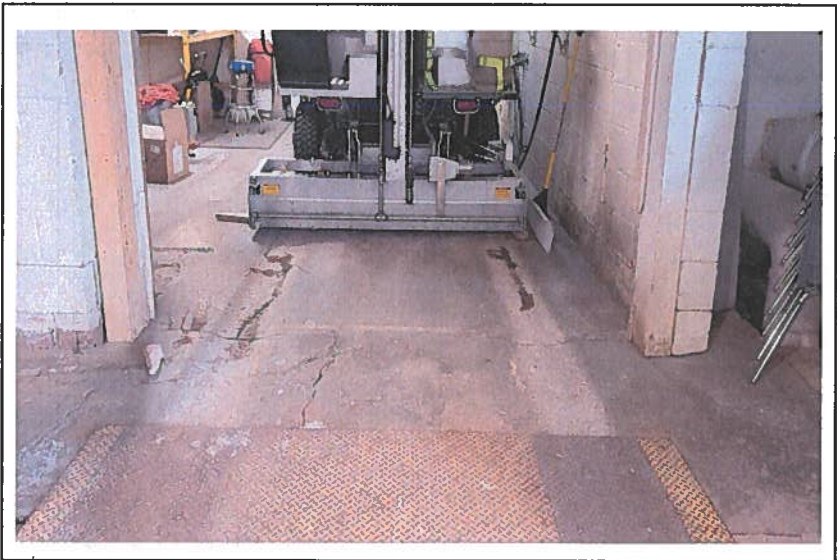
Photo 019 Major Crack in Apron Slab

- Significant cracking was observed adjacent to the ice-surfacing room (Photo 019). This is likely due to previous differential settlement of the structure. We recommend for the slab to be repaired and patched with a suitable repair mortar to prevent further deterioration.

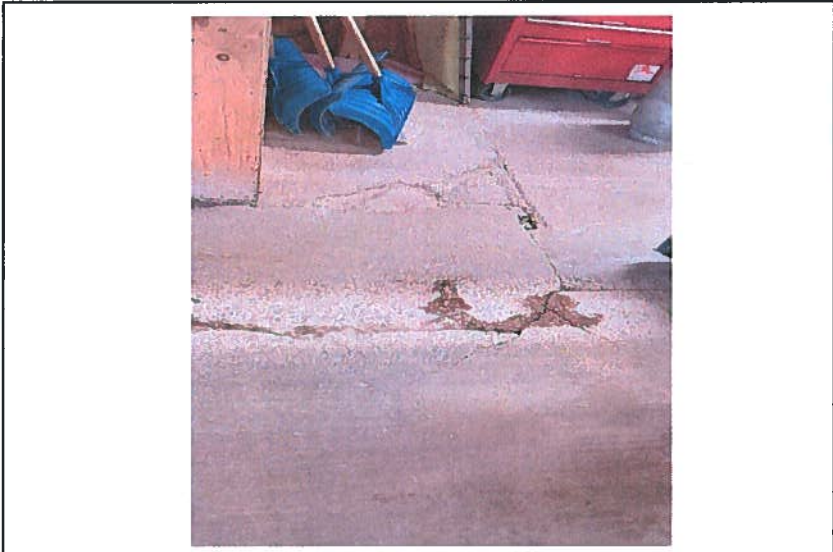
Photo 020 Resurfacing Room Rutting

- Rutting was observed in the ice-resurfacing room (Photo 020). This is likely due to driving on the slab prior to the concrete completely curing after the original pour, as well as the fatigue of the concrete over the decades of repeated loading.

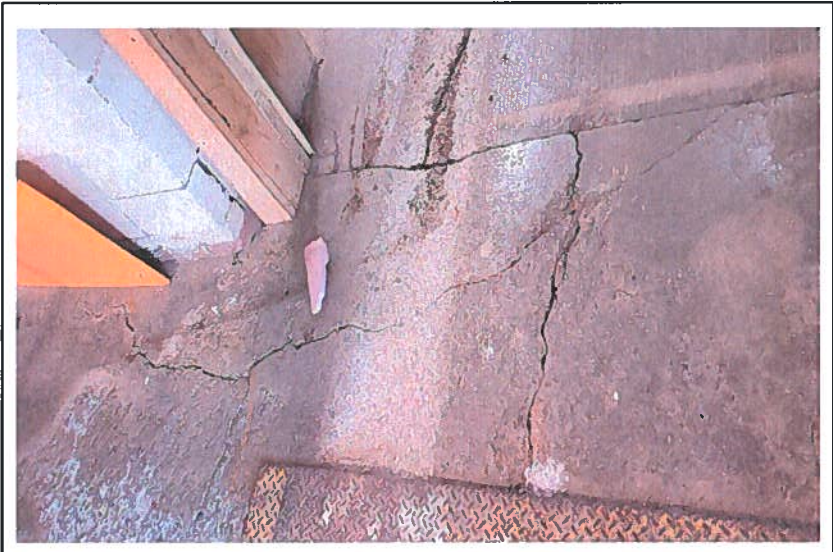
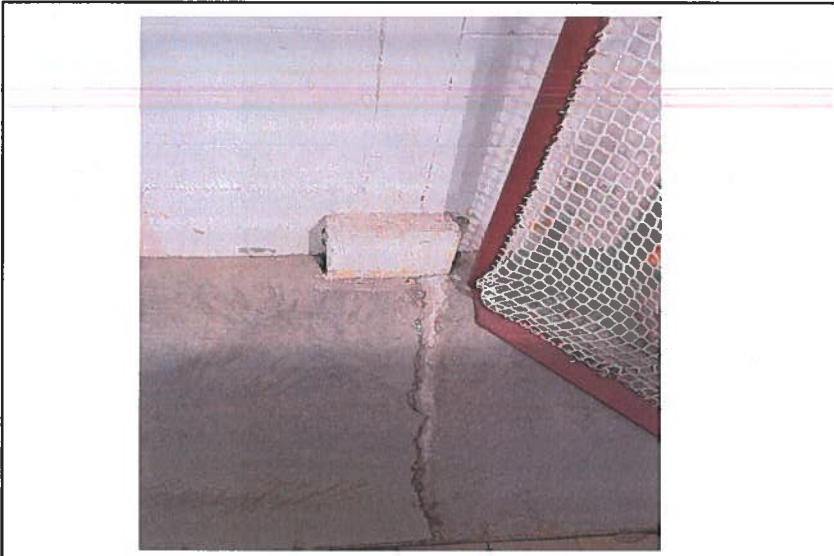
- Significant cracking was observed in the ice-resurfacing room extending outwards towards the dasher boards of the pad (Photos 021 and 022). This is likely due to repeated water/salts brought through the room by the resurfacing equipment over the years. We recommend for all loose and unsound concrete to be chipped out and removed and patched with a suitable repair mortar.

Photo 021 Cracking Starting in Resurfacing Room

Photo 022 Extents of Resurfacing Room Cracking

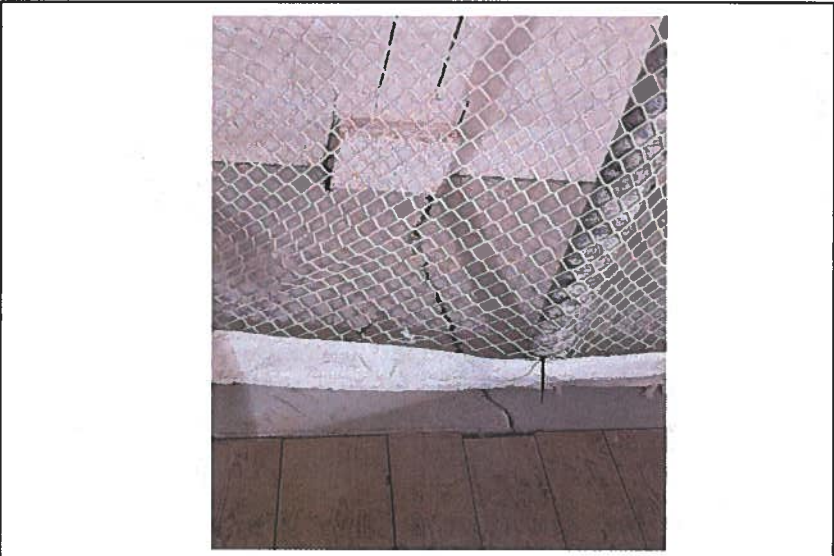
- Two (2) separate cracks were observed at the base of two (2) of the steel columns at the North side of the arena (Photos 023 and 024). This is likely due to the absence of slab saw cuts at the column locations. This is a serviceability issue and not a structural concern at this time.

Photo 023 Cracking Under North-Side Column

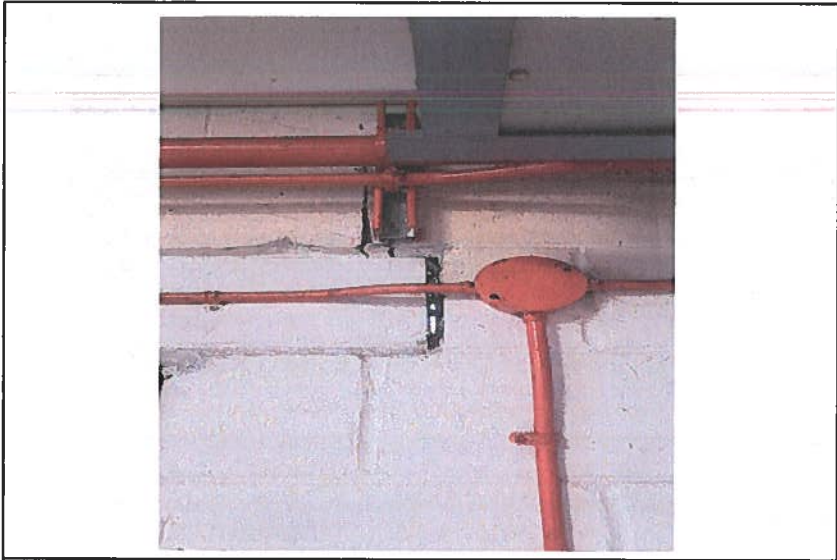
- Significant moisture accumulation during the winter months was reported in the compressor room located at the North-East corner of the building. At the time of the review, rusting and evidence of moisture was observed on the masonry block wall (Photo 026). We recommend that the rusted sections be wire brushed clean and repainted to match the existing condition.

Photo 026 Block Wall in Compressor Room

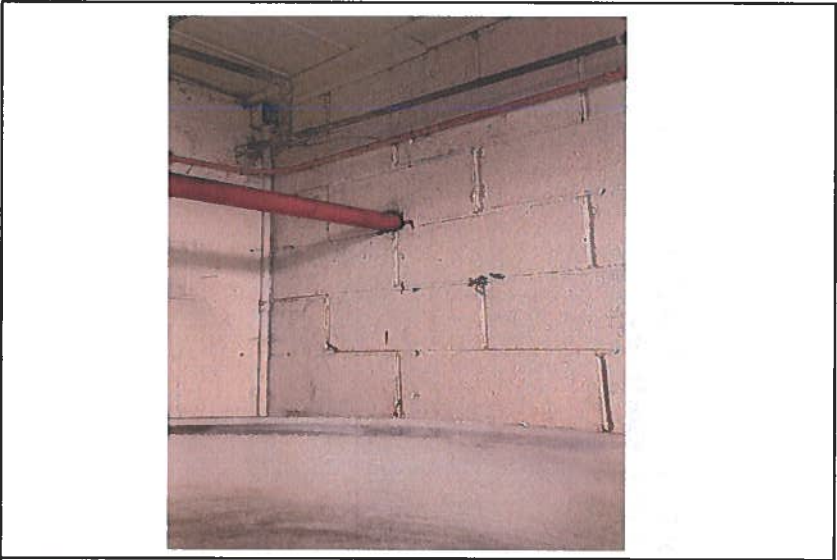
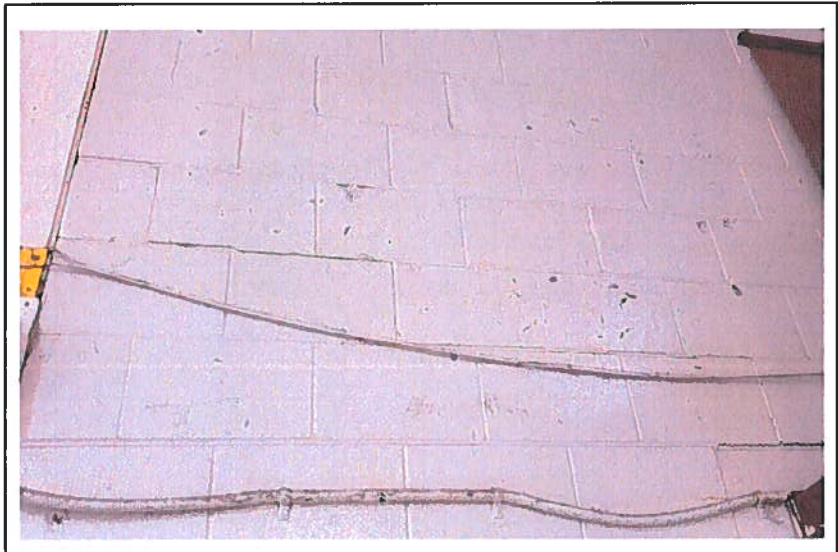
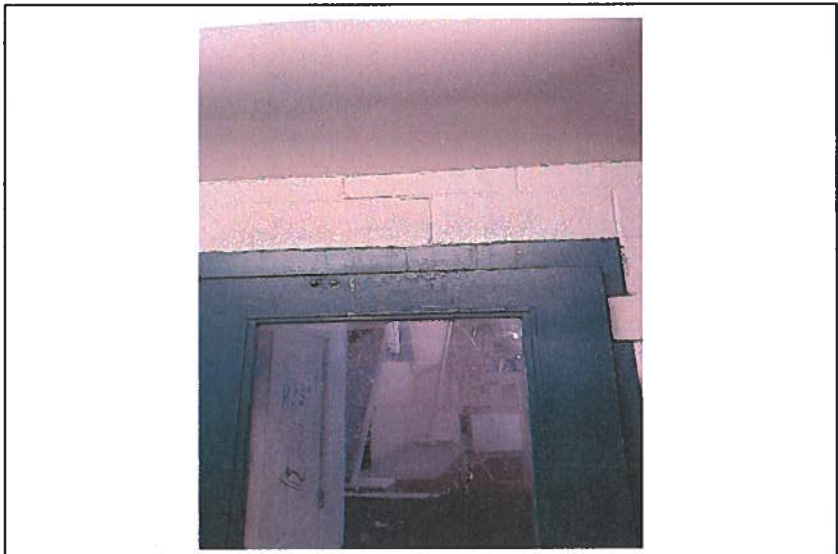
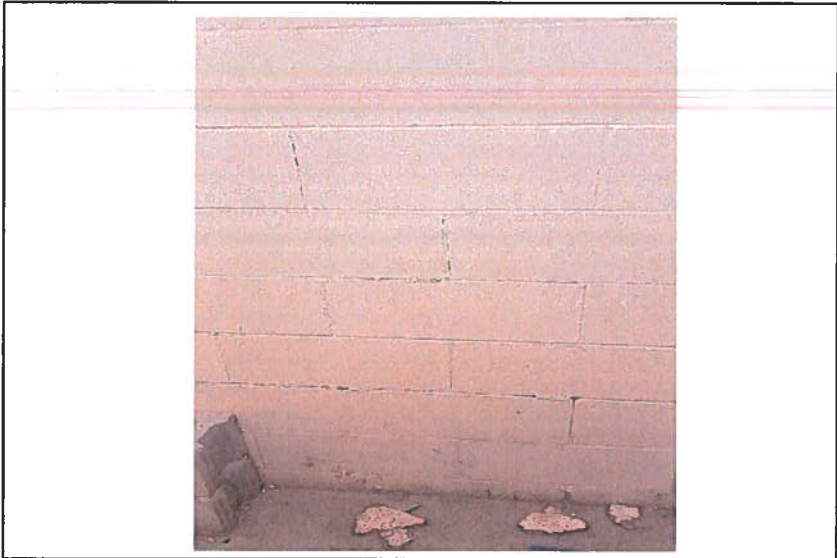
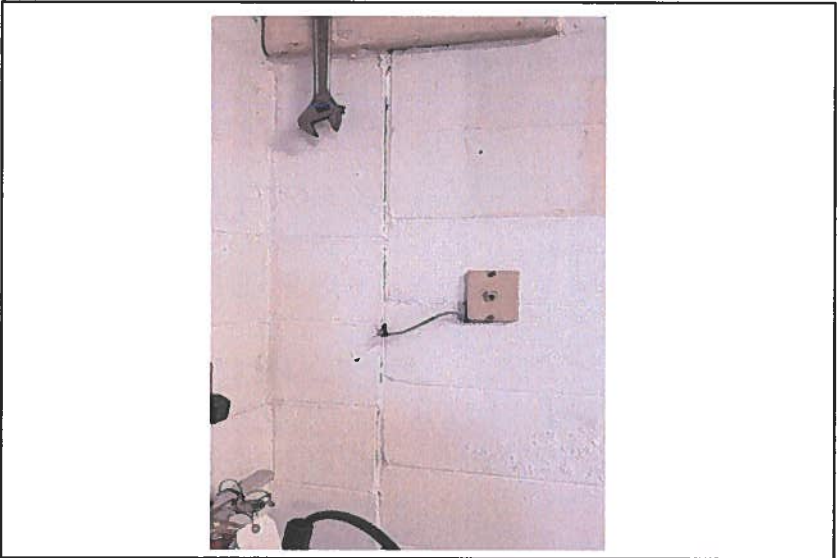
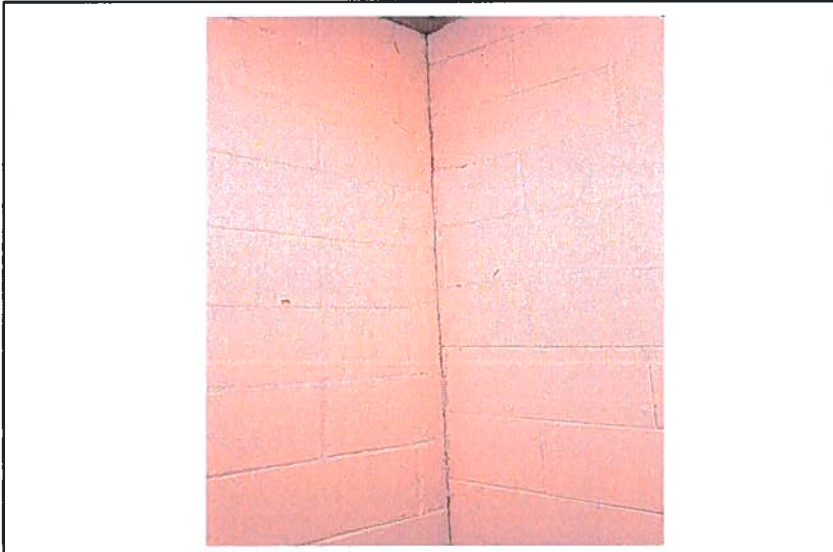
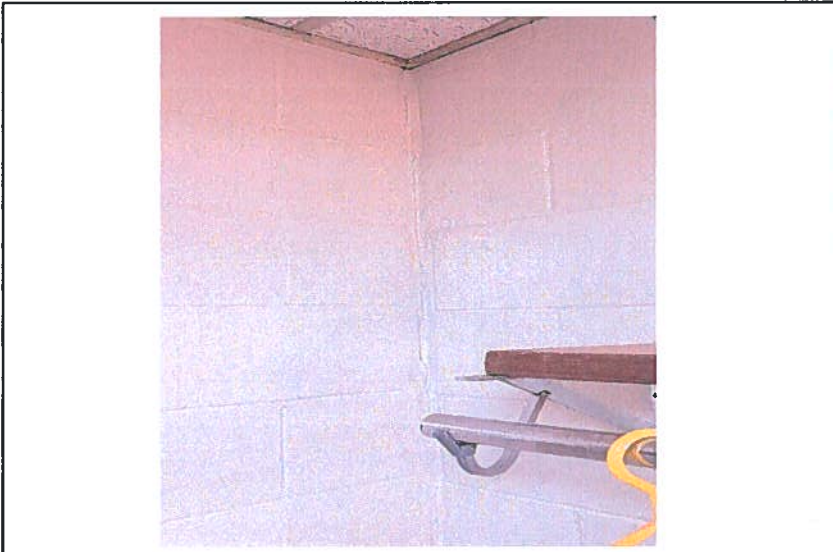
- Minor to moderate step cracking was observed at several localized areas within the arena (Photos 027, 028, 029, 030, 031, 032, 033 and 034). This is typical under the serviceability conditions for this type of structure and does not pose a structural concern. We recommend that all open/cracked joints be routed out and infilled with suitable mortar to prevent moisture from entering the building.

Photo 027 Step Cracking and Block Gapping

Photo 028 Multiple Step Cracks Behind Water Tank

Photo 029 Step Cracking Along South-Face Wall

Photo 030 Step Cracking in Lobby

Photo 031 Minor Step Cracking in West-Side Stairwell

Photo 032 Mortar Joint Cracking in Compressor Room

Photo 033 Mortar Joint Cracking in West-Side Stairwell

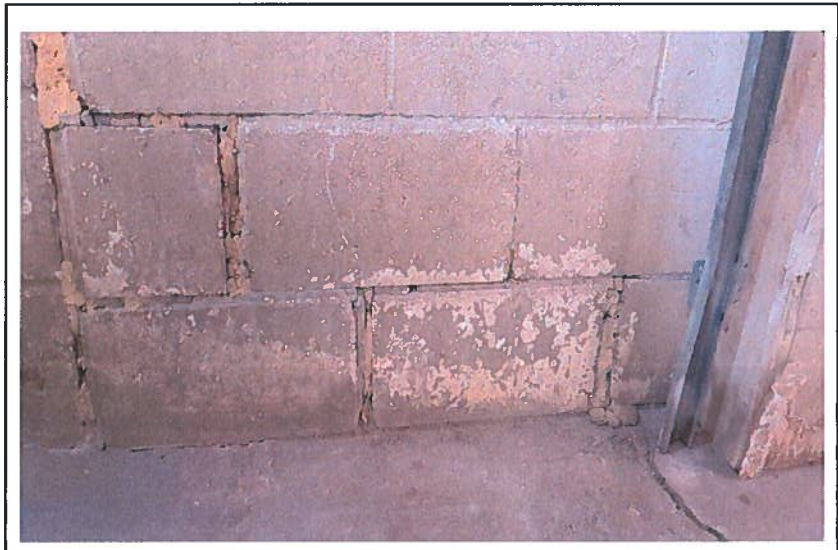
- Previous differential settlement was observed in the ice resurfacing room (Photo 036). The separation appeared to be infilled with spray foam insulation (Photo 037). This does not appear to be a new condition and does not pose structural concern. At this time we recommend that joint filler be removed and replaced with suitable mortar.

Photo 036 Differential Settlement in Ice-Resurfacing Room

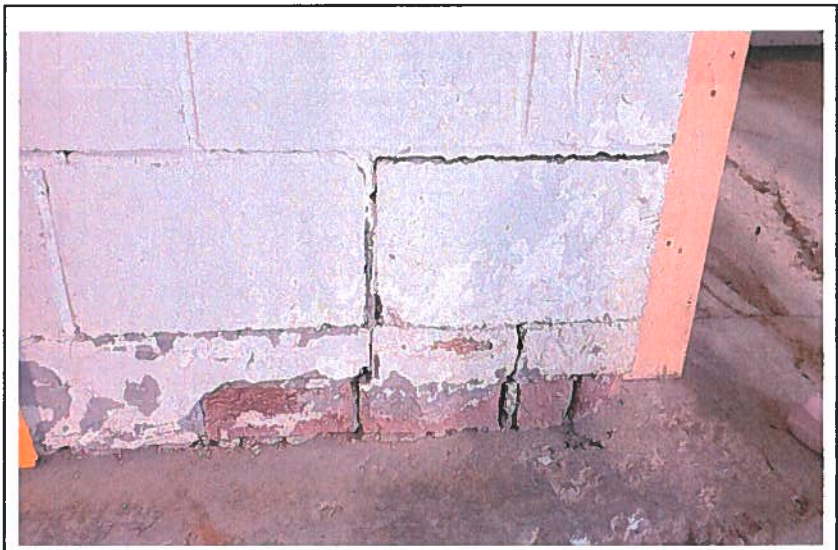
Photo 037 Existing Block Separation Repairs

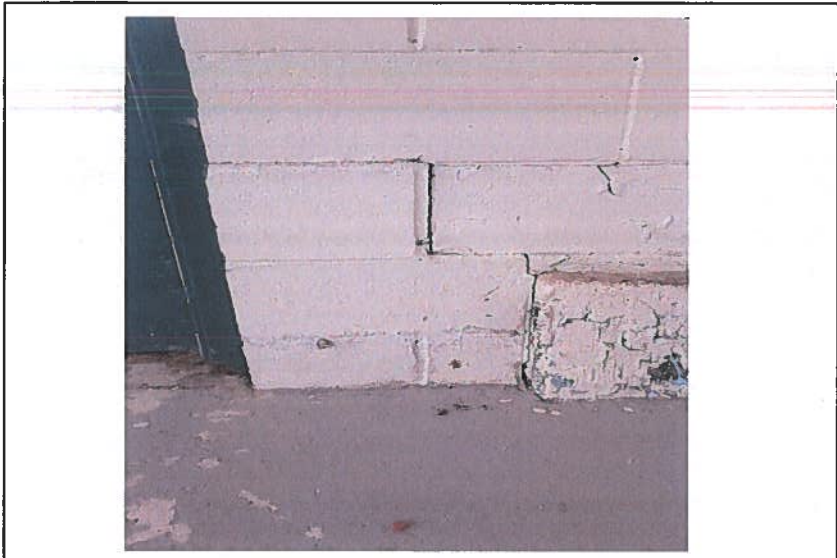
- Deterioration and displacement at the base of the concrete masonry block was observed at a localized area (Photo 038). We recommend that the deteriorated blocks be removed and replaced with concrete masonry blocks to match the existing condition.

Photo 038 Block and Joint Damage

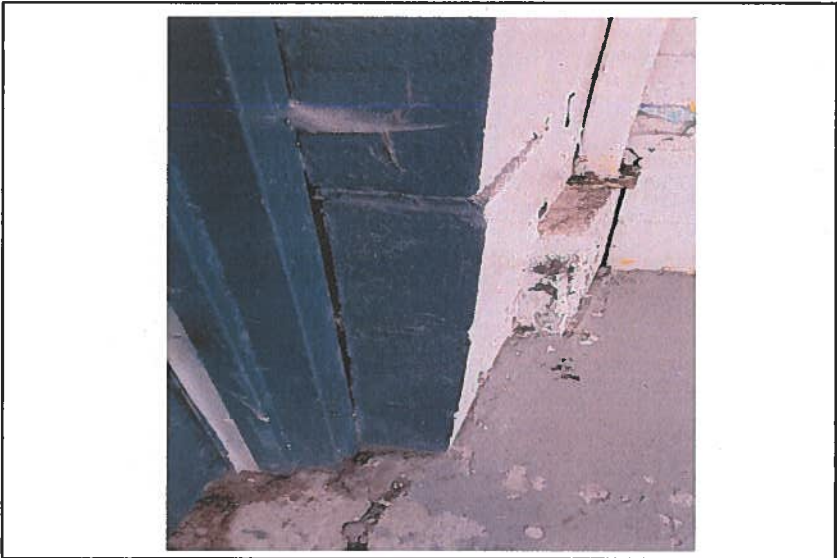
- Minor step-cracking along at the north side exit was observed (Photo 039). The wall at this location appeared to be slightly displaced from the original location at the base (Photo 040). We recommend that the displaced section of the wall be temporarily shored to facilitate the removal and rebuilding of the wall to restore to original conditions.

Photo 039 Step Cracking and Damage to West-Side Exit

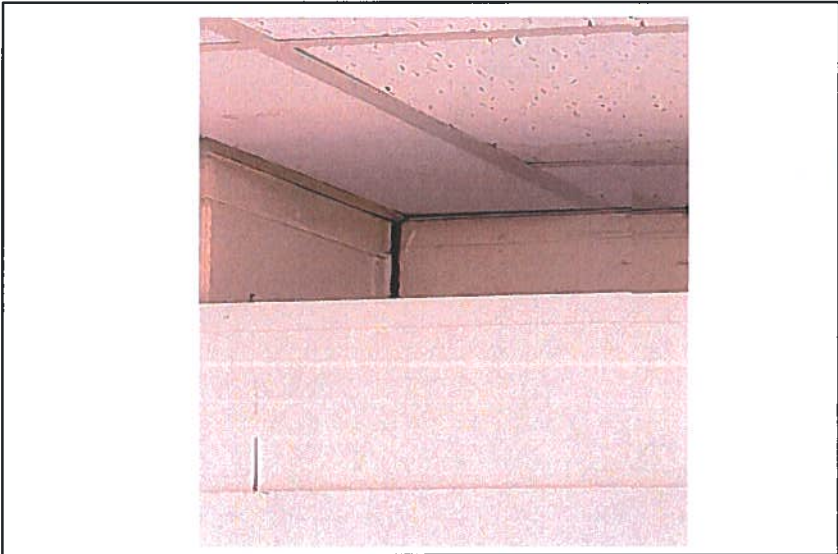
- A steel lintel in the mechanical room adjacent to changeroom 3 was observed to be bearing on a single masonry block experiencing localized cracking (Photo 048). We recommend replacing the steel lintel with a new, longer lintel with a minimum of 6" bearing on each side of the opening.

Photo 048 Localized Block Failure

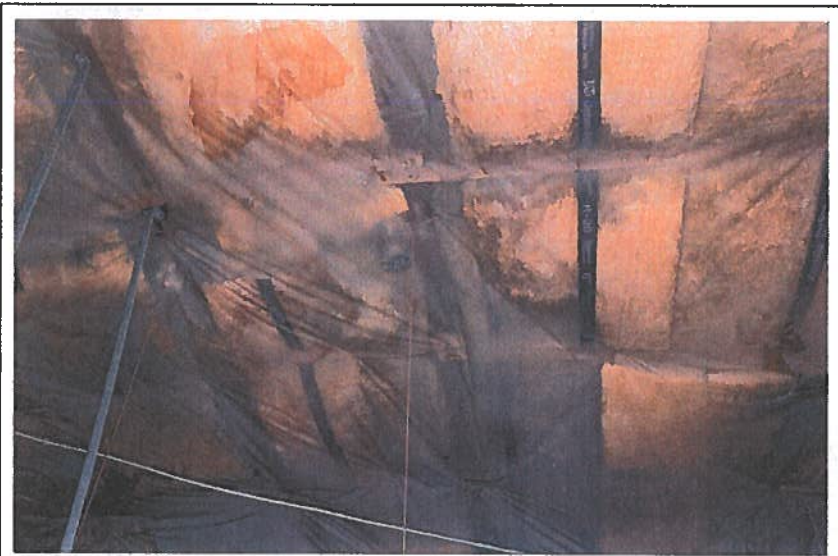
- Moisture damage was observed at the underside of the insulation. (Photos 059 and 060). This moisture is possibly damaging the roof framing system. We recommend that further intrusive testing be done to inspect the condition of the roof framing system.
- Numerous signs of moisture damage was observed by the water stains and plastic breakthroughs of the ceiling tiles (Photos 061 and 062).

Photo 059 Moisture in Roofing System

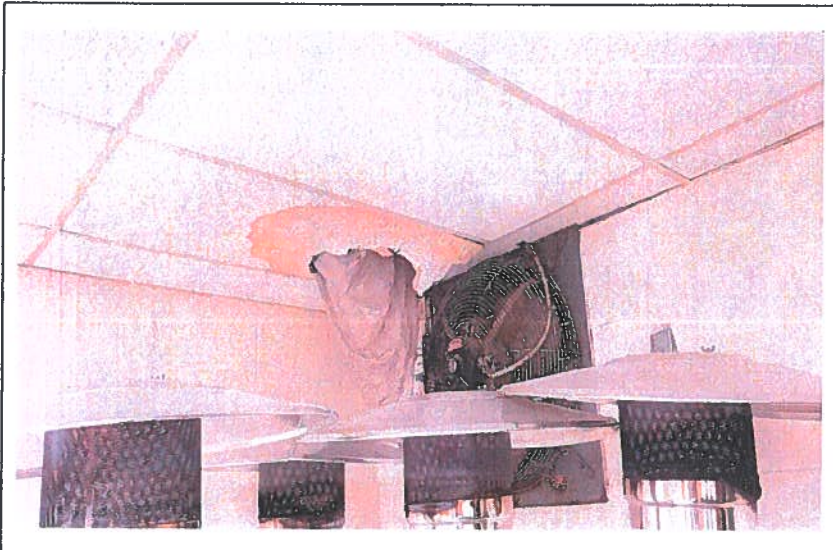
Photo 061 Signs of Moisture Damage

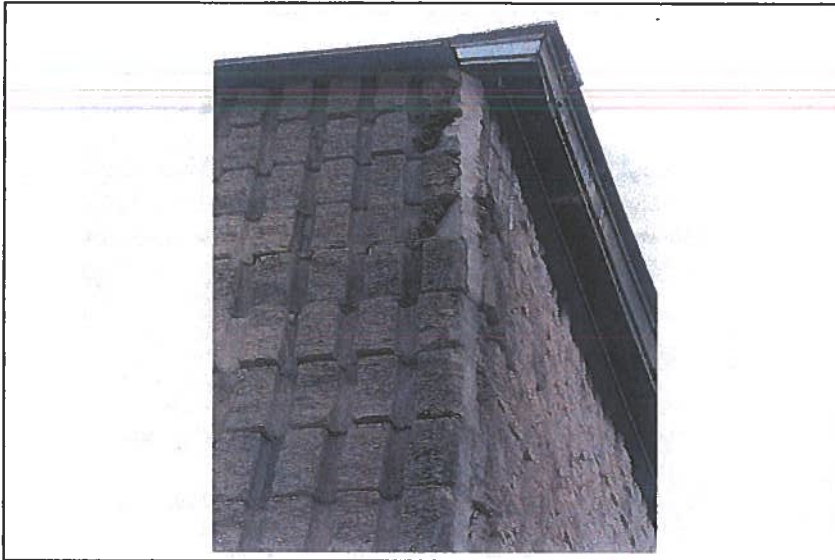
- Minor cracking of the mortar joints was observed along the architectural precast concrete wall panels at localized areas (Photo 065).
- Localized damage to single brick in the architectural precast concrete wall panels was observed (Photo 066). We recommend for the architectural precast concrete wall panels to be repaired and patched with a suitable repair mortar to prevent further deterioration of the architectural wall.

Photo 066 Localized Brick Damage

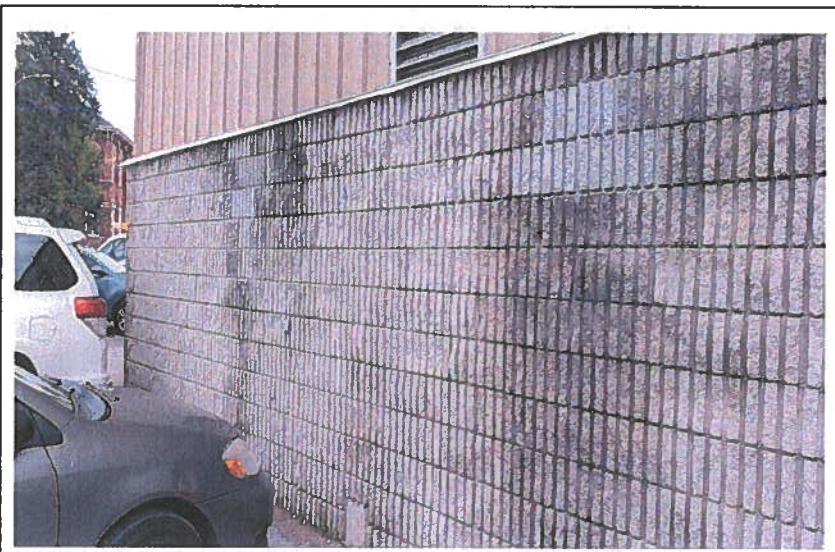
- Localized block damage was observed near the roof at the South-East Corner (Photo 067). We recommend for the architectural precast concrete wall panels to be repaired and patched with suitable repair mortar to prevent further deterioration of the architectural wall.

Photo 067 Localized Block Damage at South-East Corner

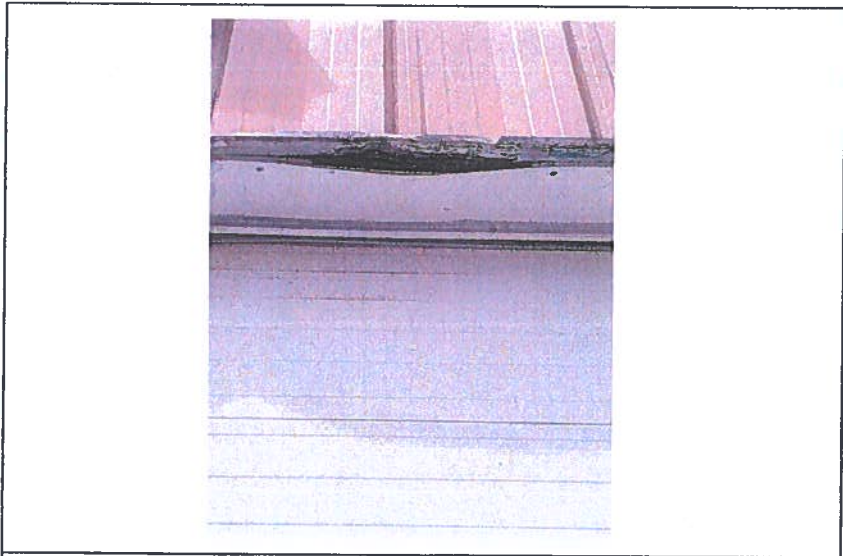
- Caulked panel joints along architectural precast concrete wall panels appear to be in good condition (Photo 075).
- Metal cladding above architectural precast concrete wall panels appears to be in good condition (Photo 076).
- Minor damage to the metal was observed above the garage door opening near the North side (Photo 077). A section of the steel lintel enclosed by the metal was visible at the damaged location and the lintel was observed to be in poor condition with significant rust accumulation and loss of cross-sectional area (Photo 078). We recommend that this lintel be exposed, removed and replaced with a new lintel to match existing conditions, and the damaged metal siding be repaired/replaced to restore to original conditions. to match the surrounding area.

Photo 077 Damage to Garage Door Opening

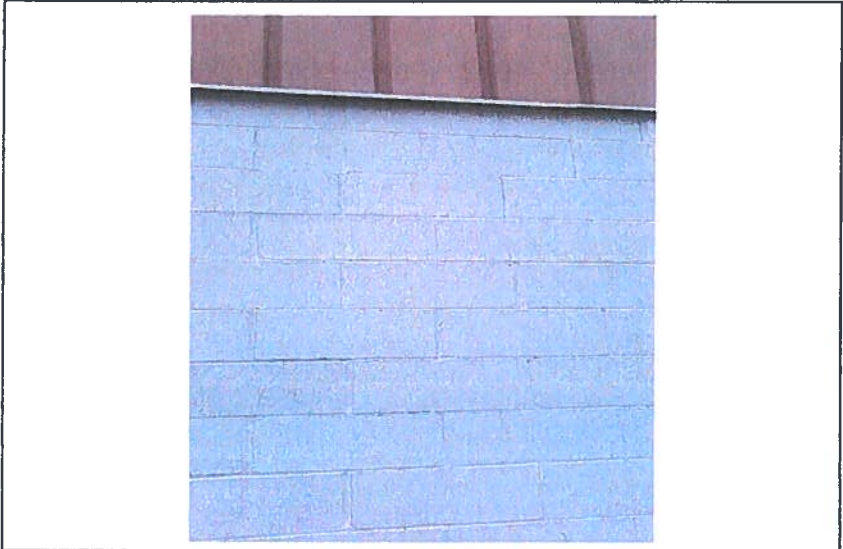
Photo 080 Step Cracking and Paint Peeling

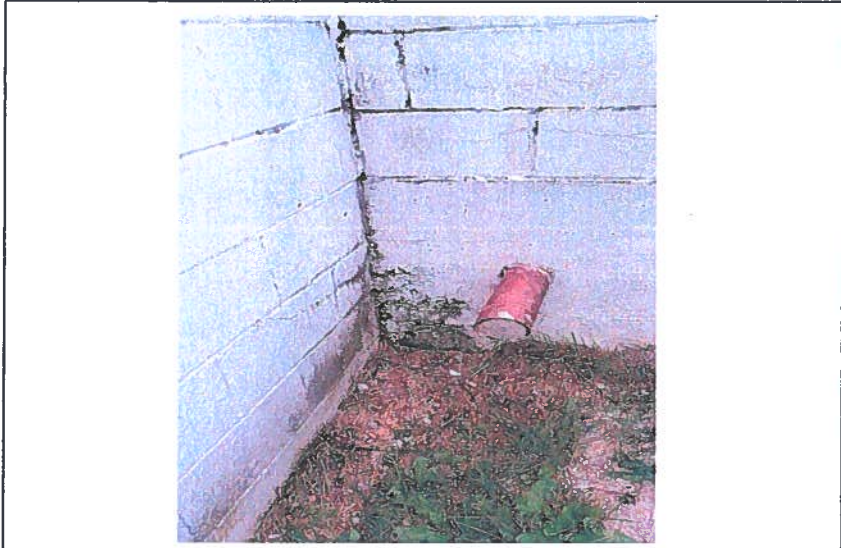
Photo 081 Step Cracking and Block Failure

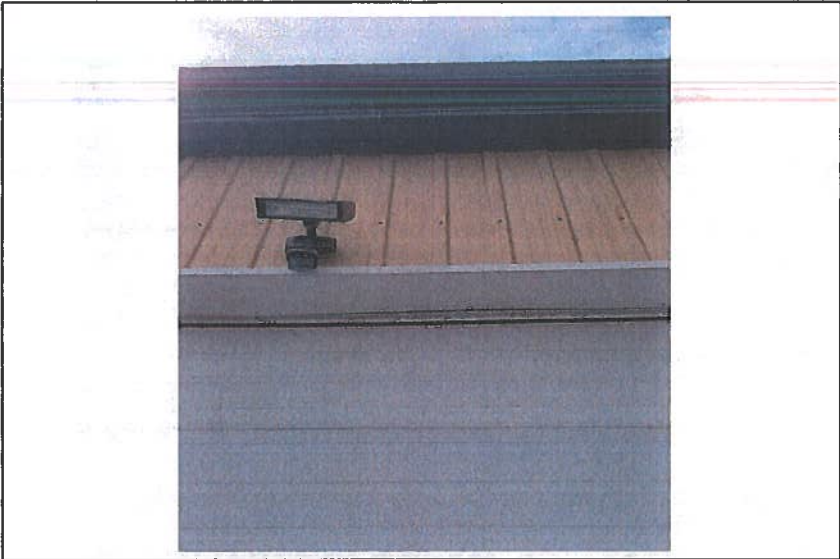
Photo 086 Damage to Garage Door Entrance

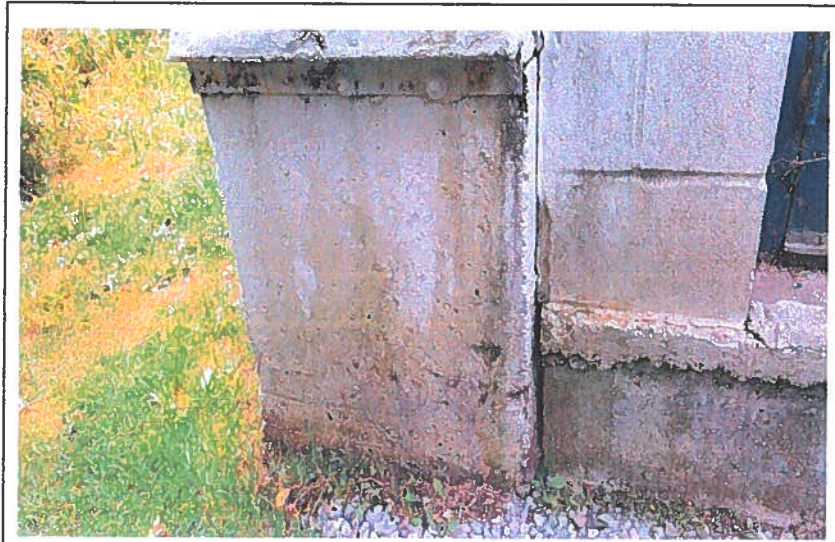
Photo 088 Mould and Moisture on Block Wal
