**BARRY BRYAN  
ASSOCIATES**

Re: **Consulting Services to Update Our Structural Investigation Report to Assess the Feasibility of Renovating the Millbrook Arena or Utilizing the Space in Other Ways  
4 Needlers Lane, Millbrook, Ontario  
BBA Project No. 22059 (REVISED)**

This structural condition audit has been undertaken by Barry Bryan Associates, Architects, Engineers, and Project Managers, for the Millbrook Arena, on behalf of the Township of Cavan Monaghan. Authorization to undertake this study was received from Mr. Gerry Barker, Park and Facilities Manager for the Township of Cavan Monaghan.

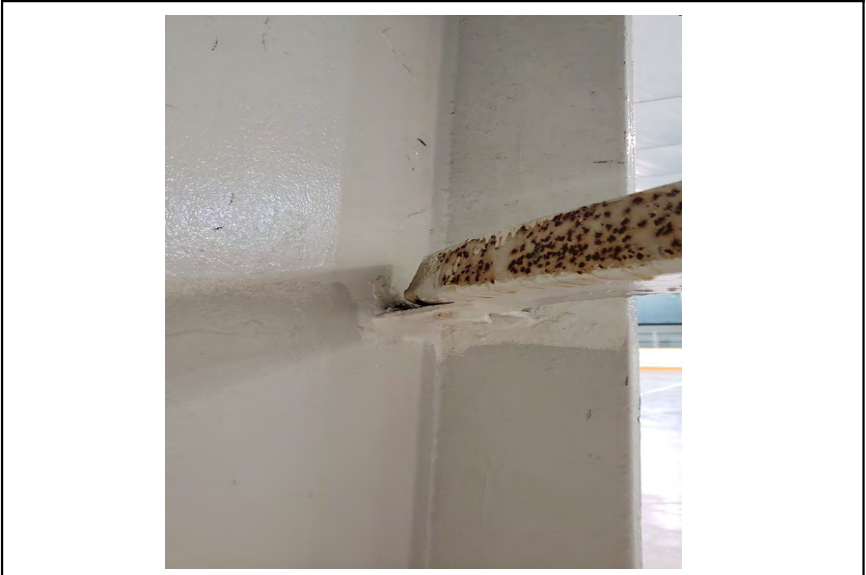
Photo 003 Pre-Engineered Frame

- Minor damage was observed at the surface of the frames resulting from repeated puck impacts (Photo 003). For aesthetics purposes, we recommend that the damaged area is cleaned and painted as required to match original conditions.

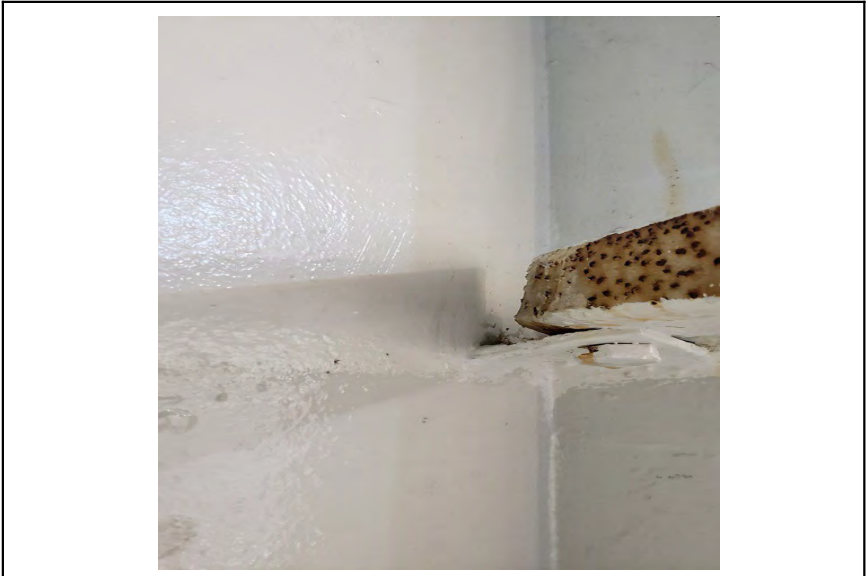
Photo 004 Rust on Frame Brace

- Minor localized surface rusting was observed along several bracing members (Photo 004). This is likely due to condensation and high humidity during occupancy. We recommend for the rusted area to be wire brushed clean to bare metal and an epoxy protective coating is applied.

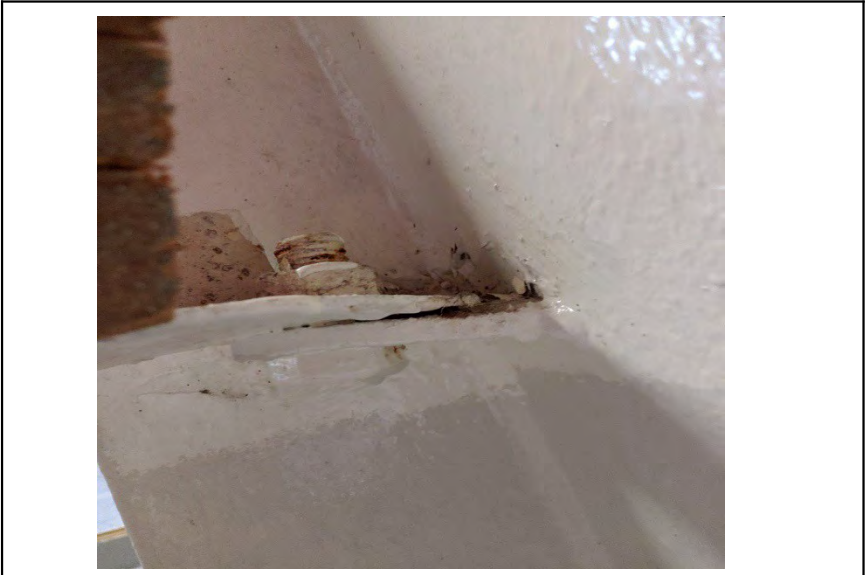
Photo 005 Bent Connection

- Bolted connections at the braces appeared to be bent at several locations, effectively causing the nut to be displaced (Photo 005). This appears to be an original condition from the fabrication of the braced connections. Further, minor surface rusting was observed at several bolted connection locations (Photo 006). We recommend for the rusted areas be wire brushed clean to bare metal and an epoxy protective coating is applied.

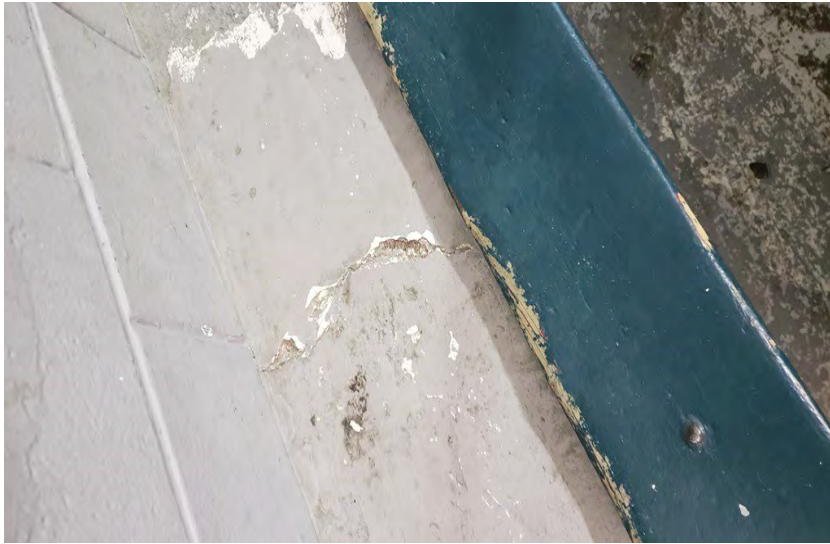
Photo 009 Bent Braced member

- Insufficient anchor bolt thread protrusion was observed at several locations. The threads at several bolted connection was not observed to extend past the nuts at the pre-engineered frame base connections (Photo 007). As this condition does not meet the minimum code requirements for thread protrusion past the nut, we recommend that the locations be plug welded to ensure connection to the foundation below is adequate.
- The lower set of braces were observed to be missing along the bleachers (Photo 008). This appears to be an as-built condition as the braces would interfere with the bleacher seating area. A single brace at the south side of the arena appears to be experiencing some deflection, this appears to be an as-built condition (Photo 009).

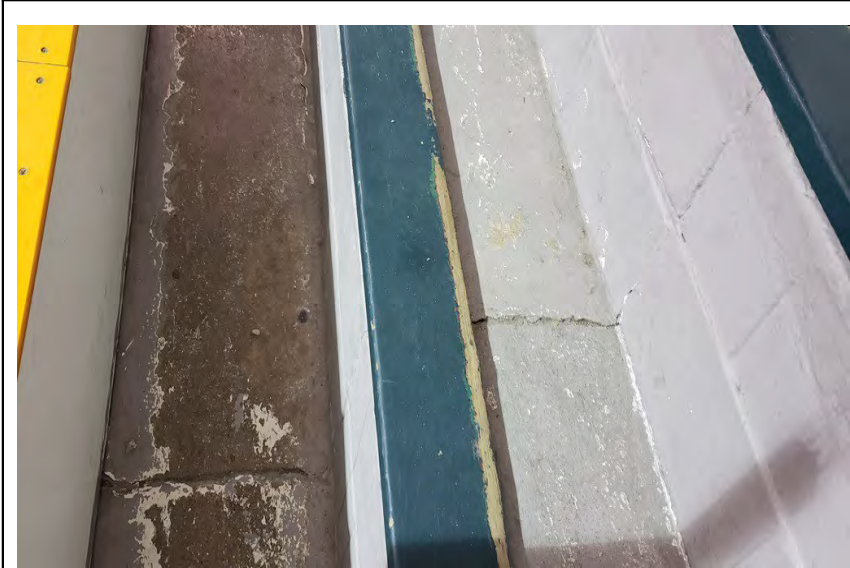
Photo 010 Paint Chipping and Crack on Bleachers

- The concrete topping was observed to experience localized minor cracking and paint chipping at localized locations (Photo 010). We recommend that all loose paint to be scraped and repainted to match existing conditions.
- Minor cracking was observed at the precast concrete joint location (Photo 011). This cracking is typical for concrete joint locations and is not a structural concern. We recommend for the joints to be routed out and infilled with a flexible calking material.

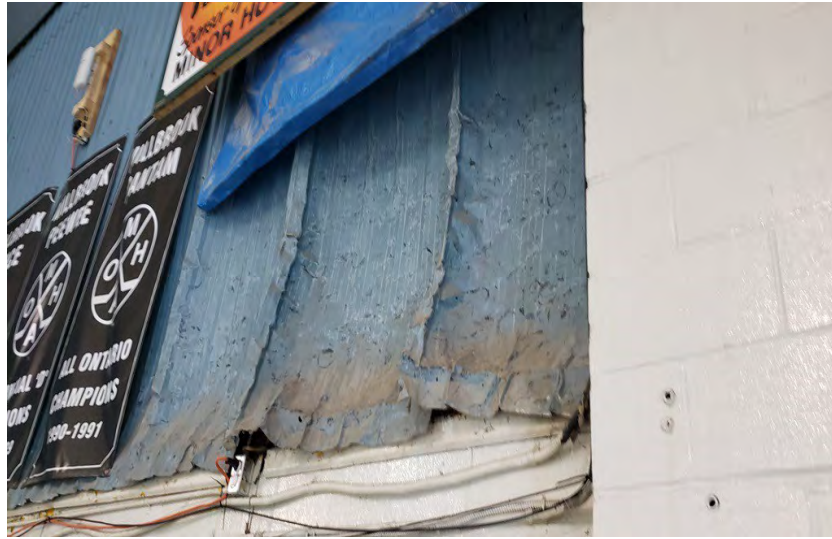
Photo 012 Localized damage to Metal Cladding

- Minor damage to the metal siding at the North-East corner was observed (Photo 012). This damage is likely a result of repeated impacts from pucks/balls within the arena. For aesthetics purposes, we recommend that the cladding is cleaned and painted as required to match original conditions.
- Significant damage to the metal cladding at the North Wall was observed (Photo 013). The cause of the damage is unclear. However, we recommend that the cladding be replaced at this location to restore to original conditions.
- The metal cladding at roof level along the North elevation appears to be separating from the adjacent cladding. We recommend that the cladding at the roof level be re-secured to match the existing conditions (Photo 014).

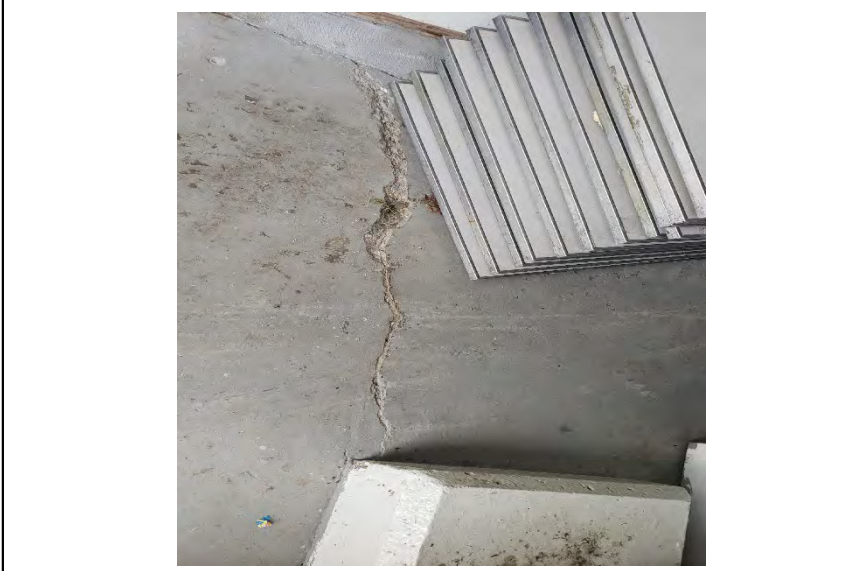
Photo 016 Thermal Cracking on Rink Slab

- Thermal cracking was observed throughout the entirety of the rink slab, the North side of the rink slab appeared to experience more cracking than the south side (Photo 016). This cracking is typical with age of concrete after years of pull-downs and thawing of the monolithic concrete slab.

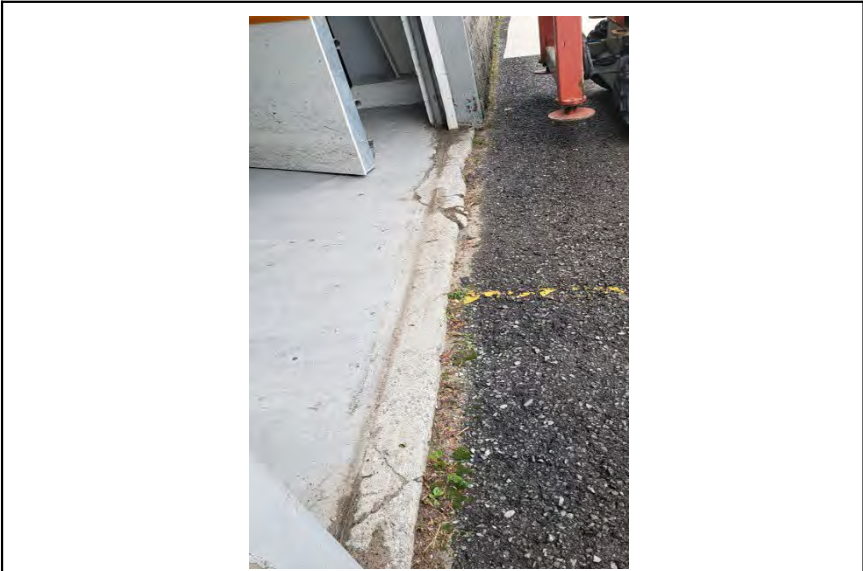
Photo 017      Cracking Outside of Compressor Room

- Moderate cracking was observed near the entrance of the compressor room (Photo 017). We recommend to infill the void space with suitable mortar to match existing conditions.

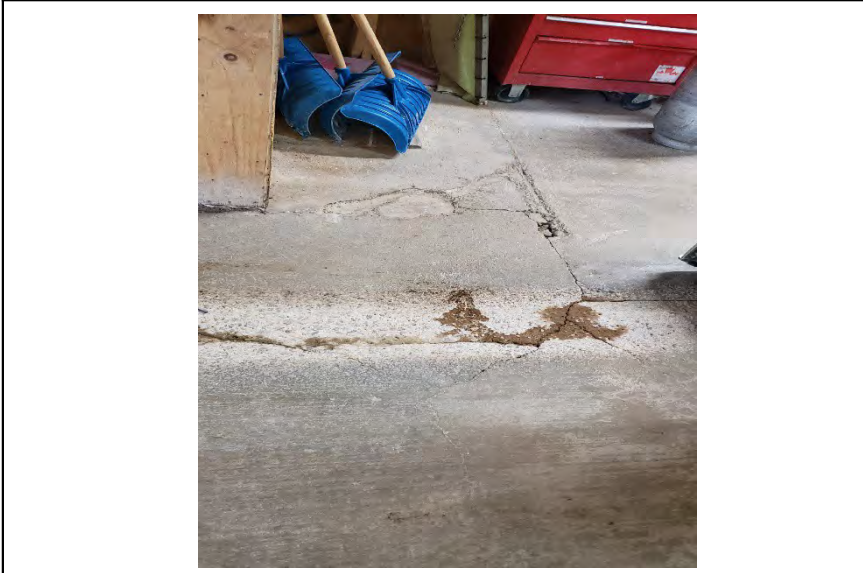
Photo 020 Resurfacing Room Rutting

- Rutting was observed in the ice-resurfacing room (Photo 020). This is likely due to driving on the slab prior to the concrete completely curing after the original pour, as well as the fatigue of the concrete over the decades of repeated loading.

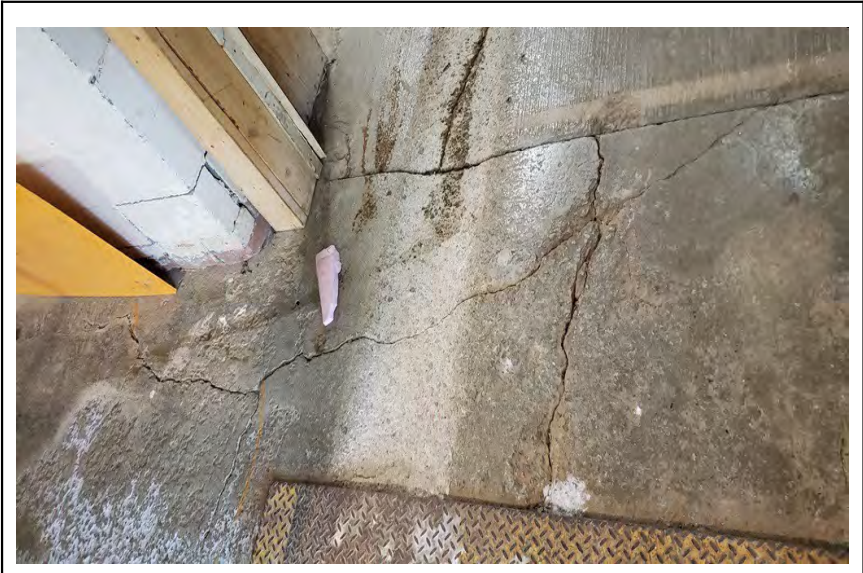
Photo 021      Cracking Starting in Resurfacing Room

- Significant cracking was observed in the ice-resurfacing room extending outwards towards the dasher boards of the pad (Photos 021 and 022). This is likely due to repeated water/salts brought through the room by the resurfacing equipment over the years. We recommend for all loose and unsound concrete to be chipped out and removed and patched with a suitable repair mortar.

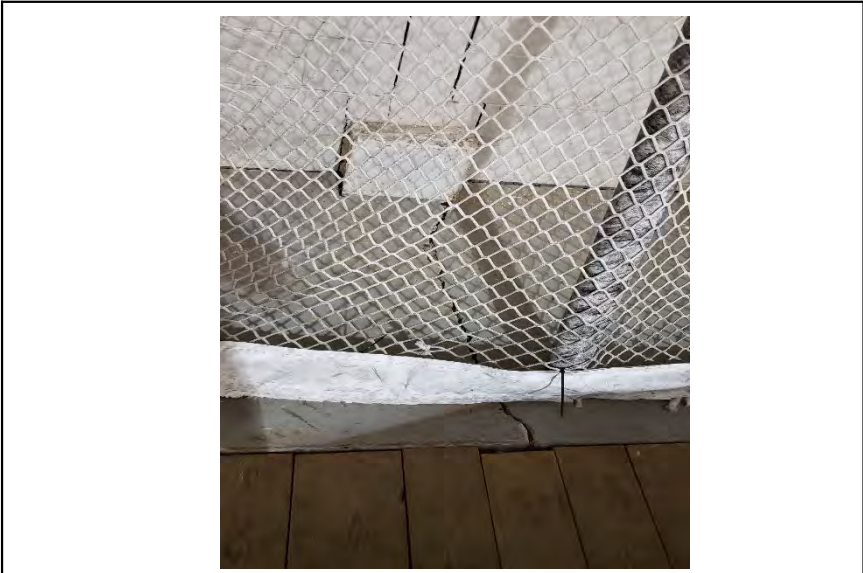
Photo 023      Cracking Under North-Side Column

- Two (2) separate cracks were observed at the base of two (2) of the steel columns at the North side of the arena (Photos 023 and 024). This is likely due to the absence of slab saw cuts at the column locations. This is a serviceability issue and not a structural concern at this time.

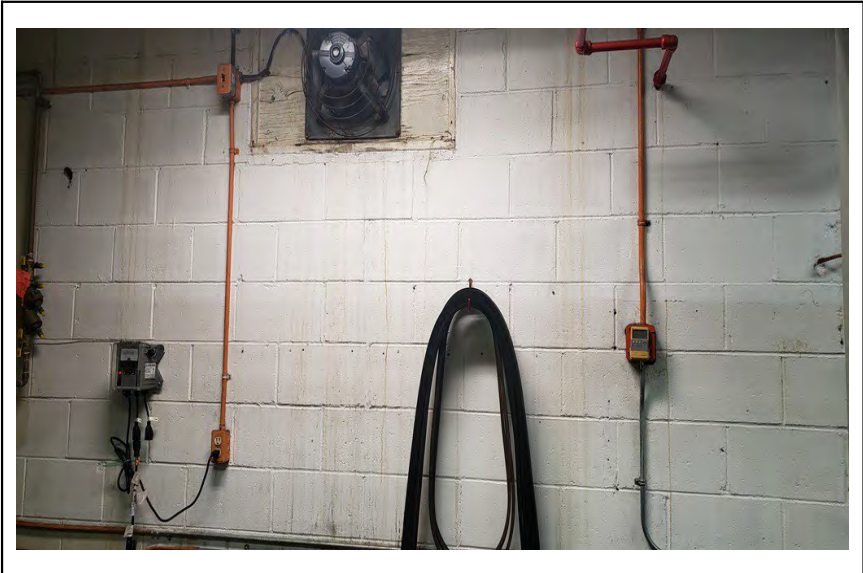
Photo 025 Crack Underneath Mechanical Equipment Stand

- Cracking was observed underneath the mechanical equipment stand supports at the North-West side of the arena (Photo 025). It appears as though a concrete levelling product has been implemented in the past, resulting in a slight transition between the floor elevations. We recommend that the transition be leveled, and the cracks be infilled with suitable mortar.

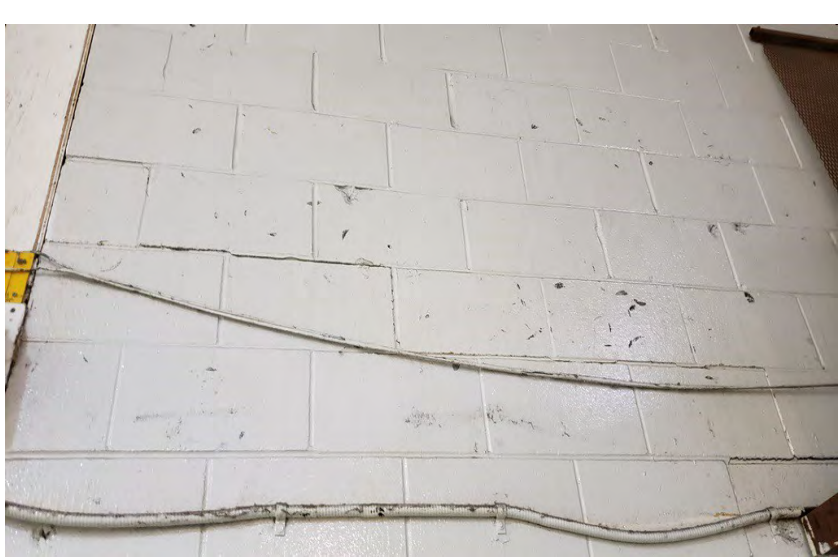
Photo 028 Multiple Step Cracks Behind Water Tank

- Minor to moderate step cracking was observed at several localized areas within the arena (Photos 027, 028, 029, 030, 031, 032, 033 and 034). This is typical under the serviceability conditions for this type of structure and does not pose a structural concern. We recommend that all open/cracked joints be routed out and infilled with suitable mortar to prevent moisture from entering the building.

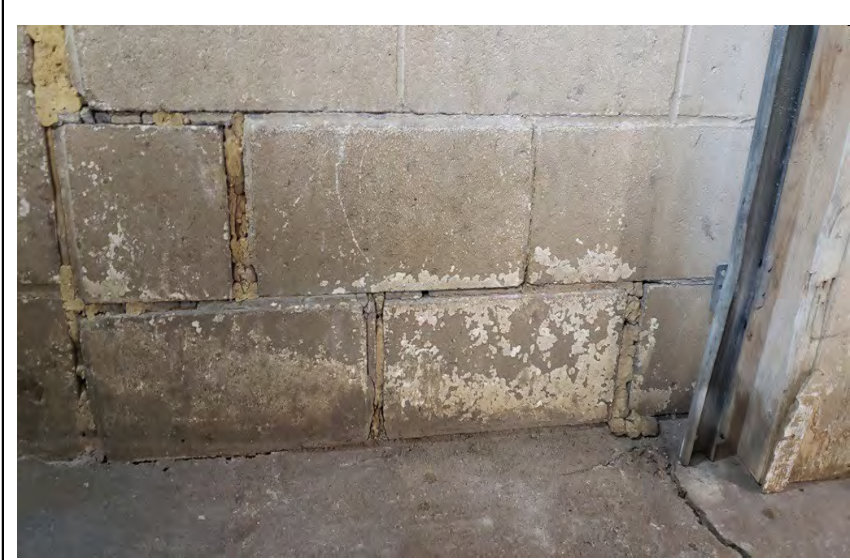
Photo 036 Differential Settlement in Ice-Resurfacing Room

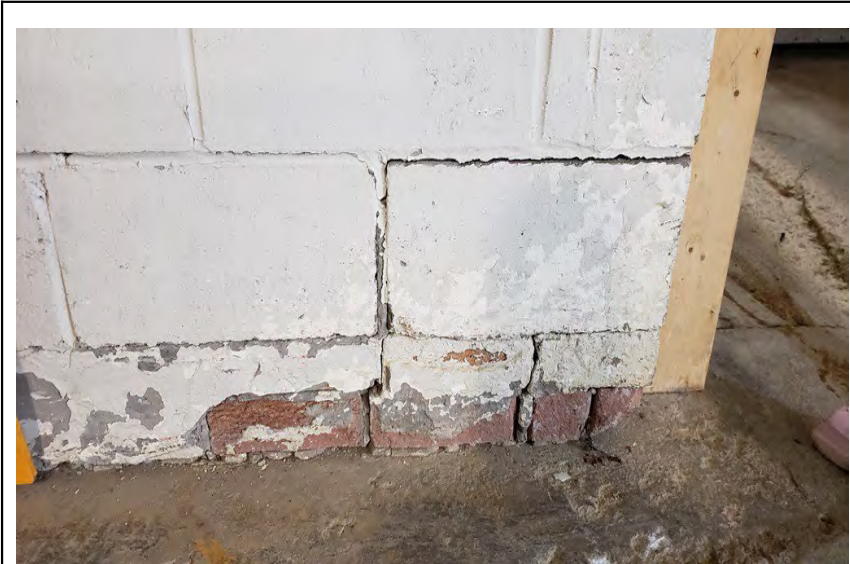
Photo 037 Existing Block Separation Repairs

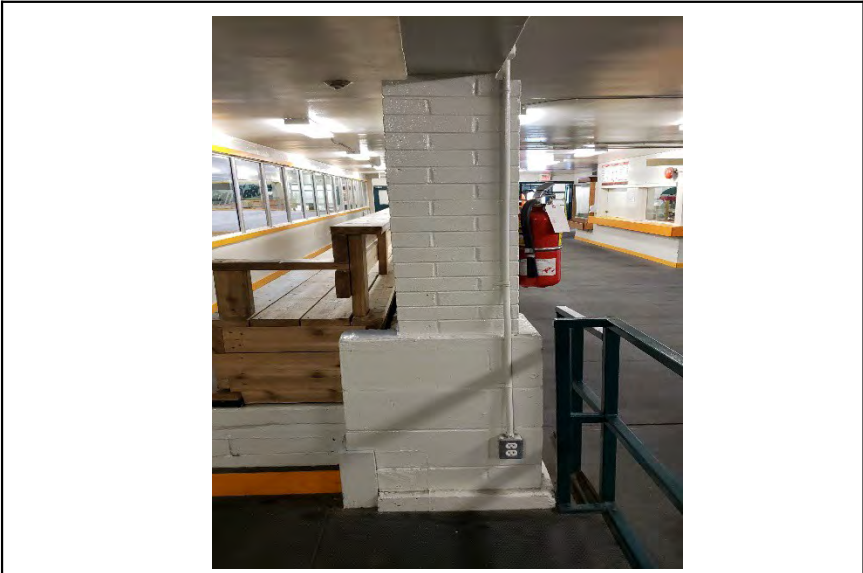
Photo 043 Localized Damage in Changeroom 3

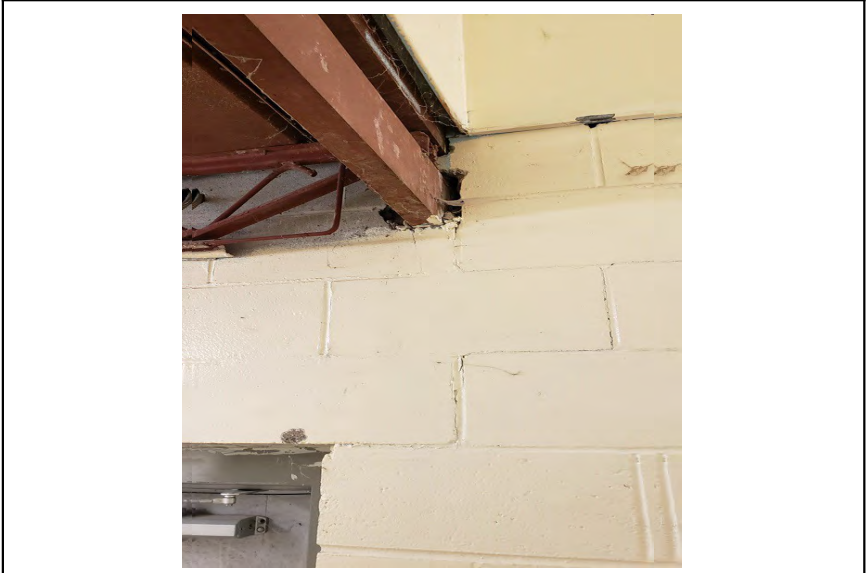
Photo 046 Paint Chipping and Moisture Damage

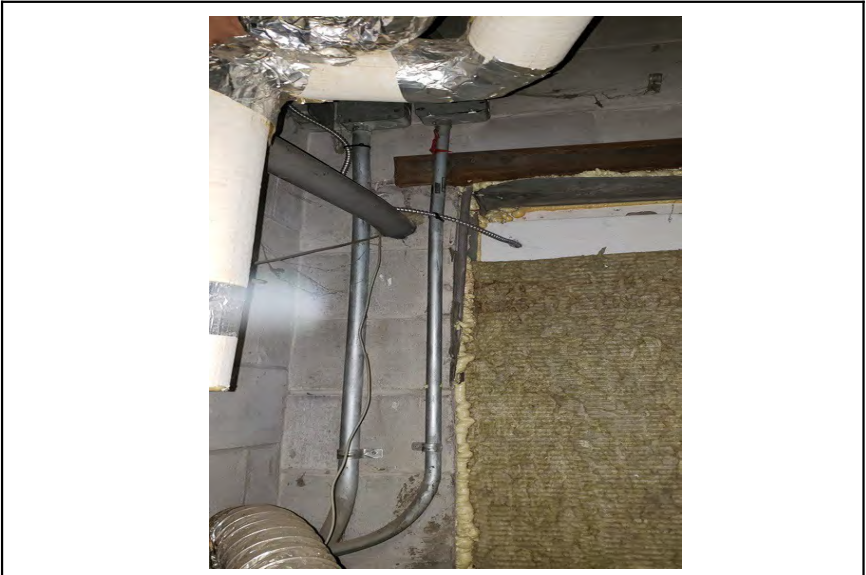
Photo 047      Localized Block Failure

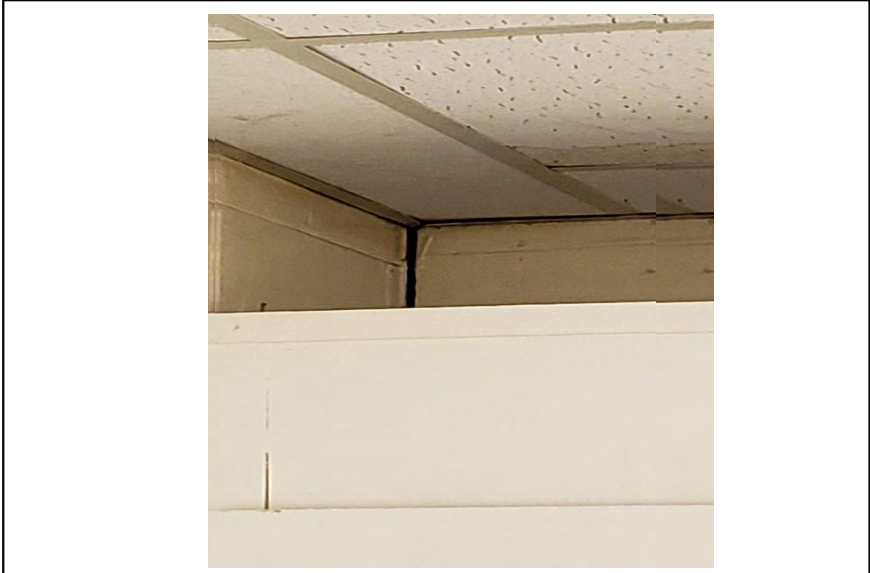
Photo 048      Localized Block Failure

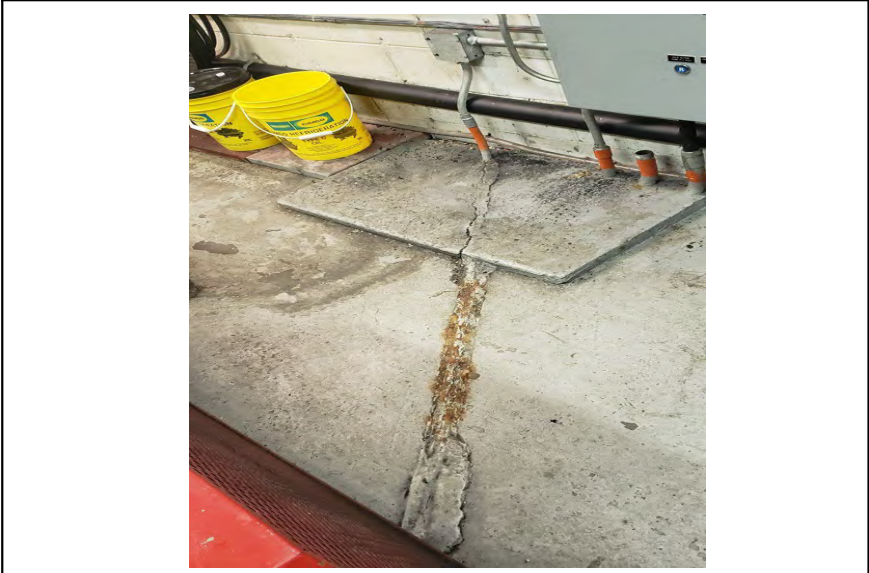
Photo 052 Concrete Staining in Compressor Room

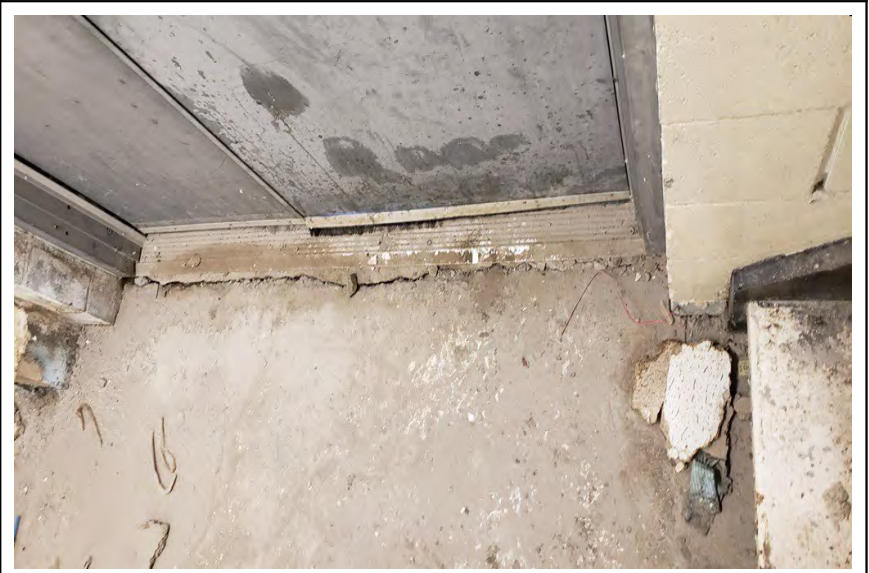
Photo 053 Concrete Damage at Electrical Equipment in Compressor Room

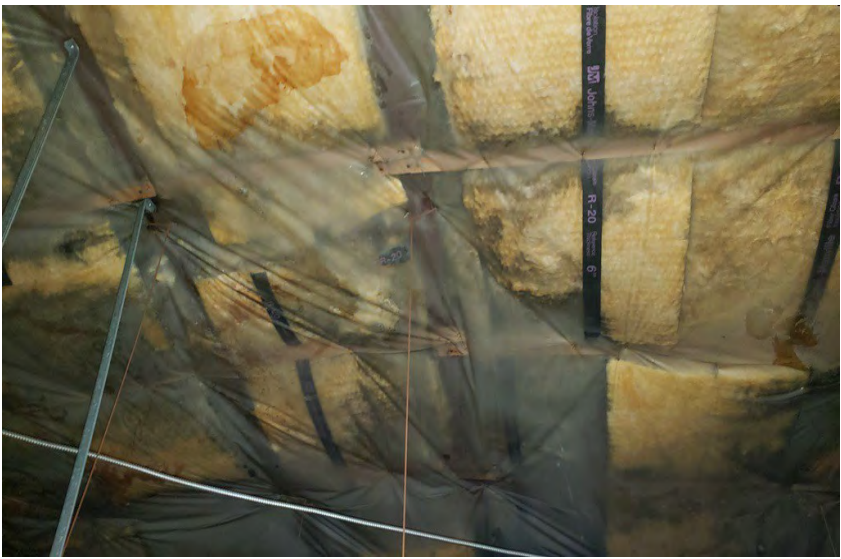
Photo 059      Moisture in Roofing System

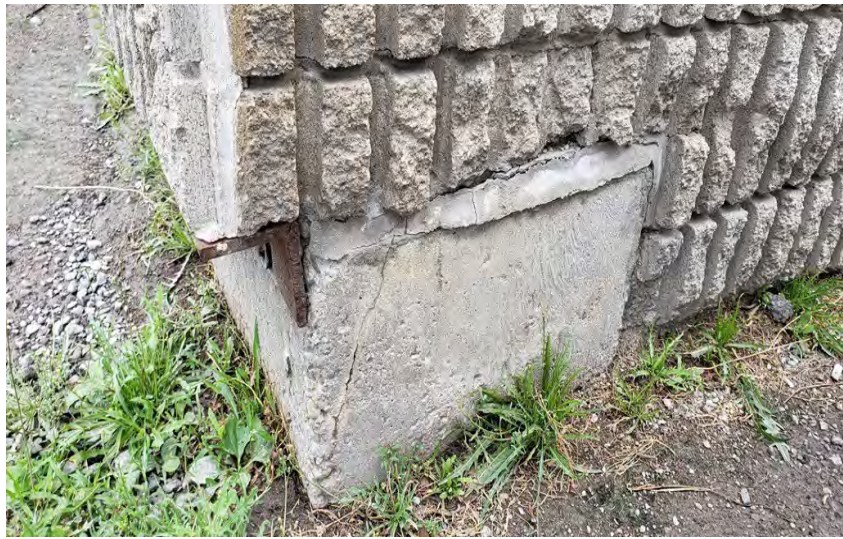
Photo 062      Signs of Moisture Damage

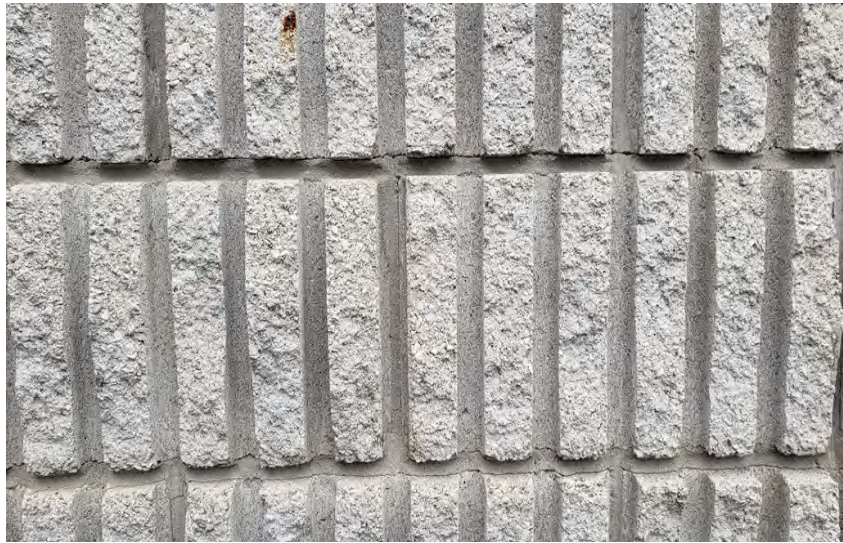
Photo 064 Cracking at Centre Foundation Wall

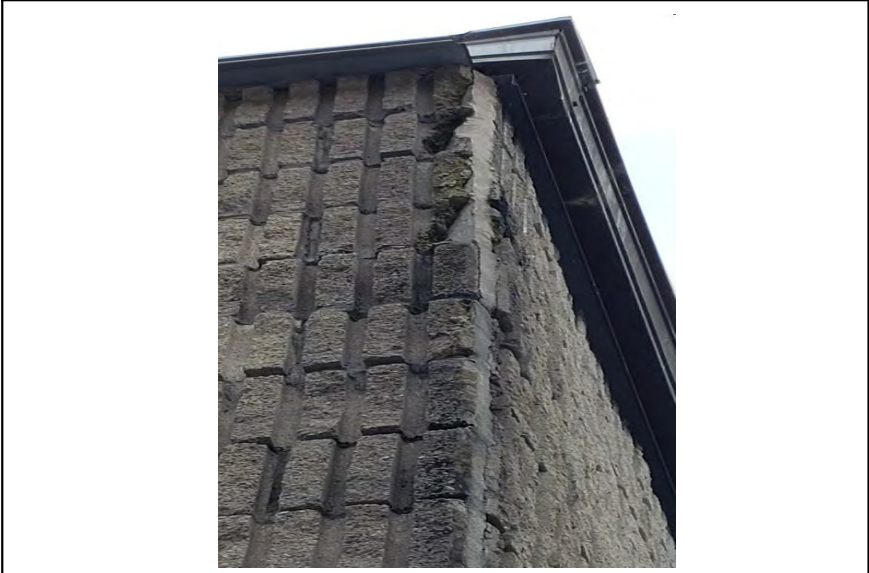
Photo 066 Localized Brick Damage

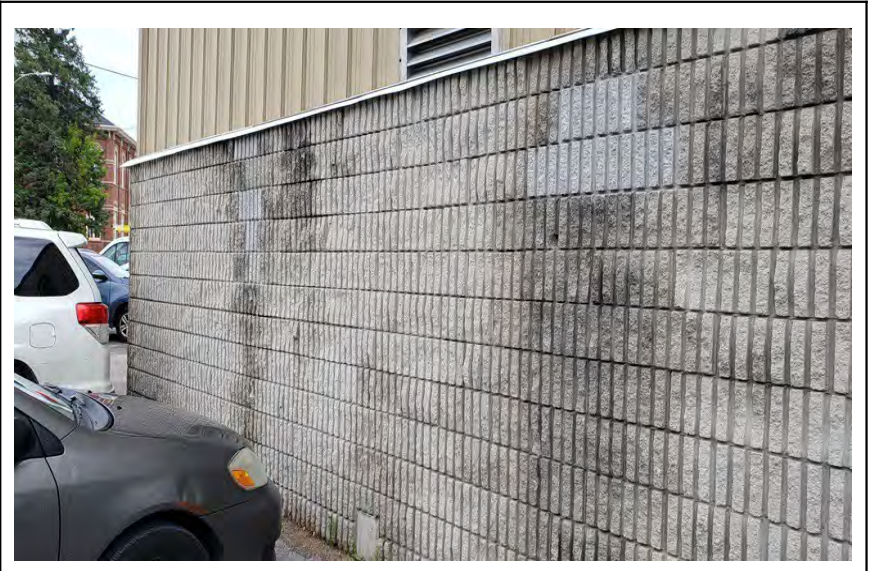
Photo 067 Localized Block Damage at South-East Corner

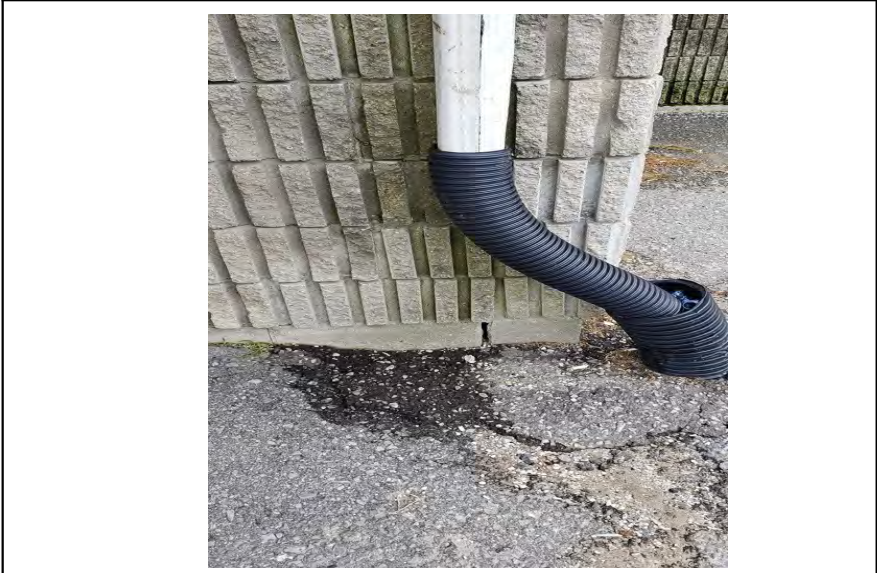
Photo 070 Damage to Sidewalk

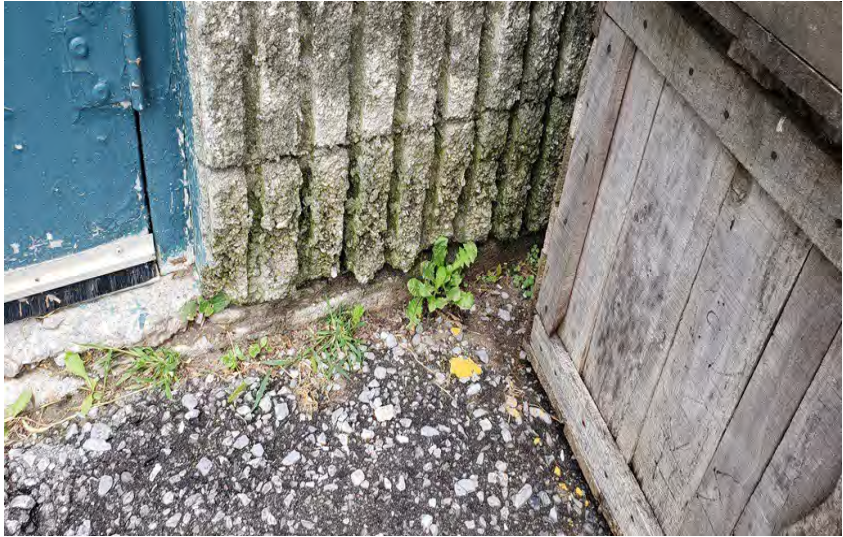
Photo 073 Moss Along East Side Wall

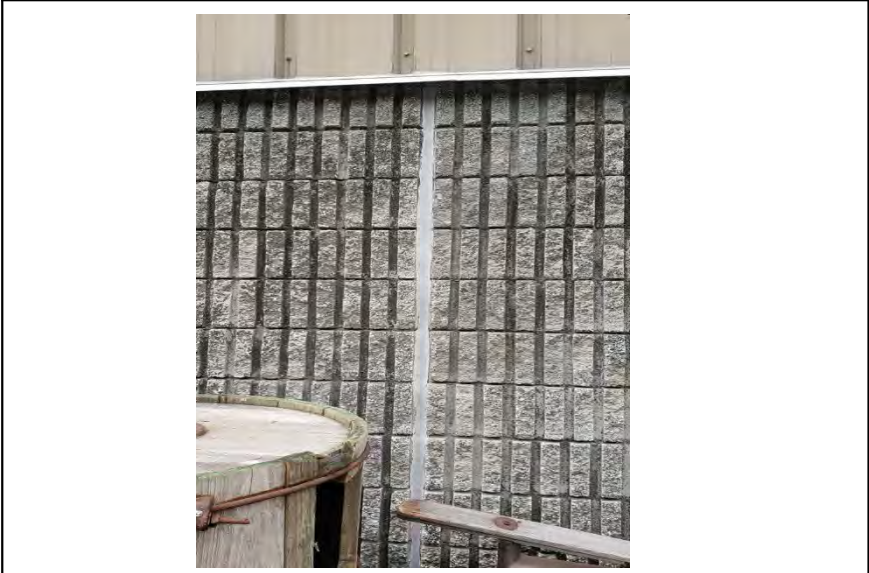
Photo 074 Deterioration of Blocks

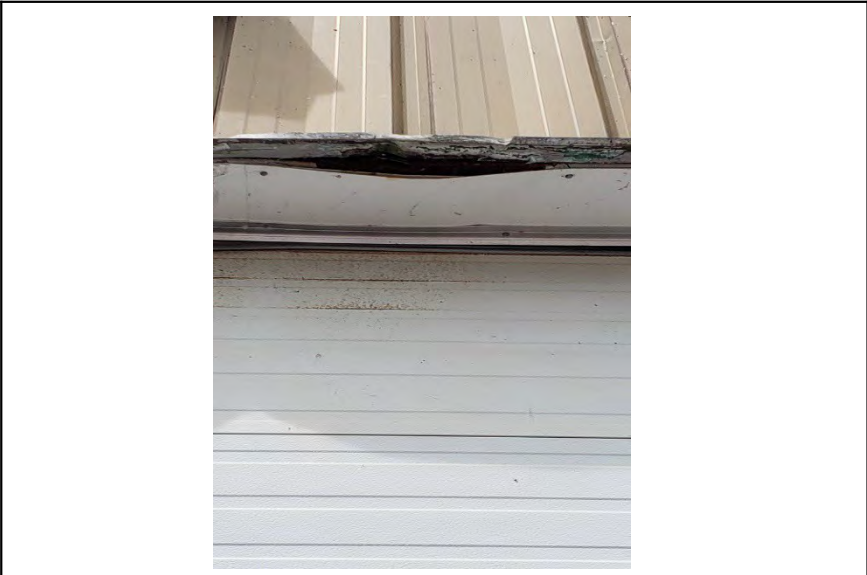
Photo 077      Damage to Garage Door Opening

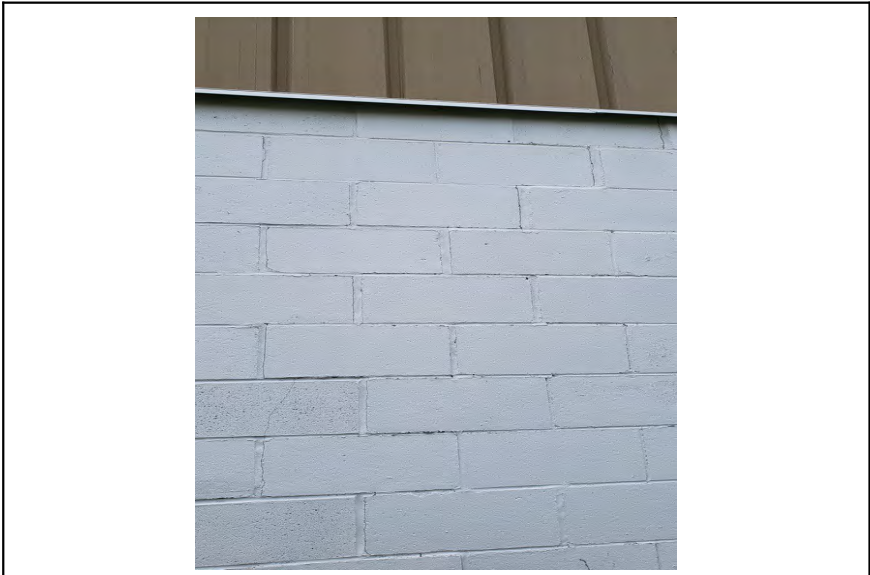
Photo 080 Step Cracking and Paint Peeling

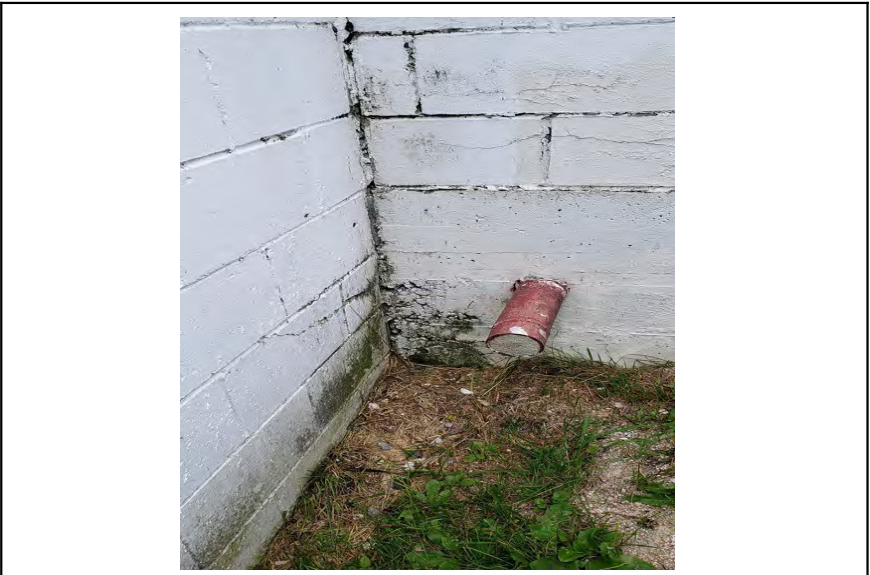
Photo 081 Step Cracking and Block Failure

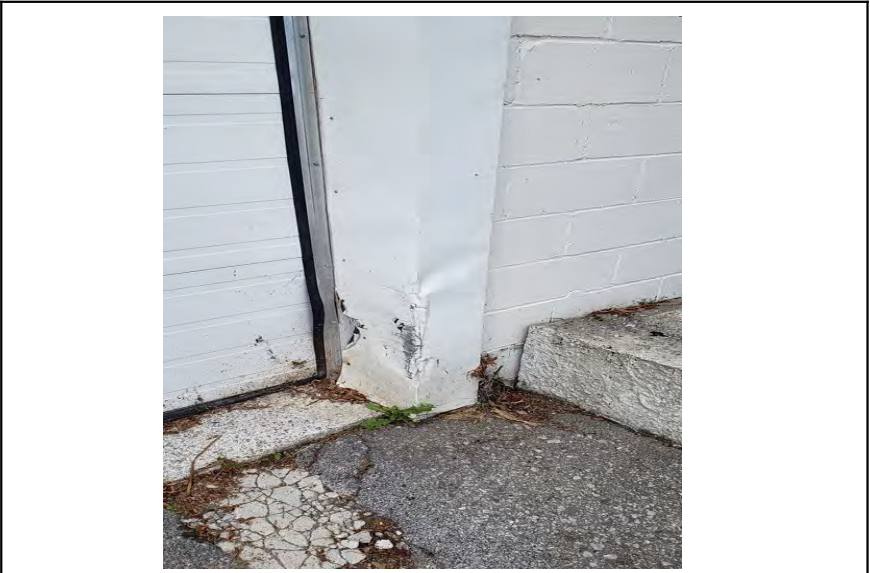
Photo 085      Damage to Garage Door Entrance

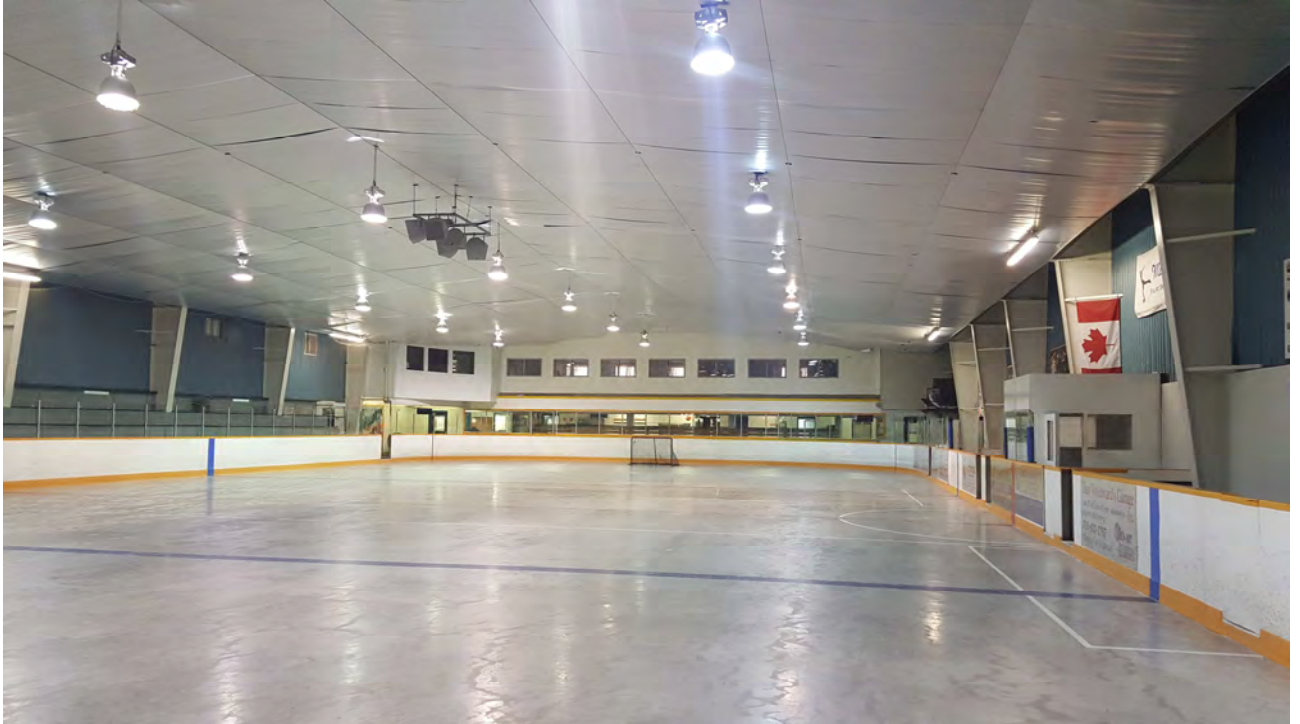
5.1 The ice surface lighting is 400W 347V Metal halide.

5.2 It is recommended to replace the existing metal halide fixtures with LED for improved control, instant on capability and longevity.

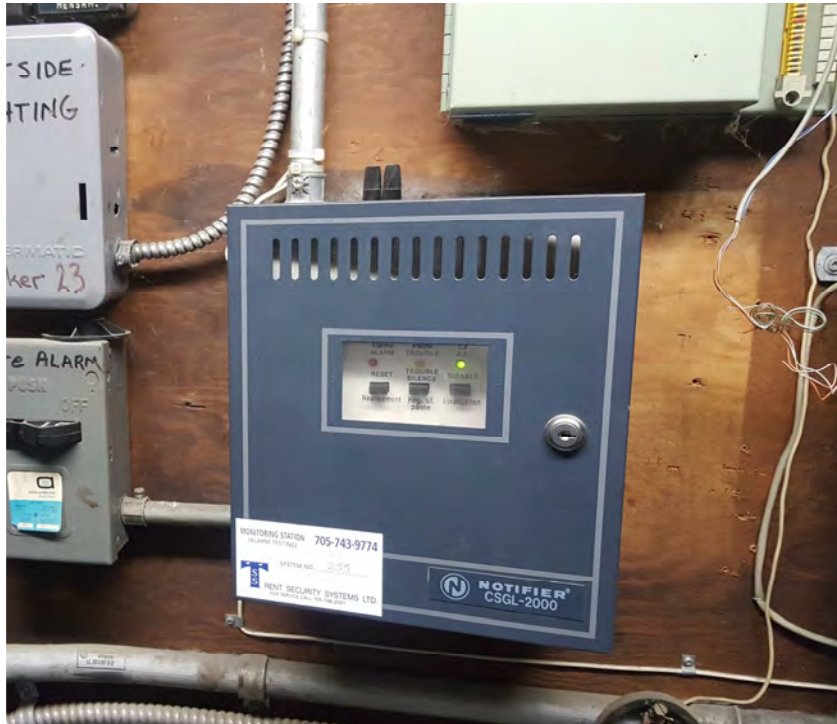
6.1 The existing fire alarm system is a single zone Notifier CSGL-2000. While it appears to be in good working order it is outdated and should be considered for upgrade.

6.2 The fire alarm devices appear to be original and should be considered for replacement.

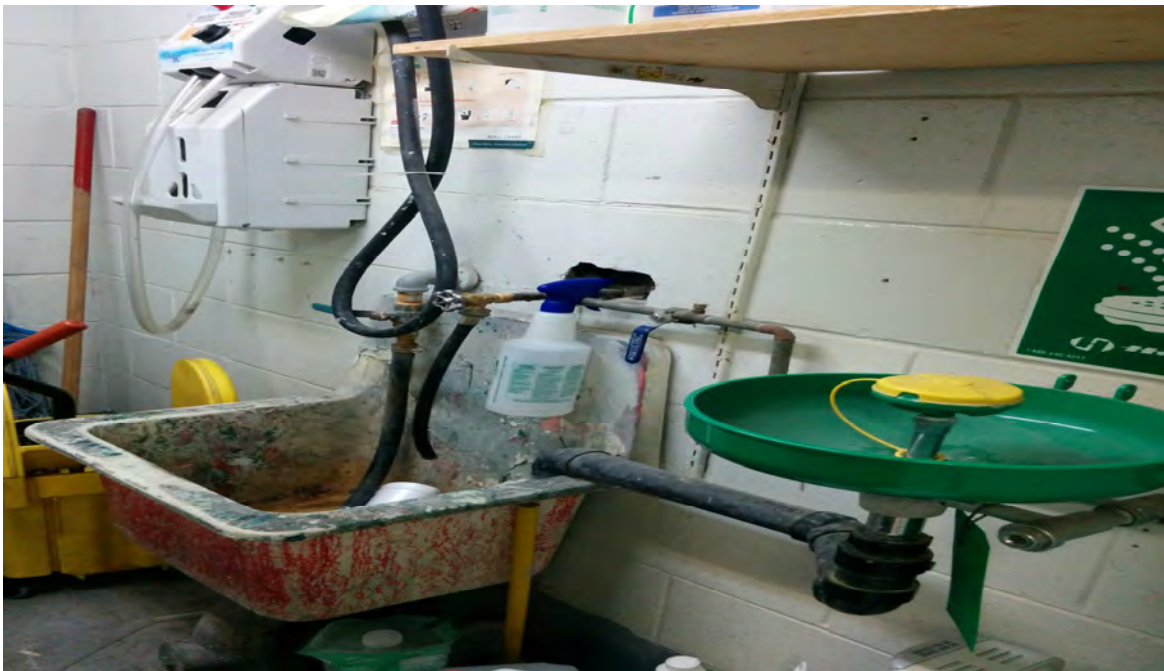
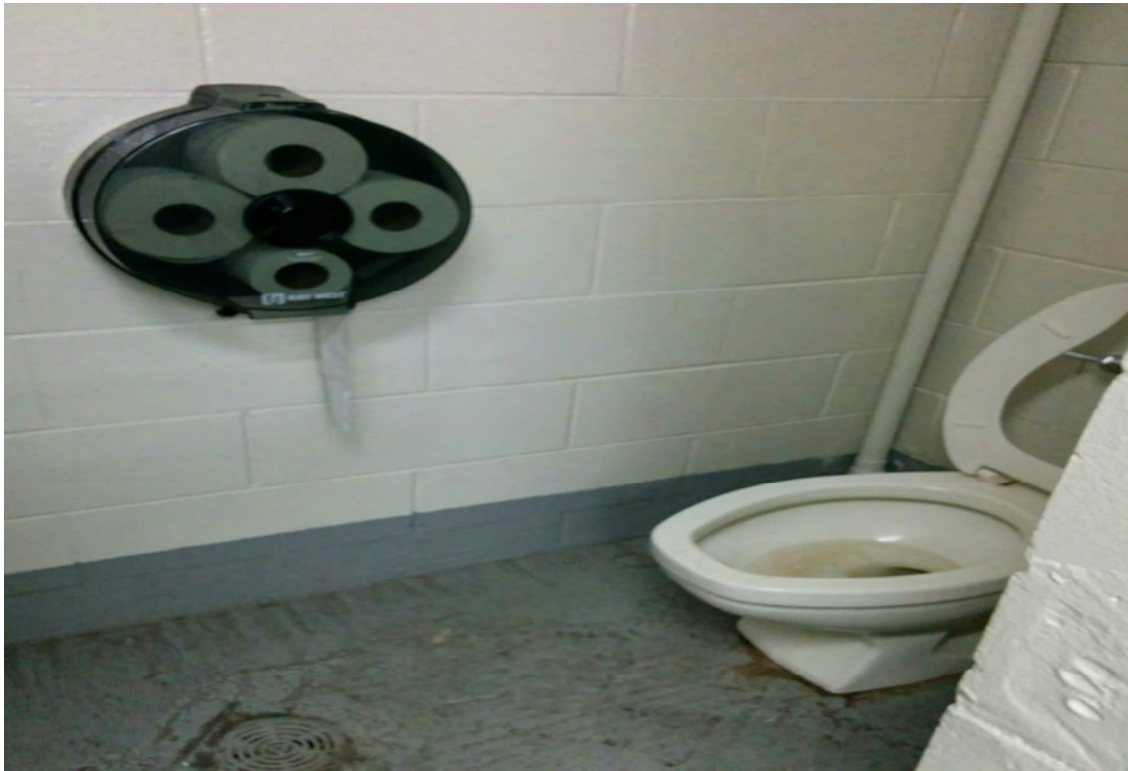
3.1 The fixtures as shown in the photos are in bad conditions and old.
