Mould Assessment – 4 Needler Lane, Millbrook, Ontario

December 6, 2024

Prepared for:
Township of Cavan-Monaghan

Cambium Reference: 21346-001

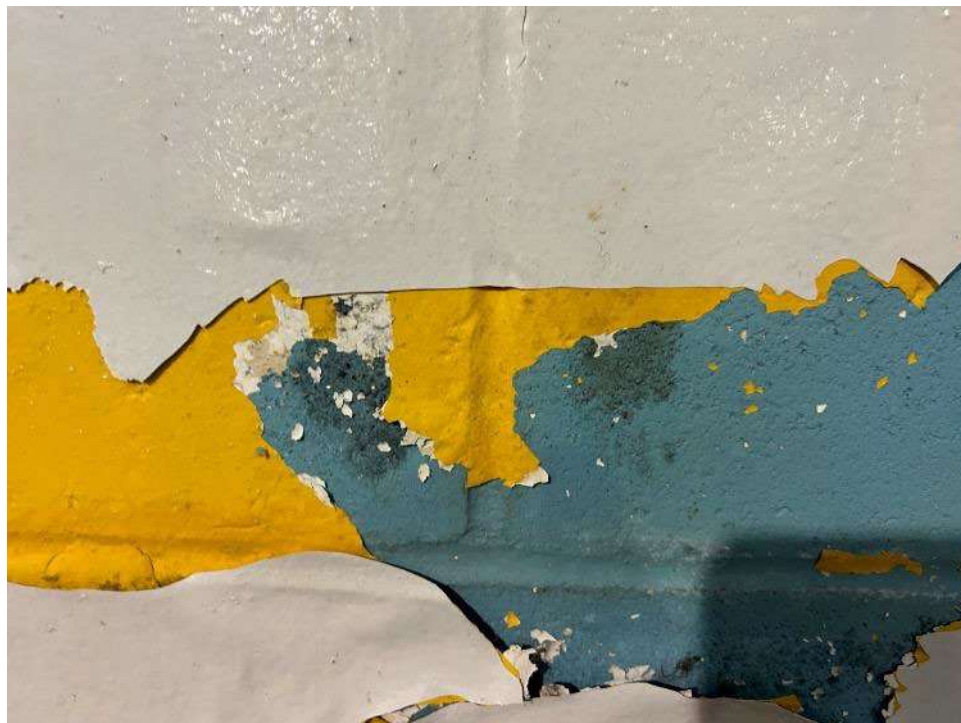
Photo 1 Mould growth on concrete in the main arena area.

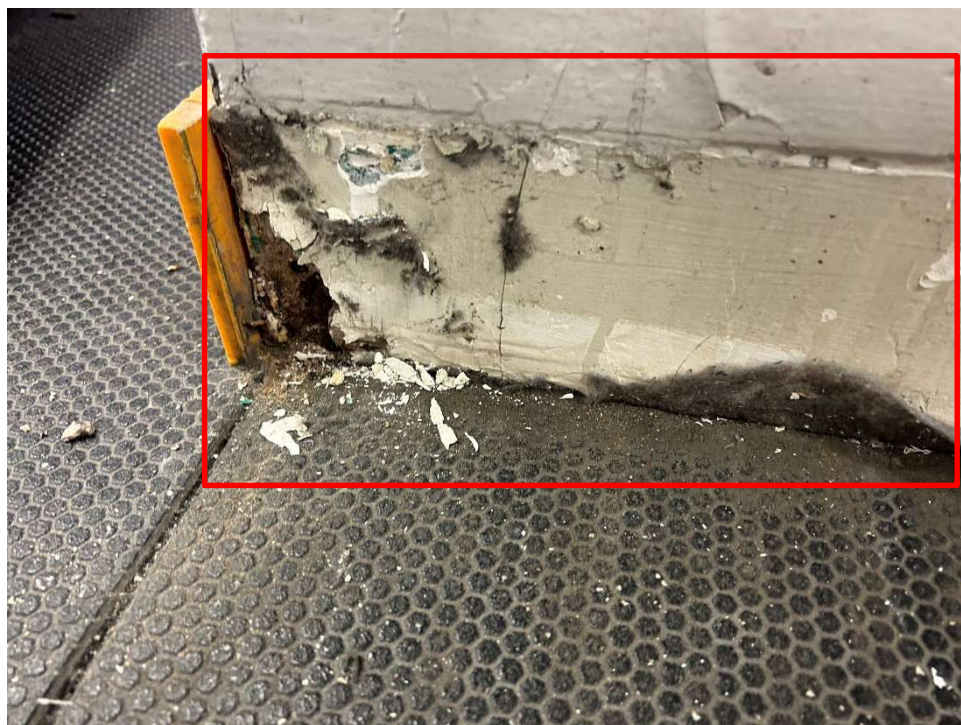
Photo 2 Mould growth on gypsum in the lobby.

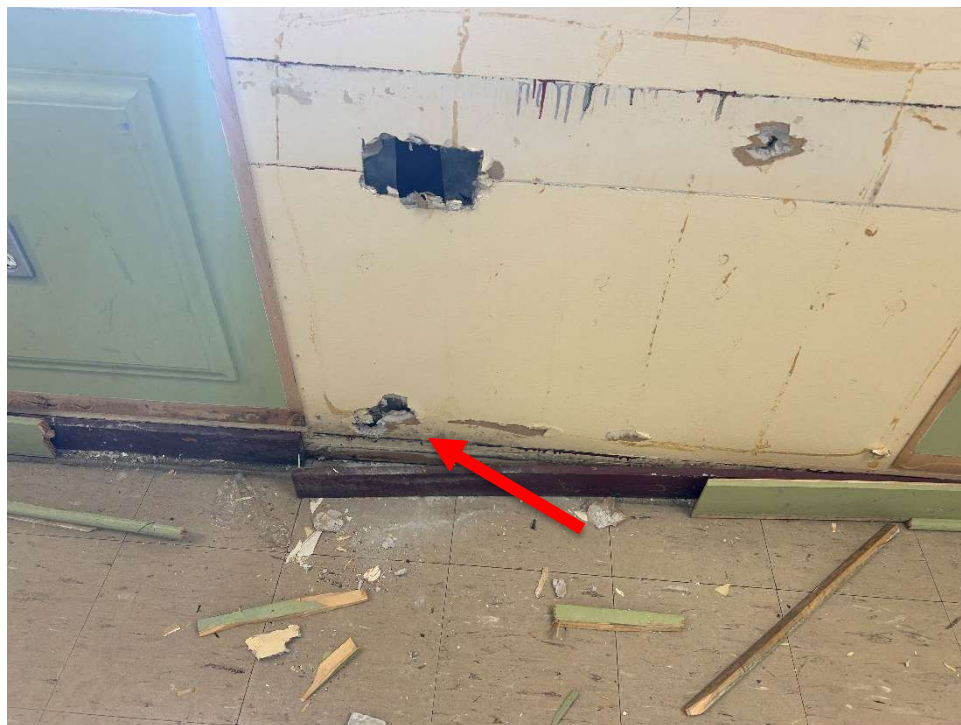
Photo 3 Mould growth on gypsum wall and wood baseboard trim in the second floor hall.

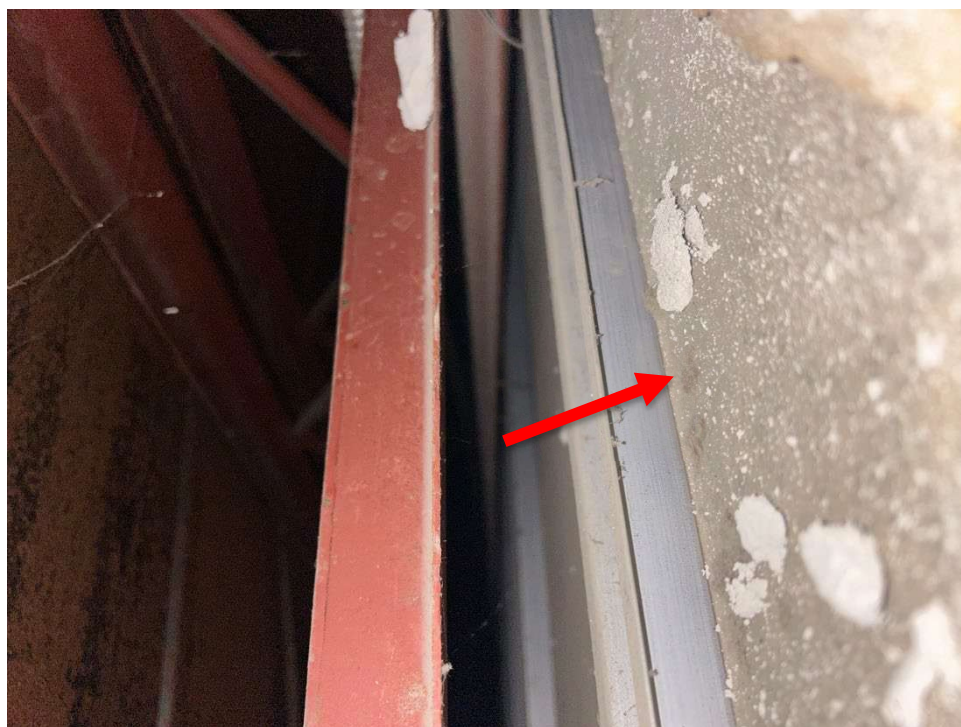
Photo 4 Mould growth on gypsum in changeroom 3.

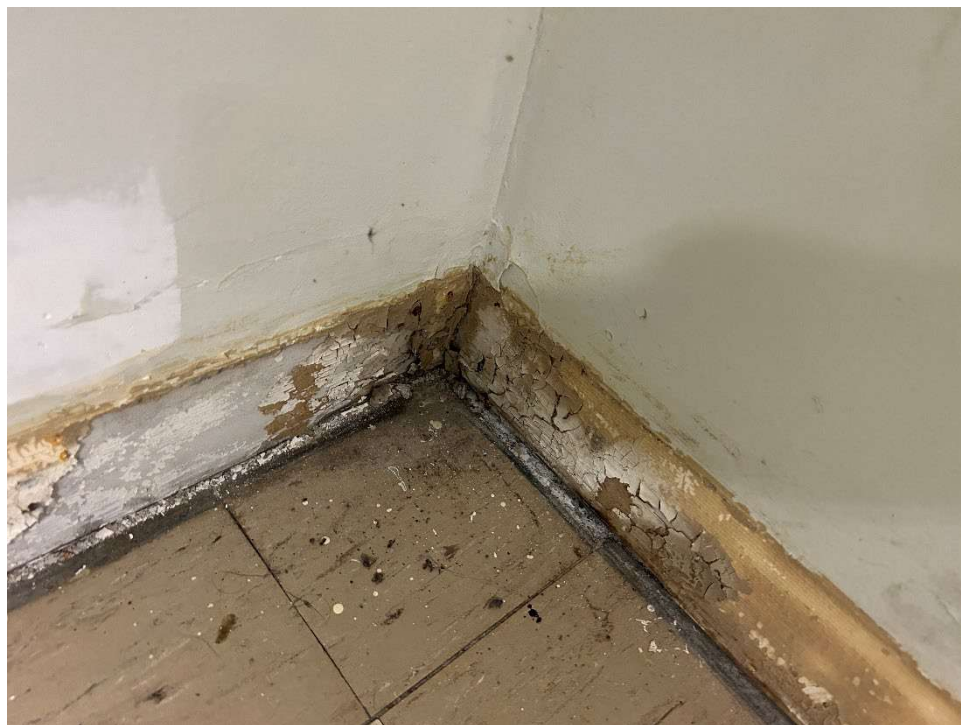
Photo 5 Mould growth on gypsum in the second-floor woman's washroom.

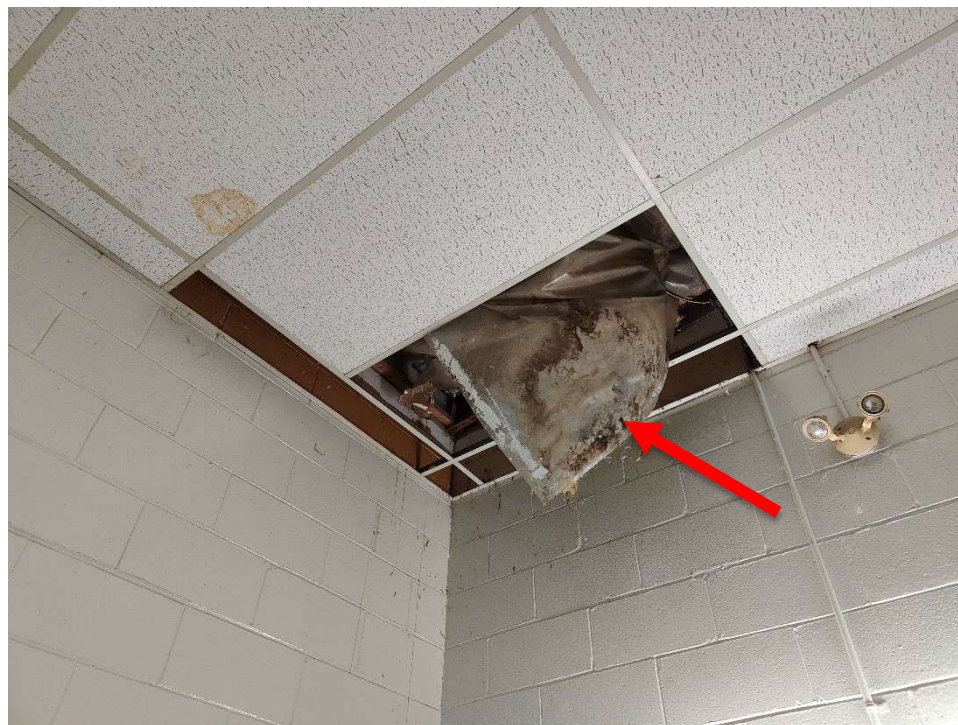
Photo 6 Mould growth on vapour barrier along with water-stained ceiling tiles.

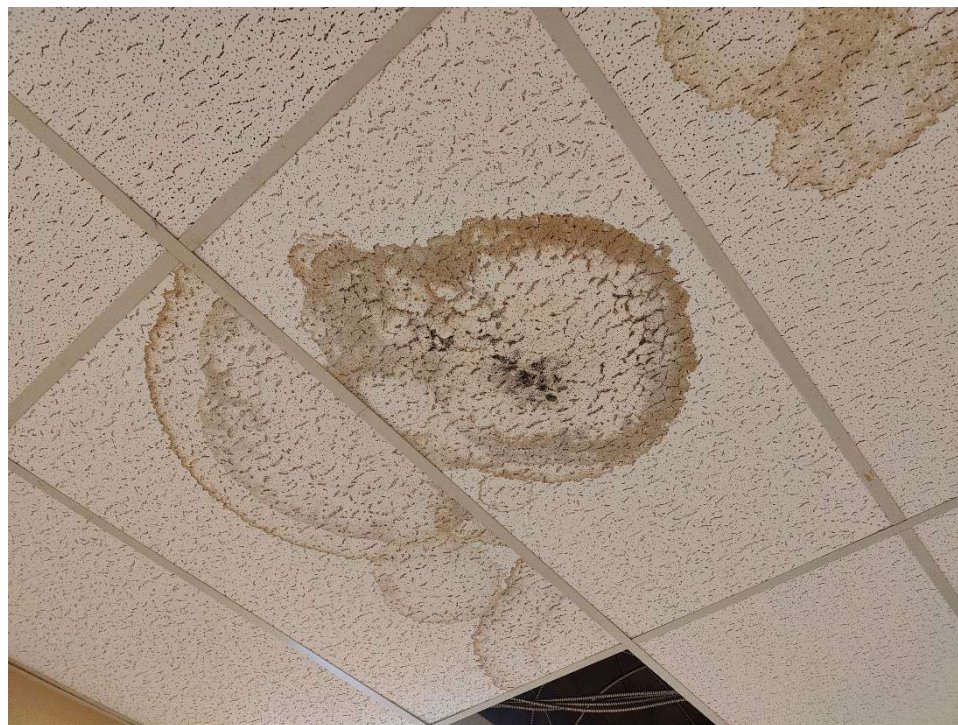
Photo 7 Mould growth on acoustic ceiling tiles.

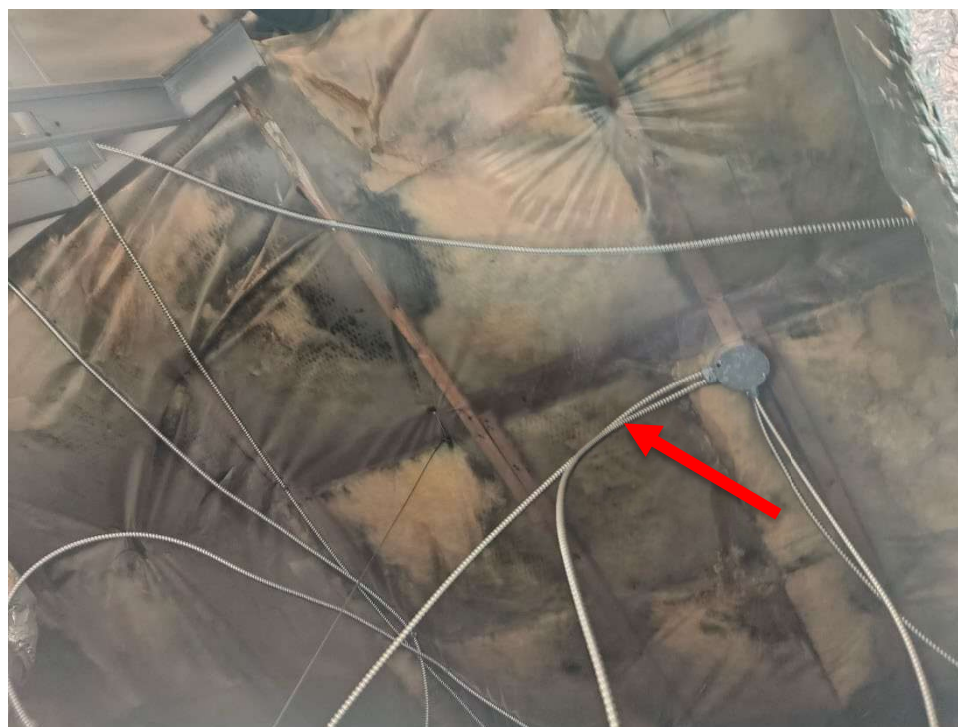
Photo 8 Mould growth on vapour barrier and fibreglass ceiling insulation.

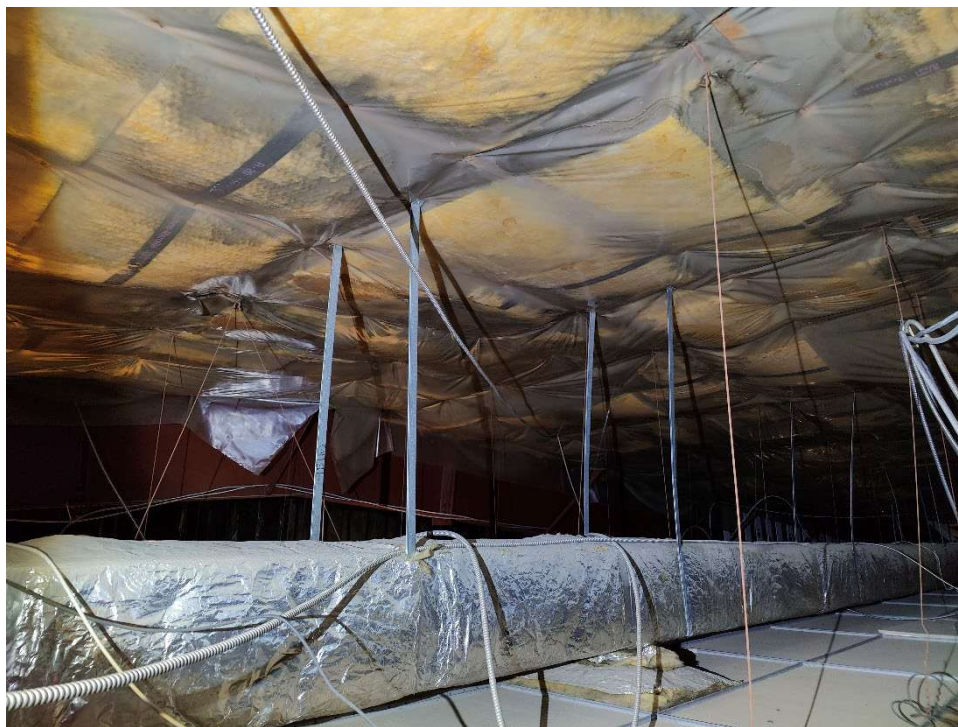
Photo 9 Mould growth vapour barrier and fiberglass insulation.

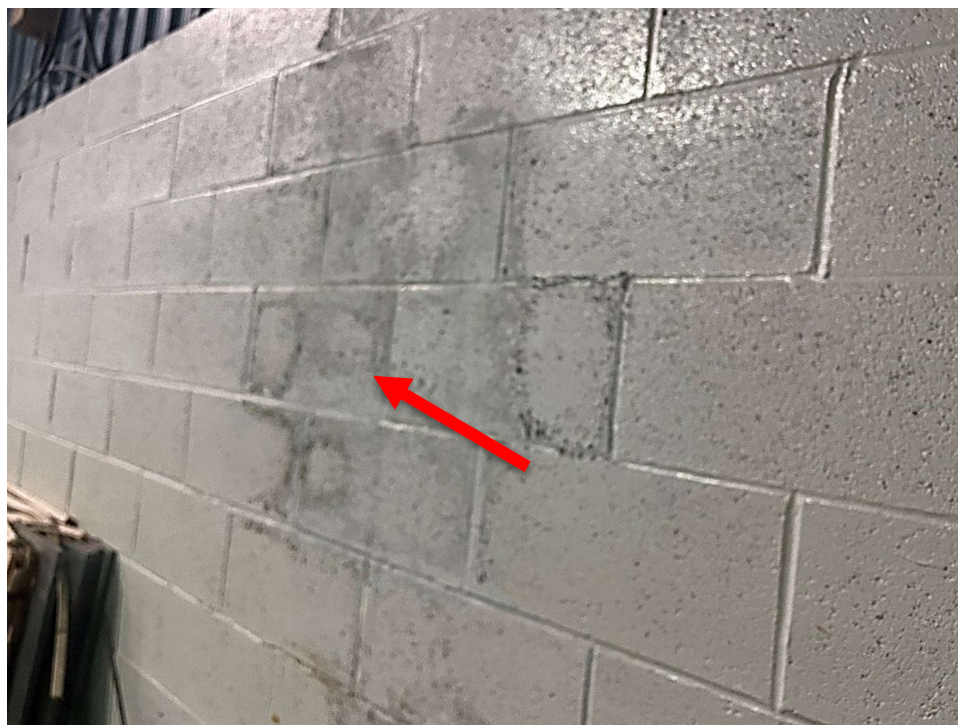
Photo 10 Mould growth concrete block wall.

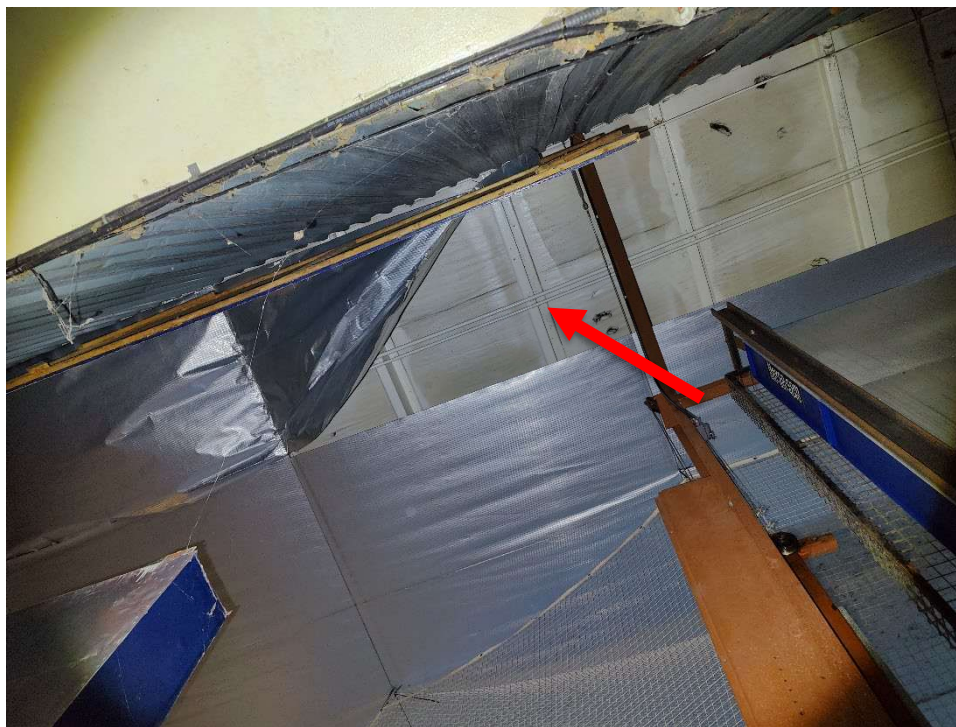
Photo 11 Mould impacted fibreglass insulation.

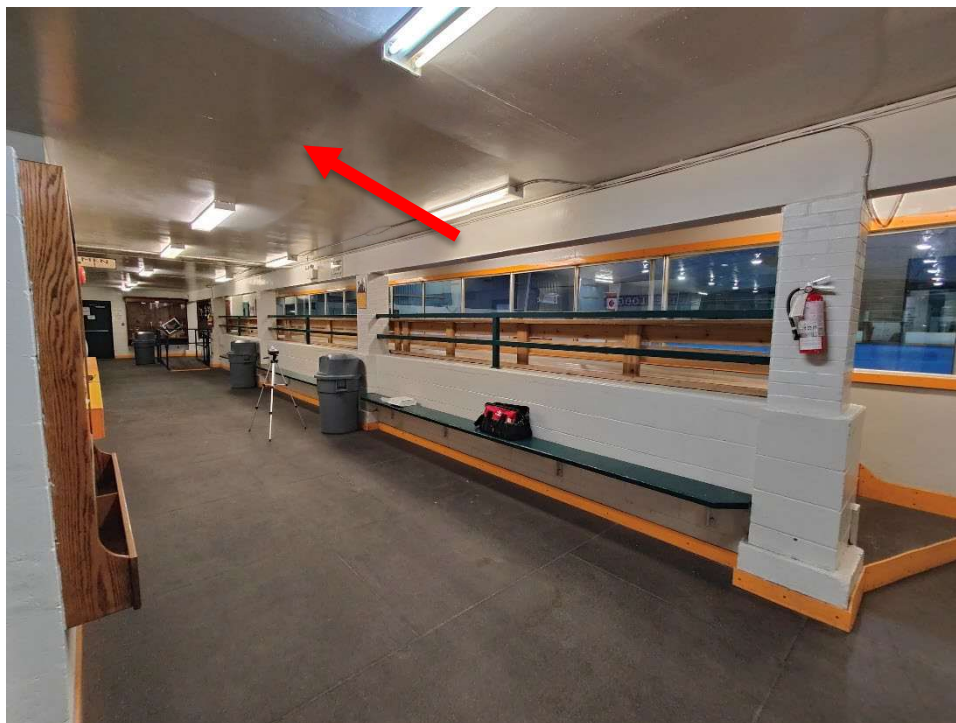
Photo 12 Mould impacted gypsum ceiling.

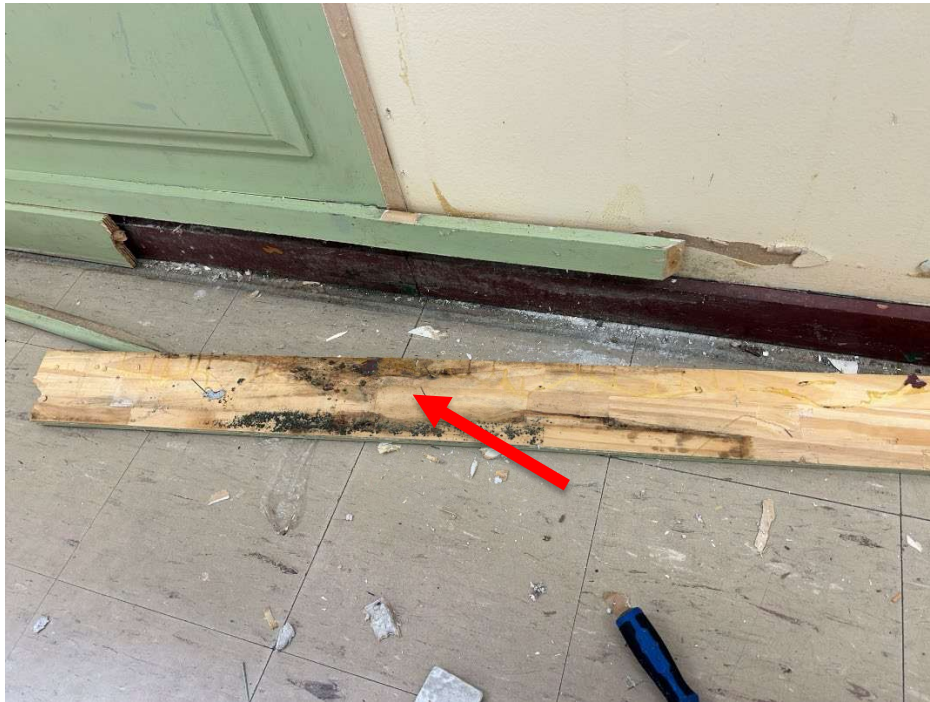
Photo 13 Mould impacted wooden baseboard.

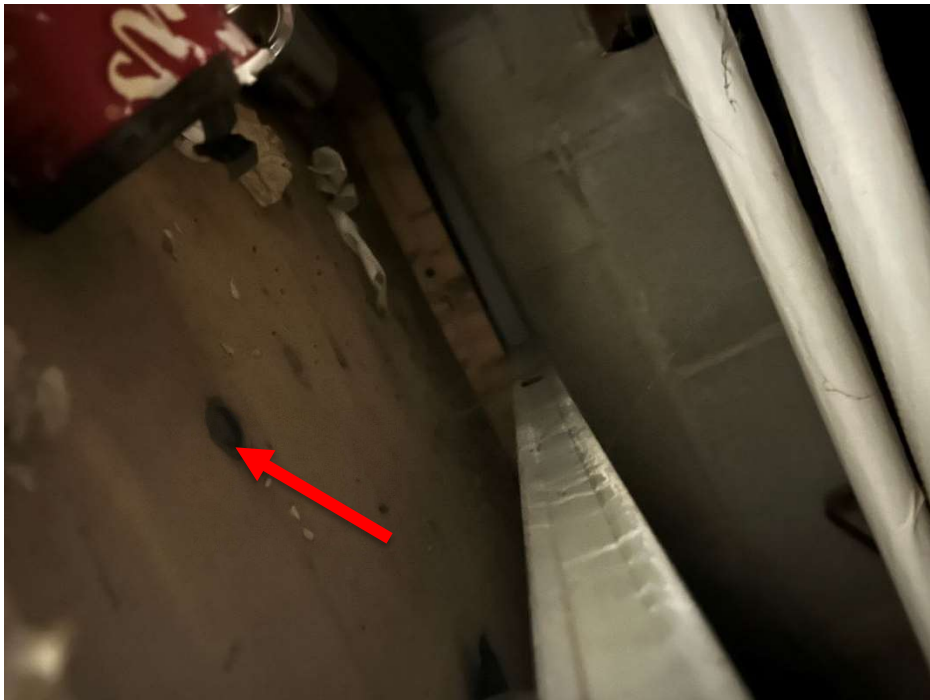
Photo 14 Mould impacted gypsum ceiling.

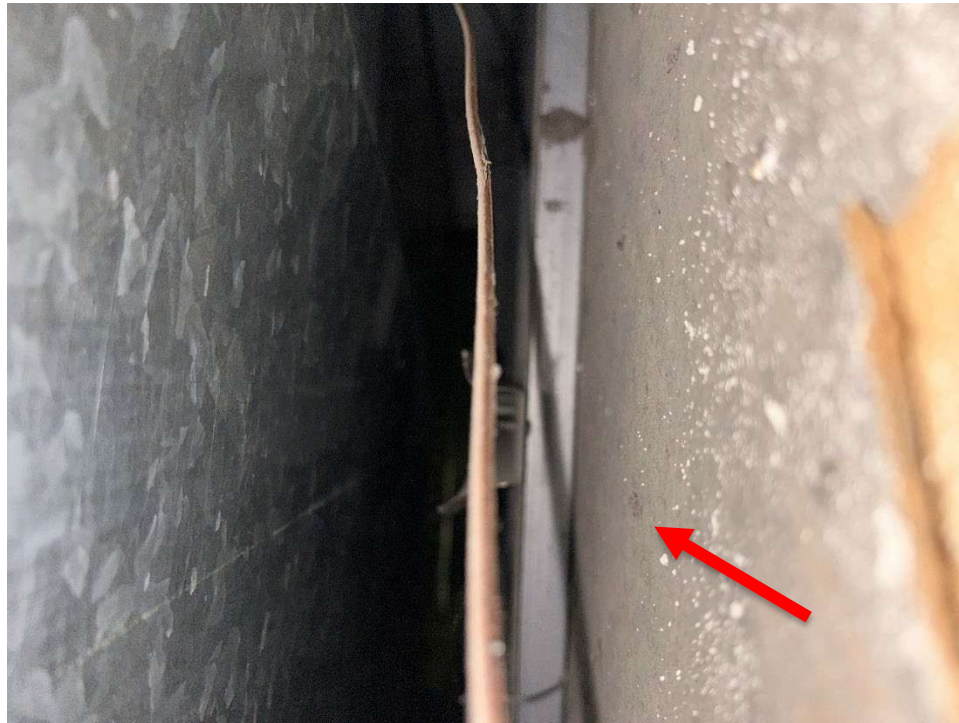
Photo 15 Mould impacted gypsum ceiling.

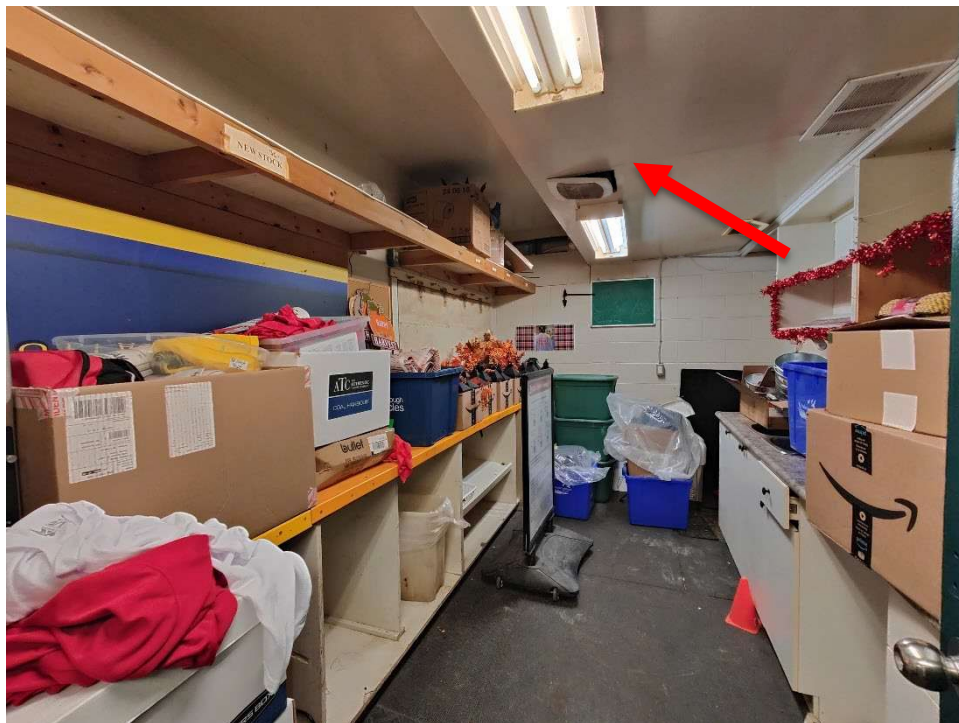
Photo 16 Mould impacted gypsum ceiling.
