## Regular Council Meeting

<b>To:</b>	Mayor and Council
<b>Date:</b>	December 16, 2024
<b>From:</b>	Chris Allison, Parks and Facilities Manager
<b>Report Number:</b>	Parks and Facilities 2024-05
<b>Subject:</b>	Mould Assessment Results and Required Remediation at Millbrook Arena

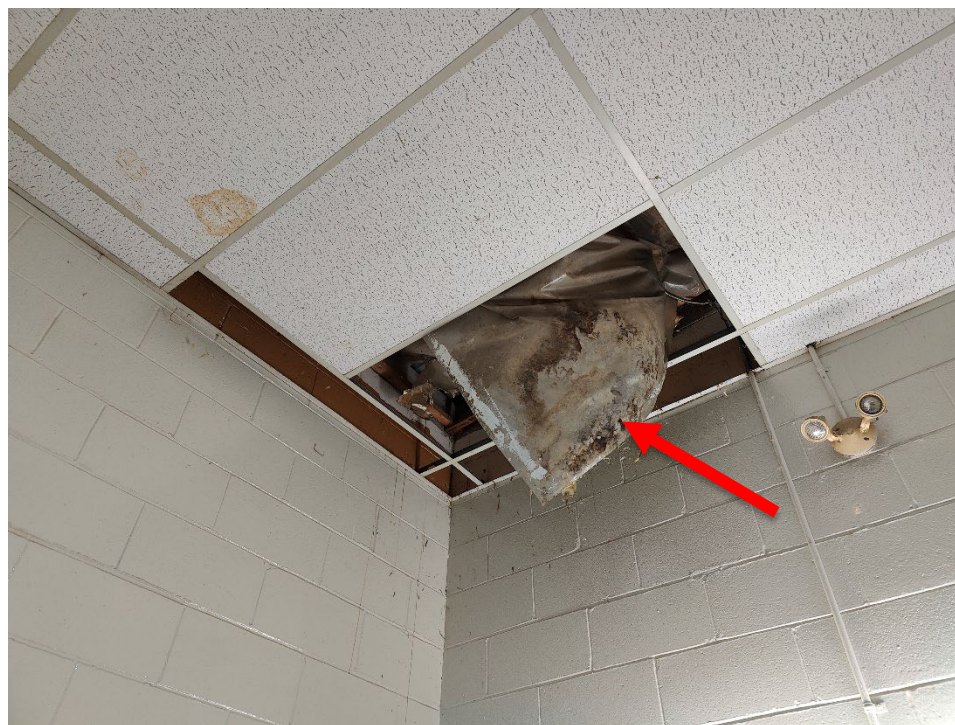
**Photo 5** Mould growth on gypsum in the second-floor woman's washroom.

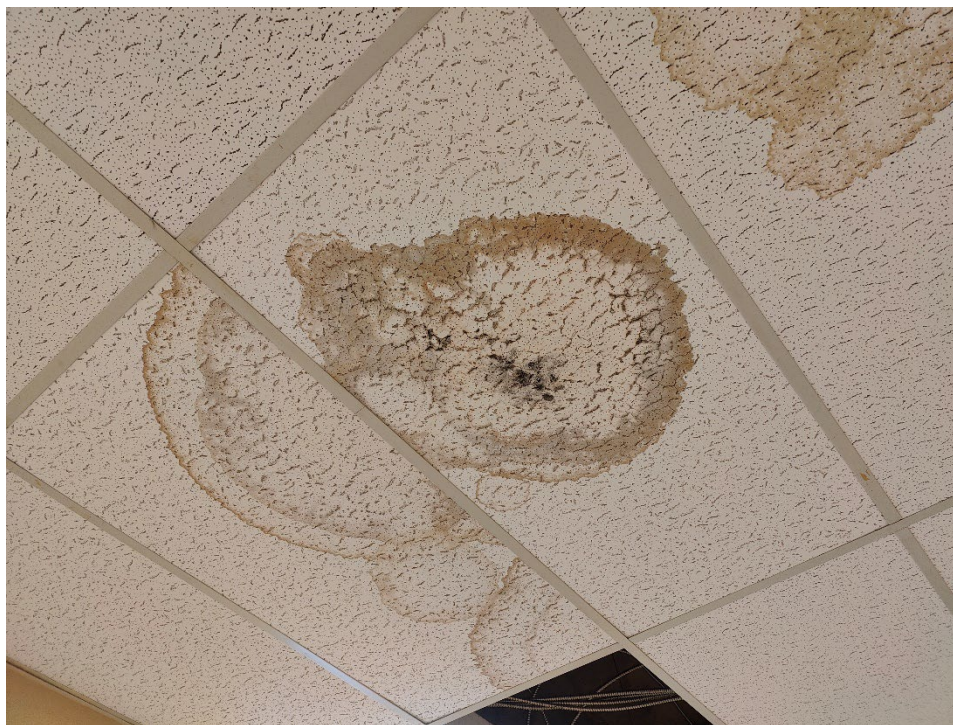
**Photo 6** Mould growth on vapour barrier along with water-stained ceiling tiles.

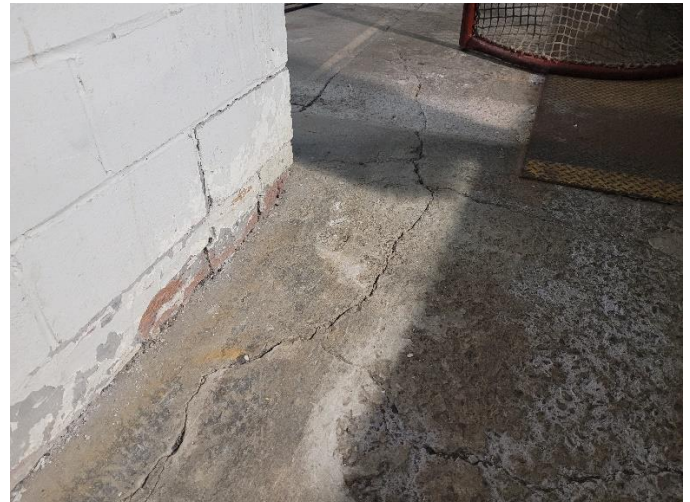
Photo 07 – Cracked Apron Slab

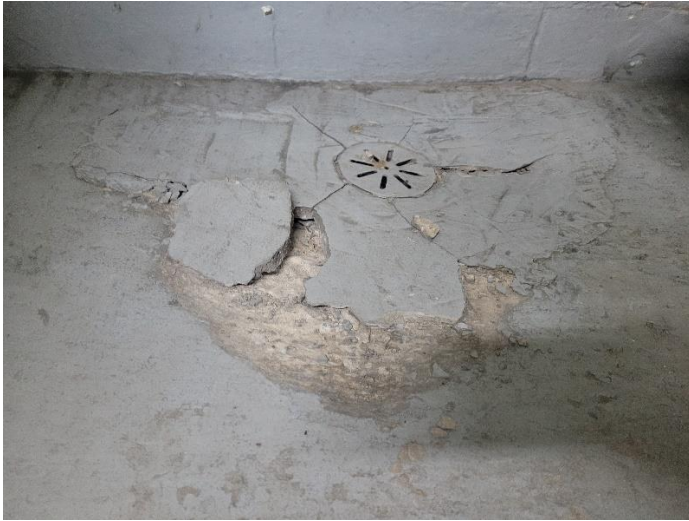
Photo 12 – Damaged Slab in Washroom

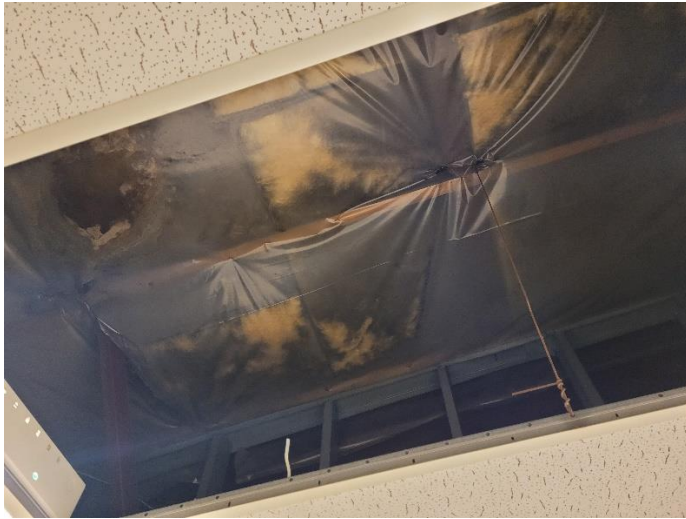
Photo 16 – Damaged Roof Insulation and Evidence of Moisture

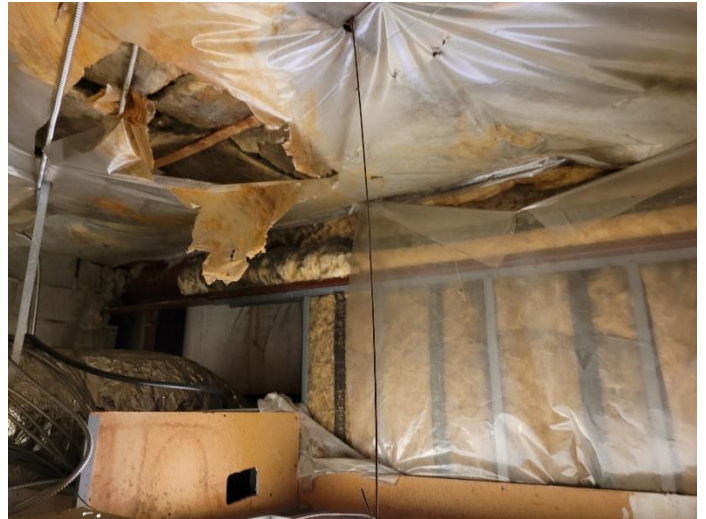
Photo 17 – Mould and Evidence of Moisture

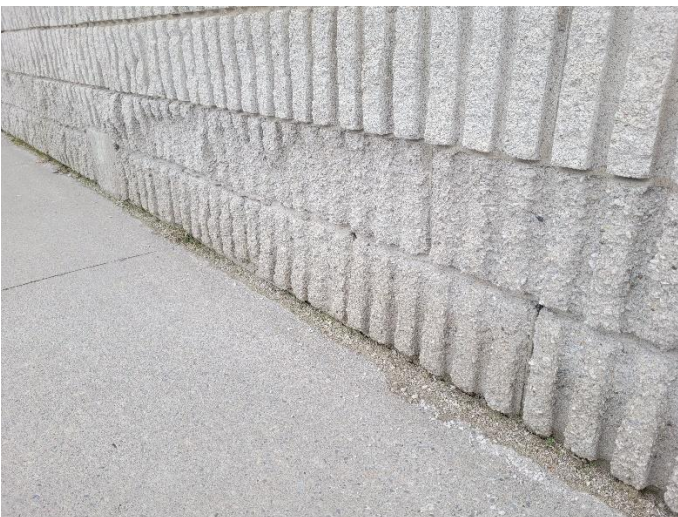
Photo 22 – Damaged Split Ribbed Block at Southeast Corner

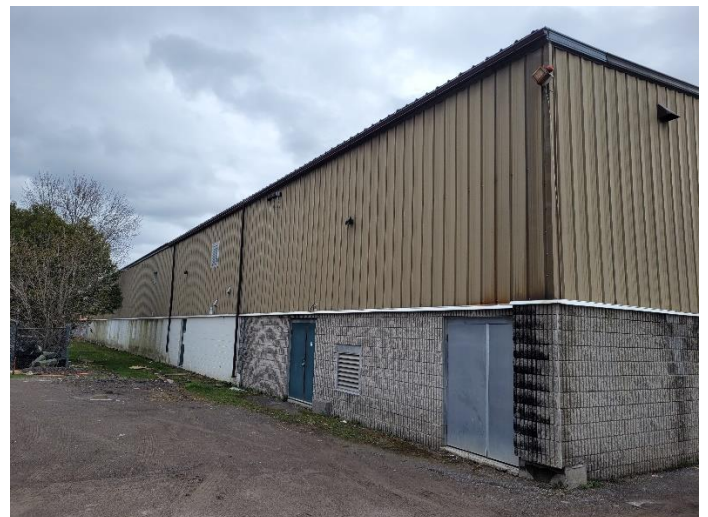
Photo 23 – Damaged Split Ribbed Block at Southeast Corner

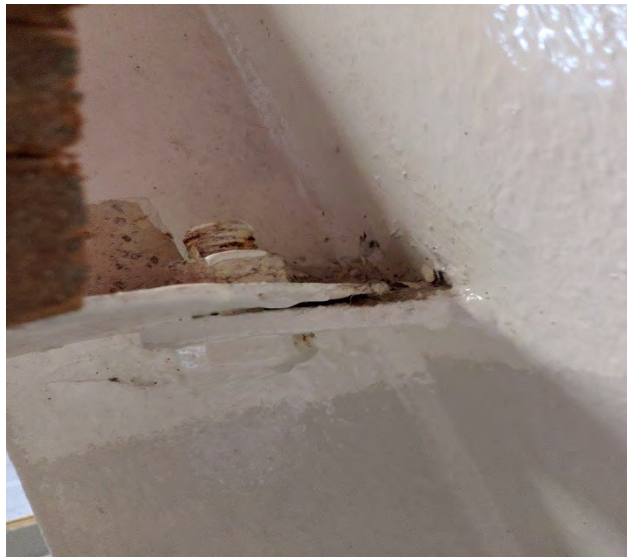
Photo 005      Bent Connection

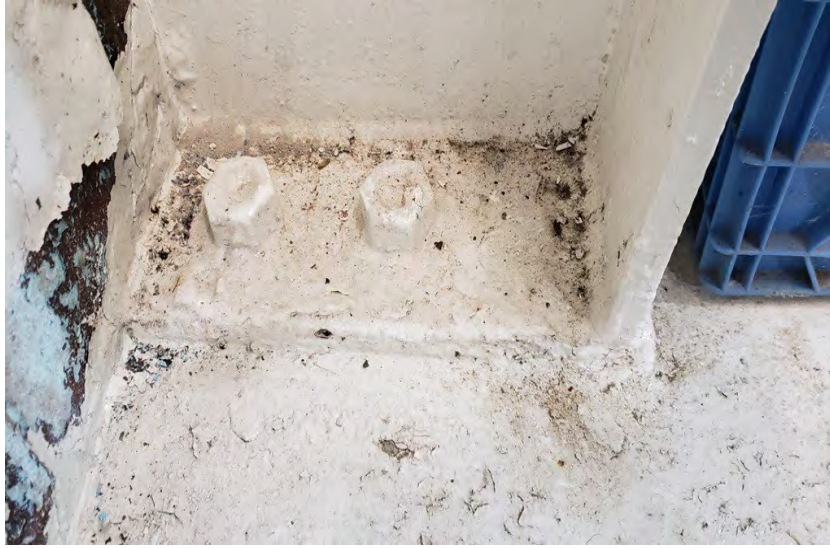
Photo 006      Rusted Bracing Connection

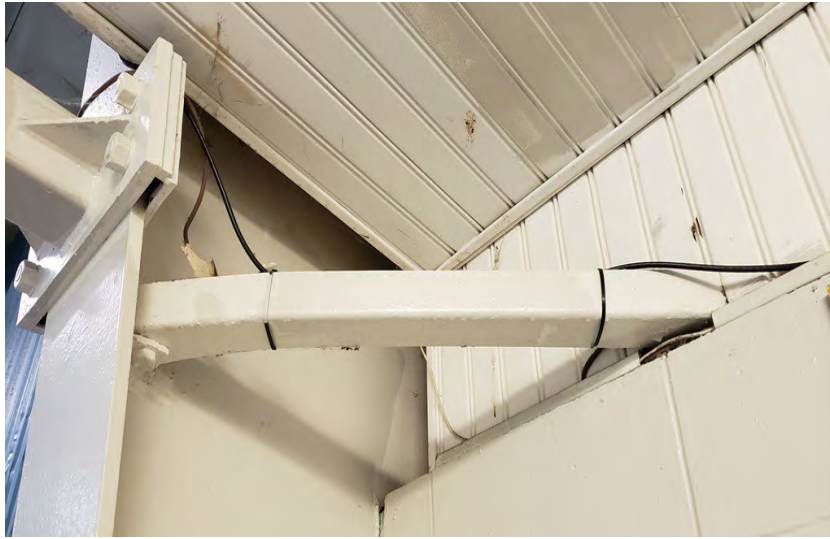
Photo 008      Missing Brace at Southmost Frame

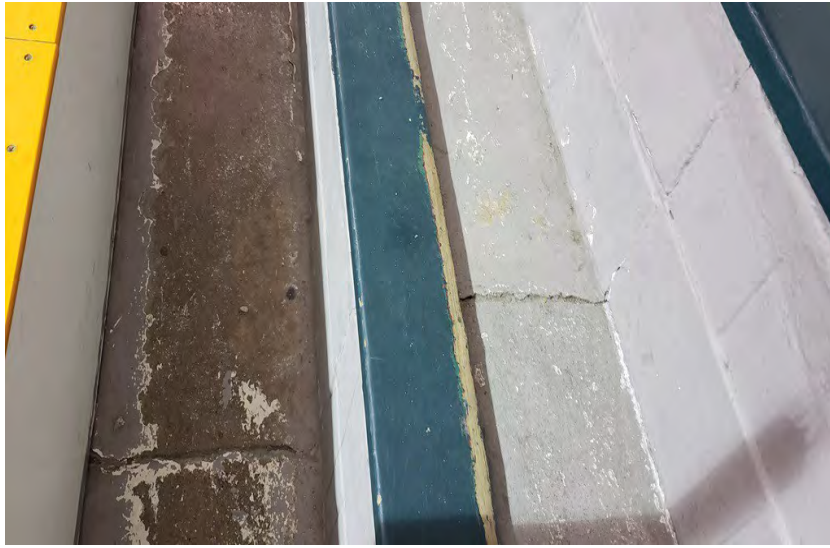
Photo 010      Paint Chipping and Crack on Bleachers

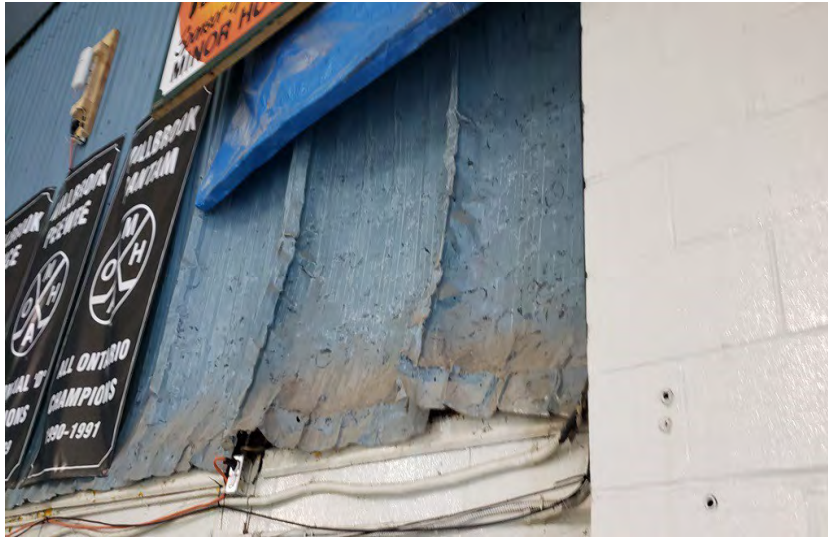
Photo 012      Localized damage to MetalCladding

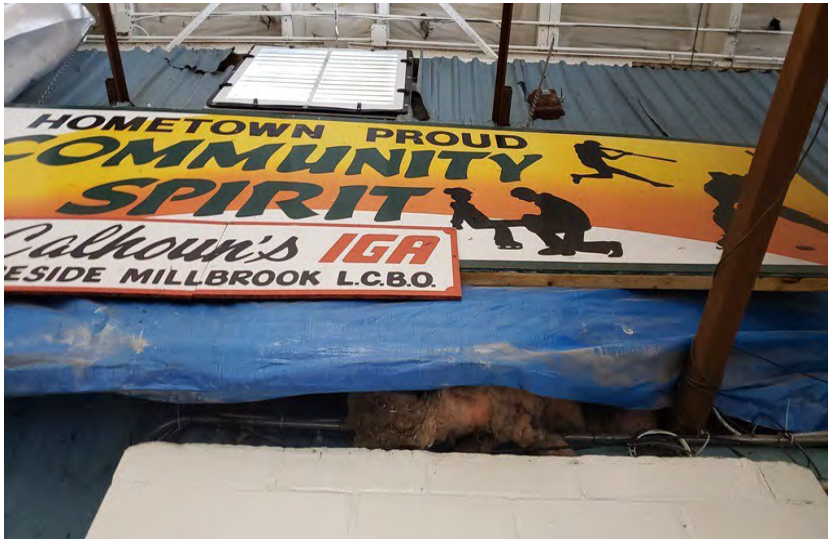
Photo 013      Significant Damage to Metal Cladding

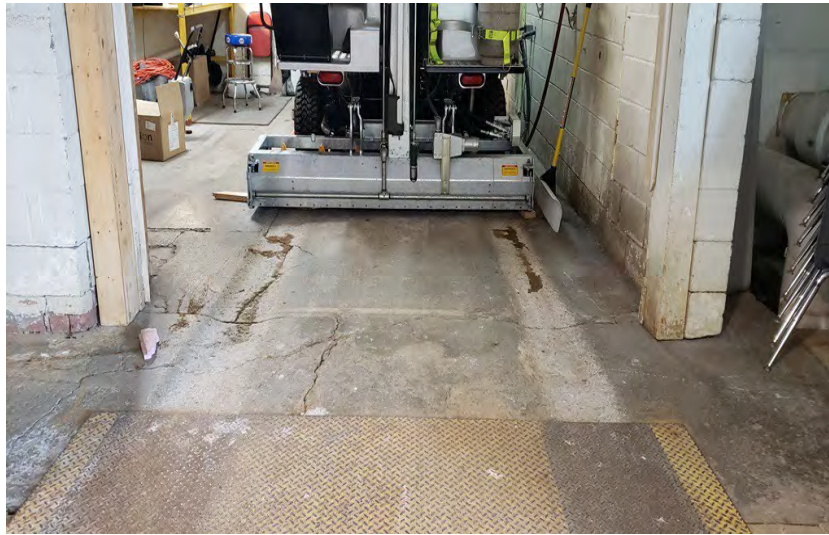
Photo 019      Major Crack in Apron Slab

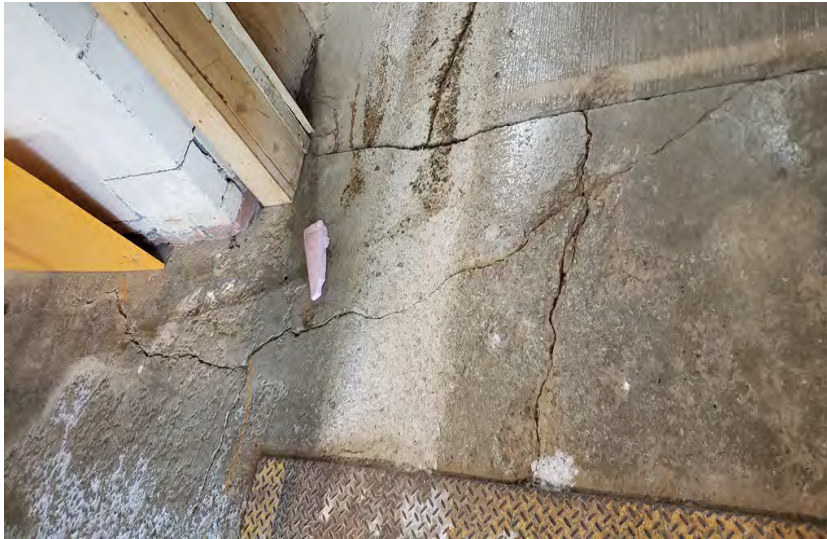
Photo 021      Cracking Starting in Resurfacing Room

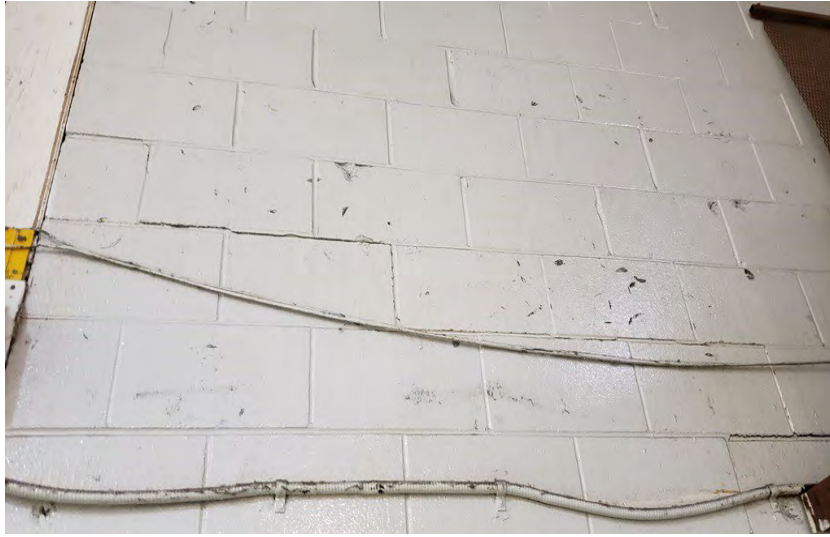
Photo 028      Multiple Step Cracks Behind Water Tank

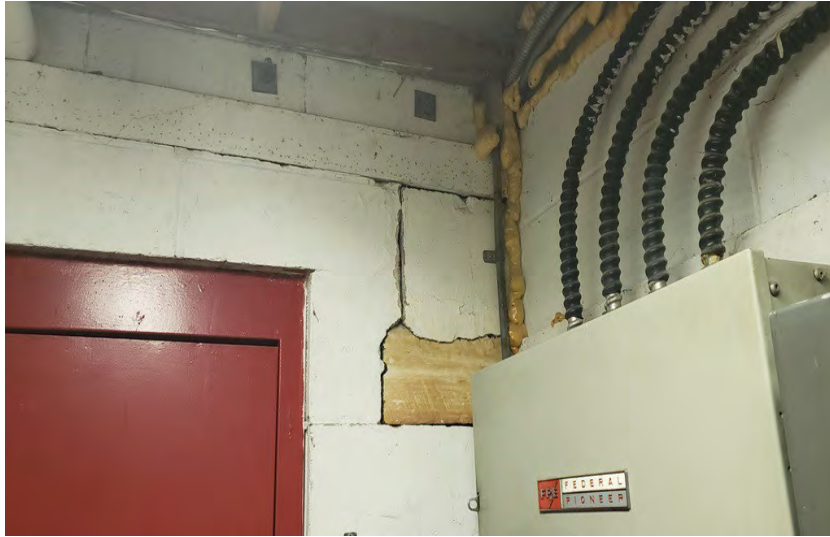
Photo 034      South-Side Stairwell Mortar JointCracking

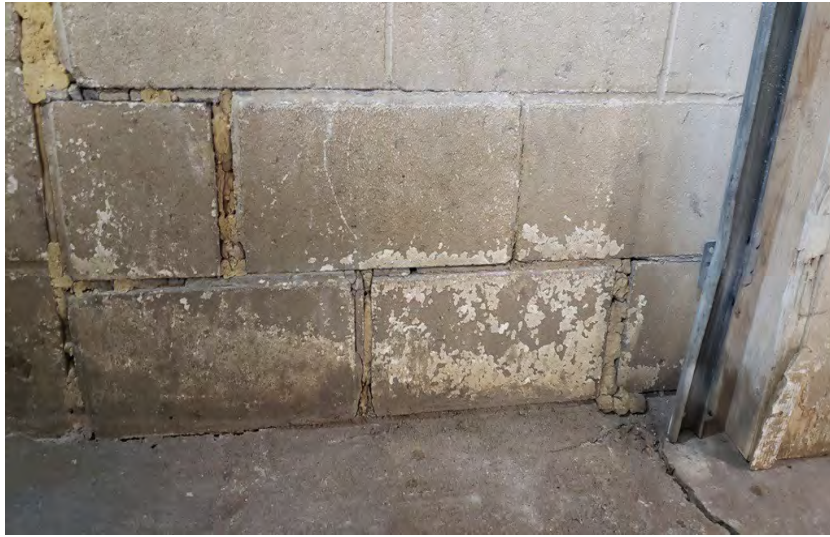
Photo 036      Differential Settlement in Ice-Resurfacing Room

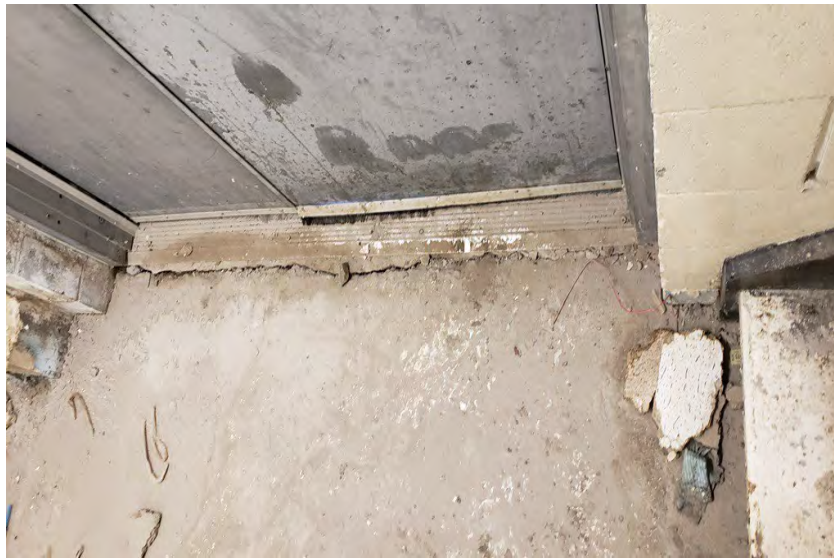
Photo 053      Concrete Damage at Electrical Equipment in  
Compressor Room

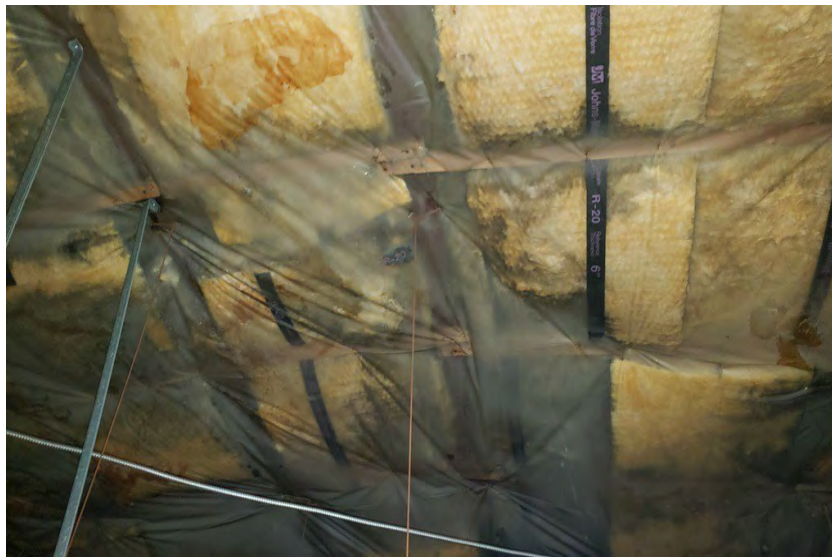
Photo 059      Moisture in Roofing System

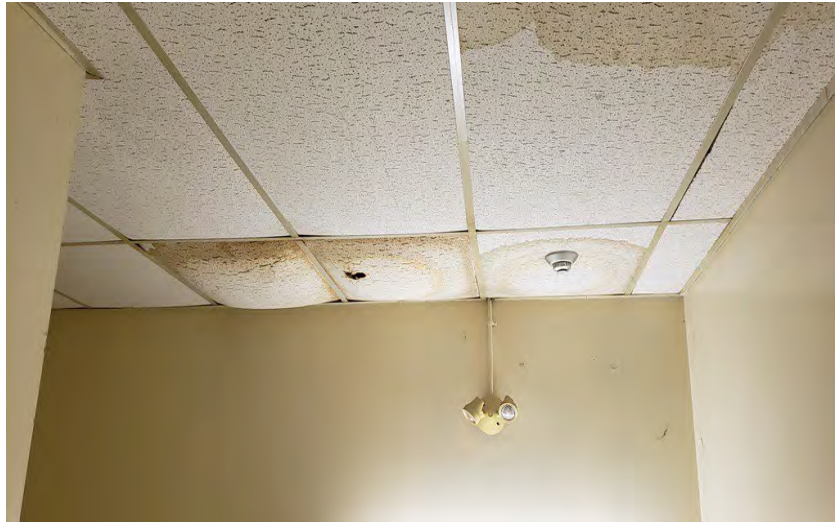
Photo 060      Moisture in Roofing System

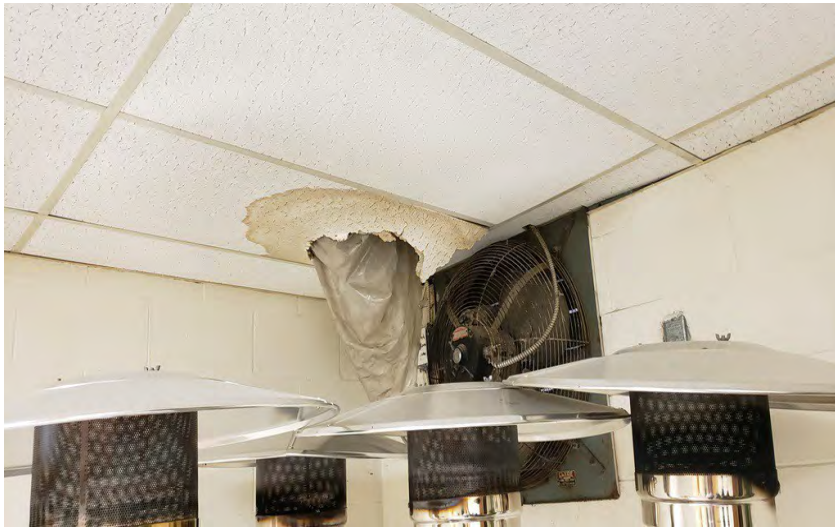
Photo 061      Signs of Moisture Damage

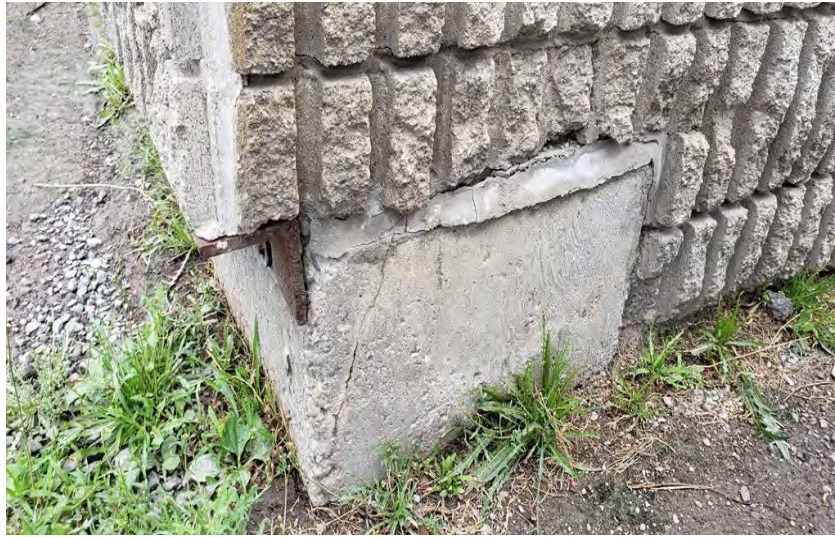
Photo 062      Signs of Moisture Damage

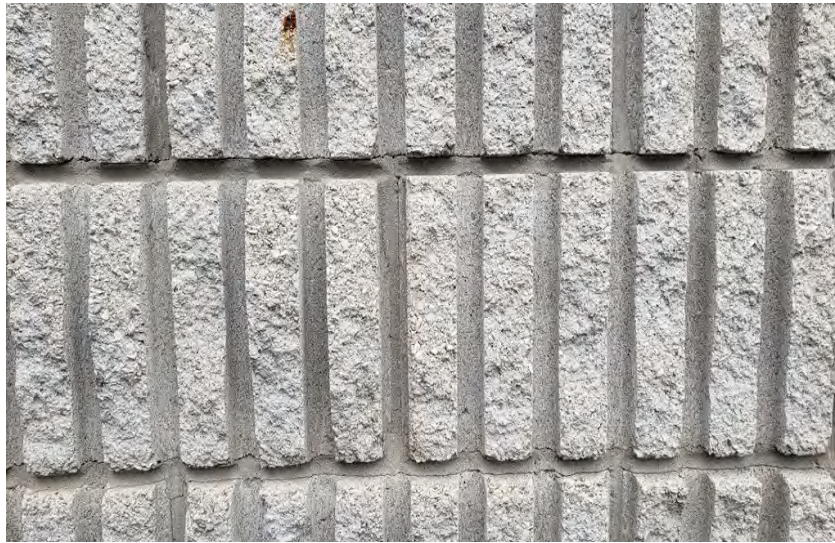
Photo 064      Cracking at Centre Foundation Wall

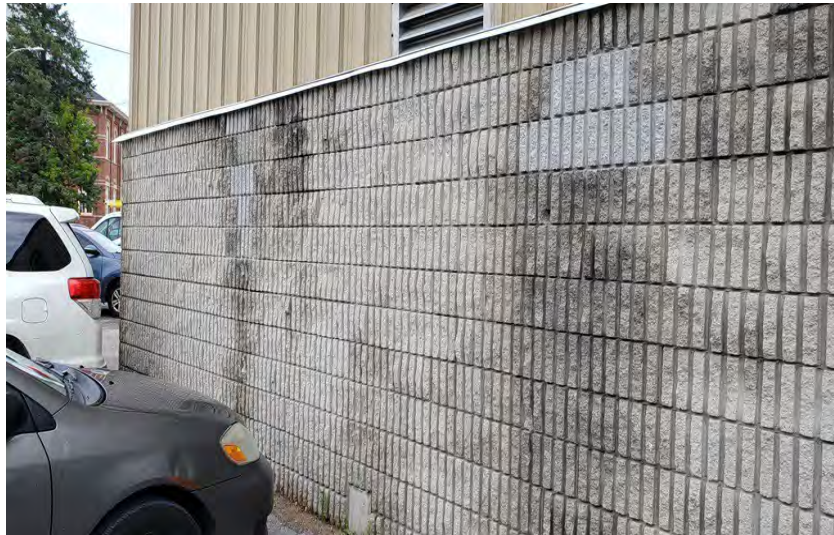
Photo 067      Localized Block Damage at South-East Corner

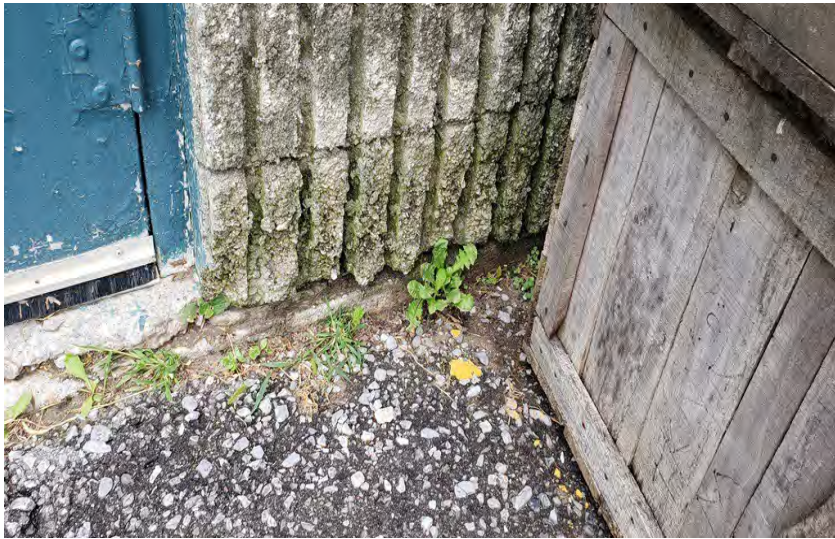
Photo 073 Moss Along East Side Wall

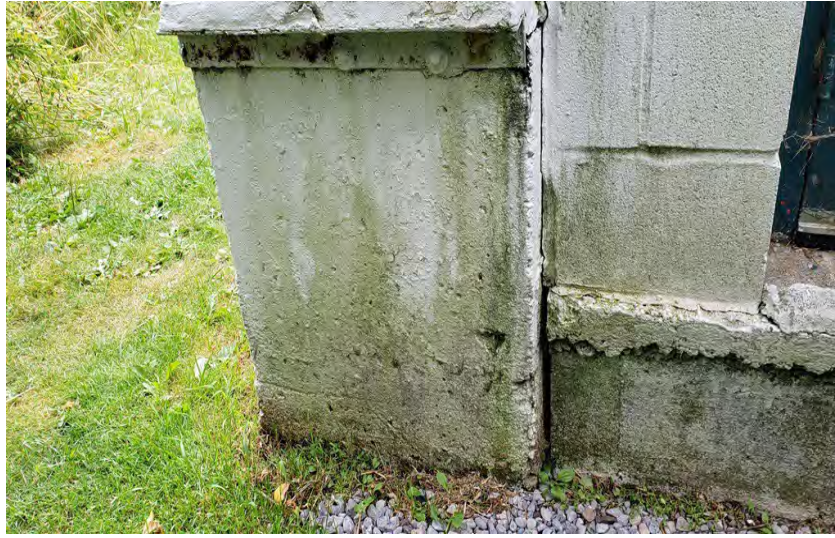
Photo 088      Mould and Moisture on Block Wal

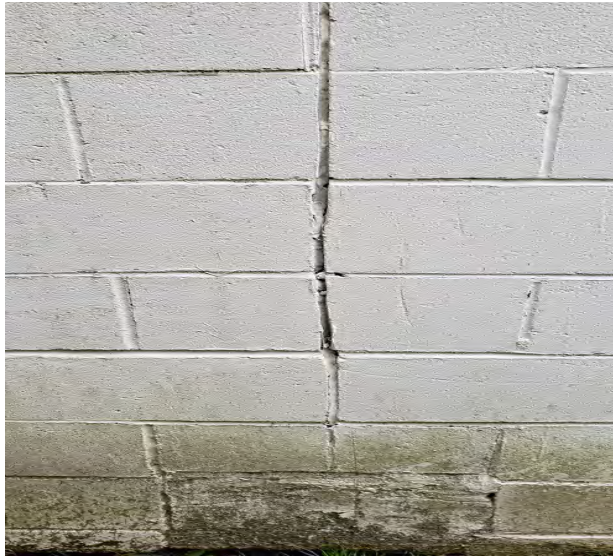
Photo 090      Mould Along West Side

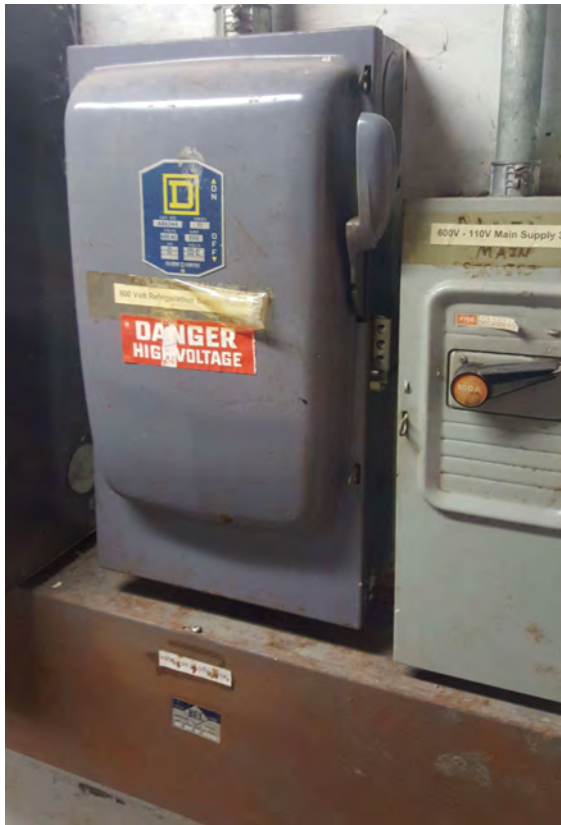
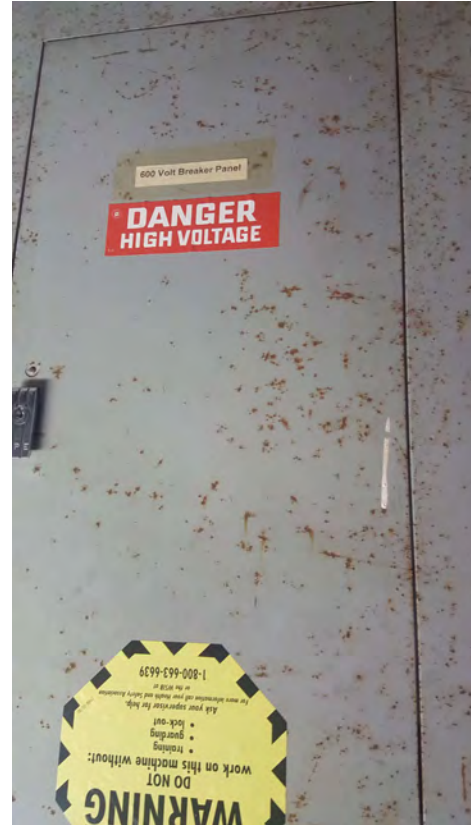
- 3.8 The Panel board, a federal pioneer NHDP 225A 3 phase 4 pole model, supplies the ice surface lighting, de-humidifiers and exhaust fans.
- 3.9 The 600V equipment appears to be all original and is all very dated with signs of many years of wear. The splitter is completely covered in rust caused by the high humidity in the area where the equipment is installed.

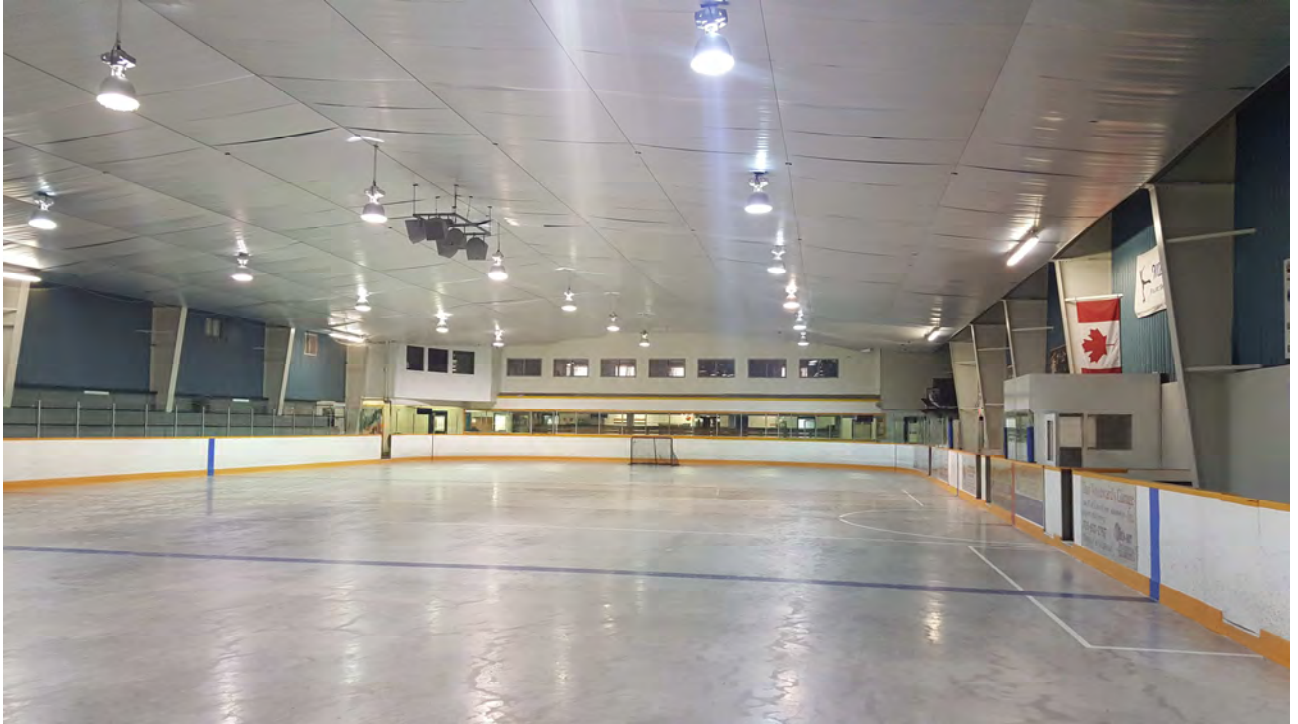
5.1 The ice surface lighting is 400W 347V Metal halide.

5.2 It is recommended to replace the existing metal halide fixtures with LED for improved control, instant on capability and longevity.

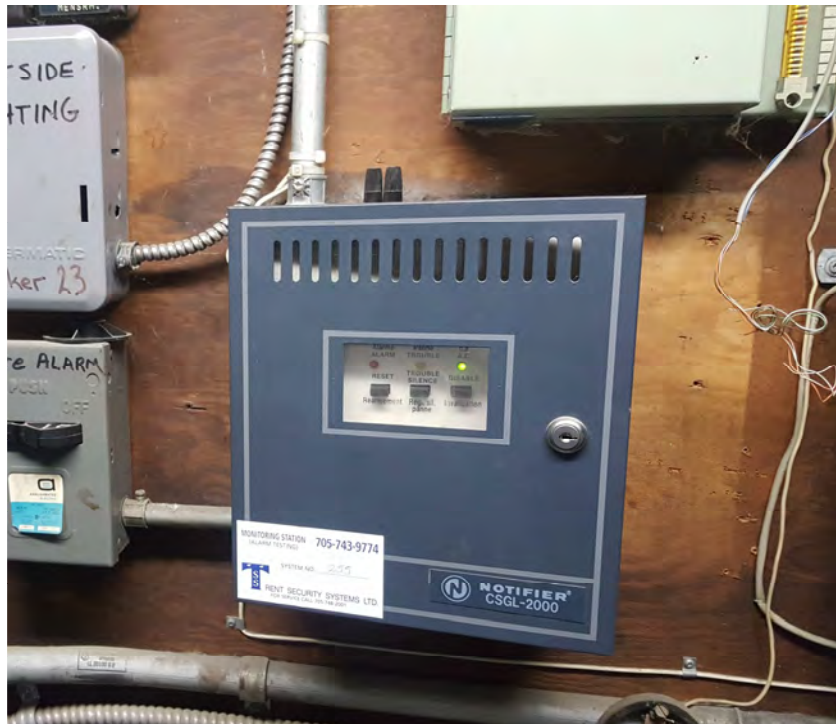
- 6.1 The existing fire alarm system is a single zone Notifier CSGL-2000. While it appears to be in good working order it is outdated and should be considered for upgrade.

- 6.2 The fire alarm devices appear to be original and should be considered for replacement.
- 6.3 The notification devices are bells. Consider adding strobe coverage for improved notification.

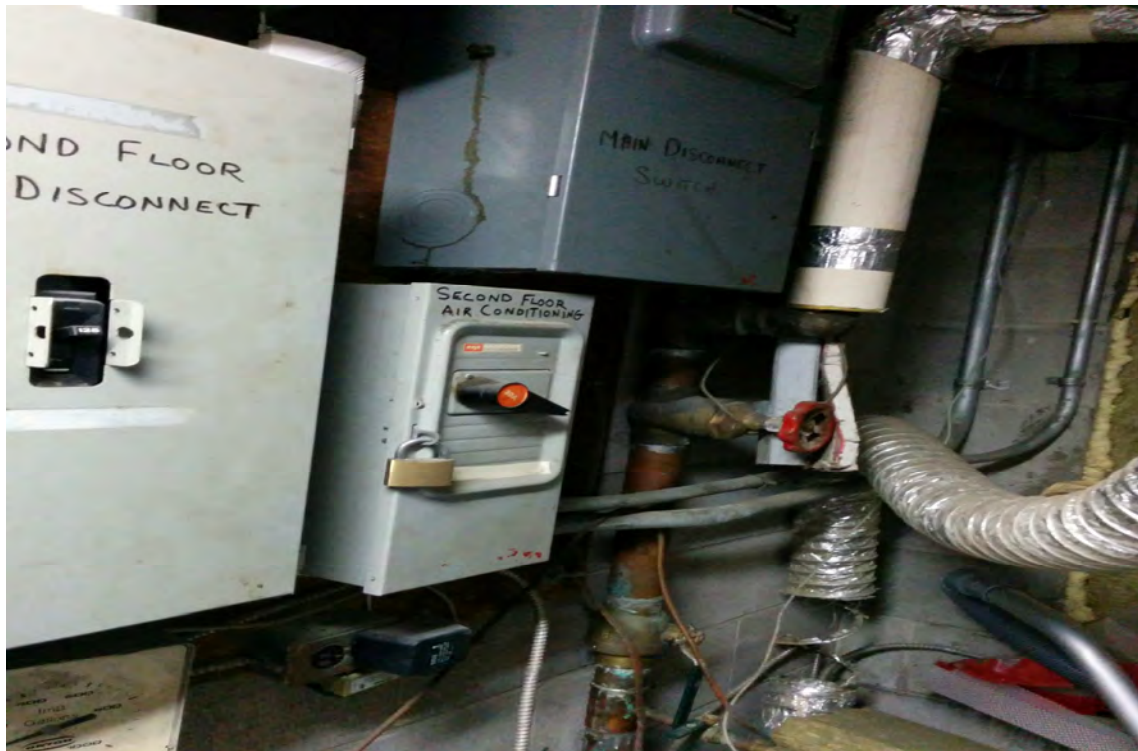
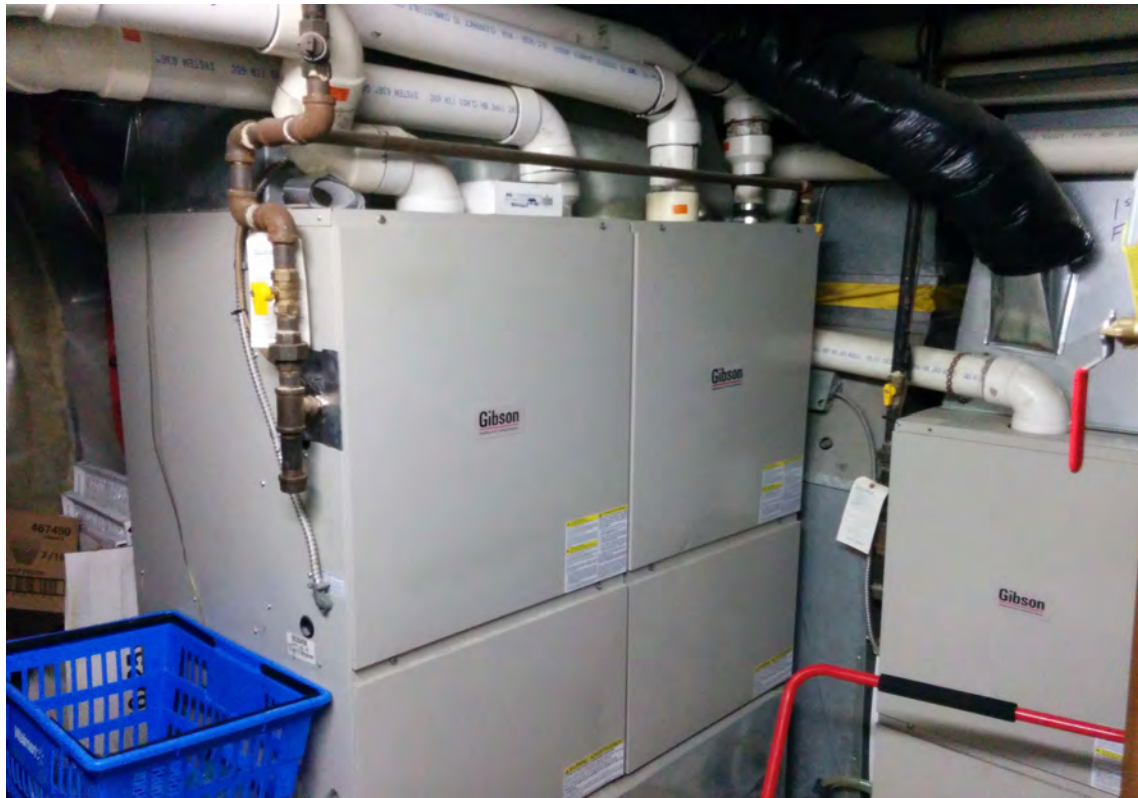
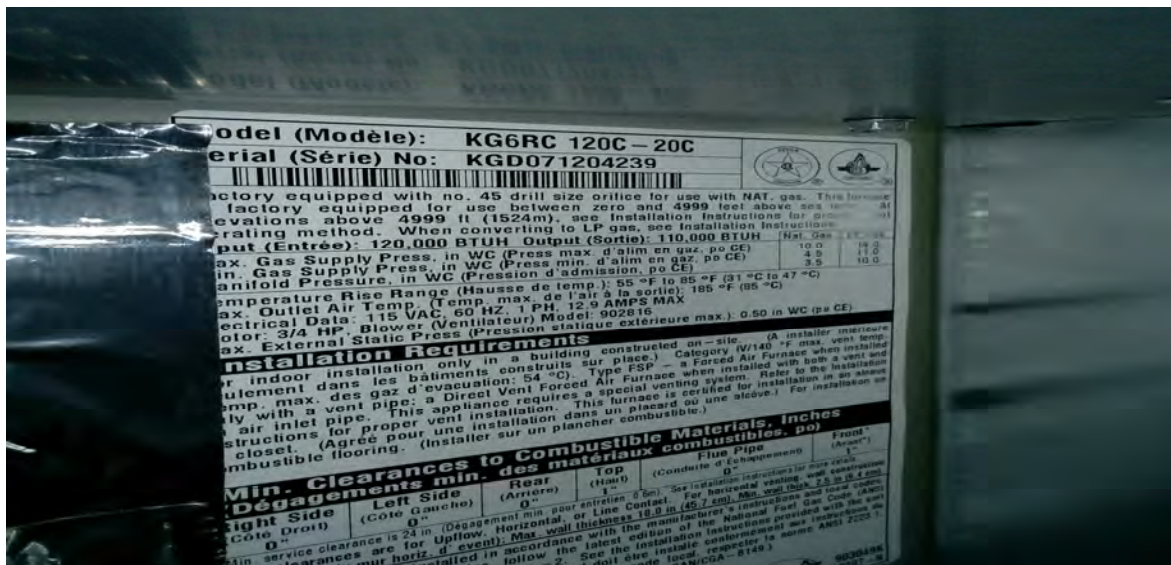
- 2.1 The building has four Gibson furnaces for heating only, each has a capacity of 110,000 Btu/hour with efficiency of more than 90%, natural gas fueled.
- 2.2 The building has no cooling as there is no direct expansion coils above the furnaces and a roof top unit could not be verified on the roof.
- 2.3 The building has no ventilation, no heat recovery or energy recovery units, no ventilation ducts and no exhaust duct from the ducting system.
- 2.4 There are no heating, cooling or ventilation calculations to verify if the furnaces are covering the heating load or the cooling capacity required and ventilation or outside fresh air required for the whole building.
- 2.5 The mechanical room is cramped, cluttered and very small for all the equipment in it.

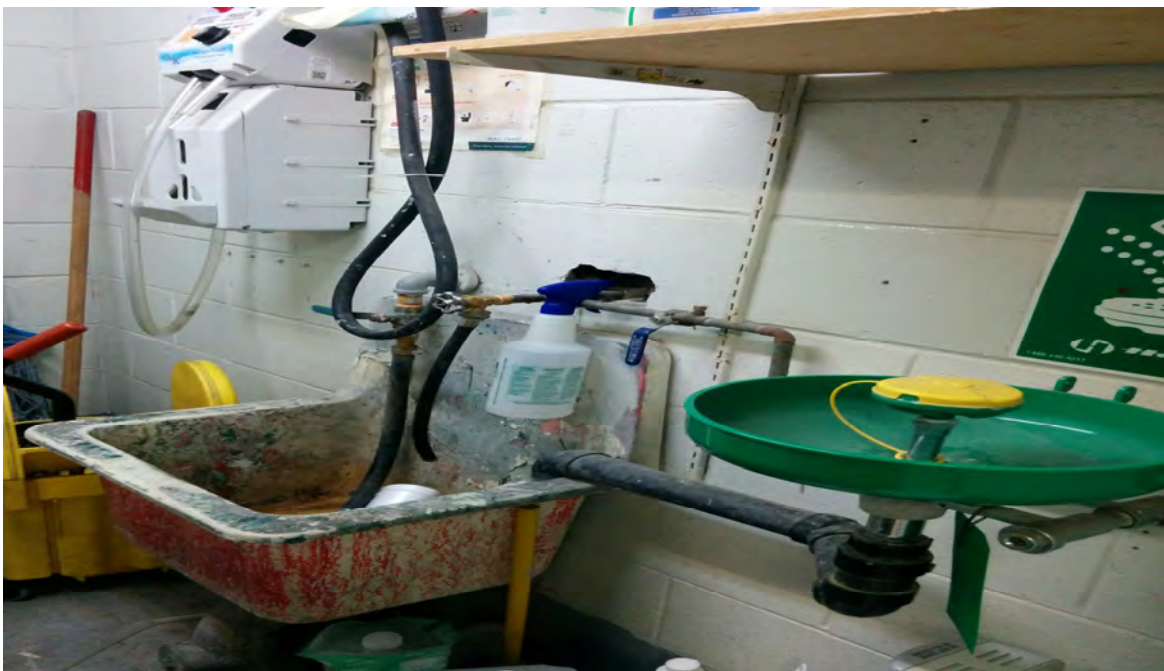
3.1 The fixtures as shown in the photos are in bad conditions and old.

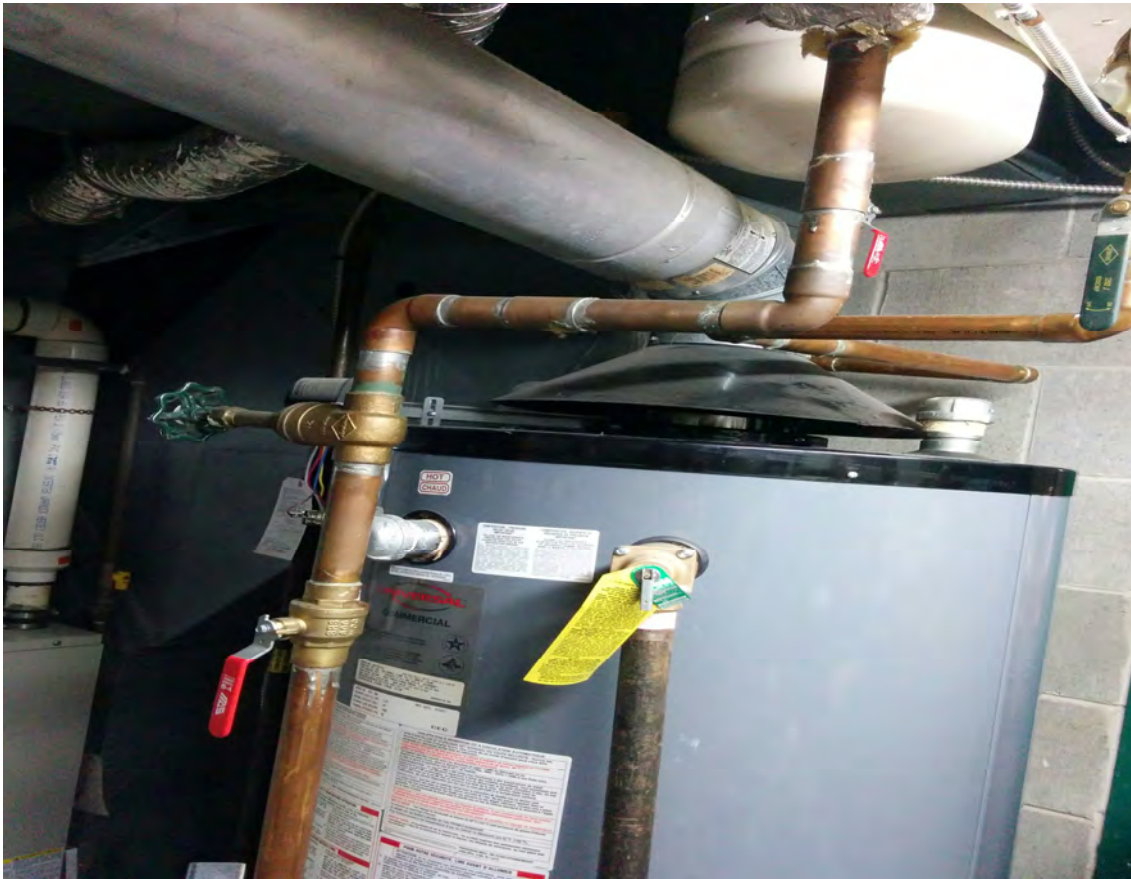
- 4.1 The fixtures are old, low efficiency and at the end of their life.
- 4.2 The pipe system could not be verified as most of it were in the ceiling space or inside walls.
- 4.3 The hot water tank is a good condition and the pipes inside the mechanical room are copper and in a good condition.
- 4.4 The incoming main domestic water pipe, valves and the meter are old, no back-flow meter was noticed.
- 4.5 No insulation on hot water pipes noticed in the whole building except some pipes in the mechanical room.
- 4.6 There was an expansion tank installed above the hot water tank.
- 4.7 No ventilation in the mechanical room and no recirculating pump.
- 4.8 No clearances around all equipment.
