## Regular Council Meeting

<b>To:</b>	Mayor and Council
<b>Date:</b>	December 16, 2024
<b>From:</b>	Chris Allison, Parks and Facilities Manager
<b>Report Number:</b>	Parks and Facilities 2024-05
<b>Subject:</b>	Mould Assessment Results and Required Remediation at Millbrook Arena

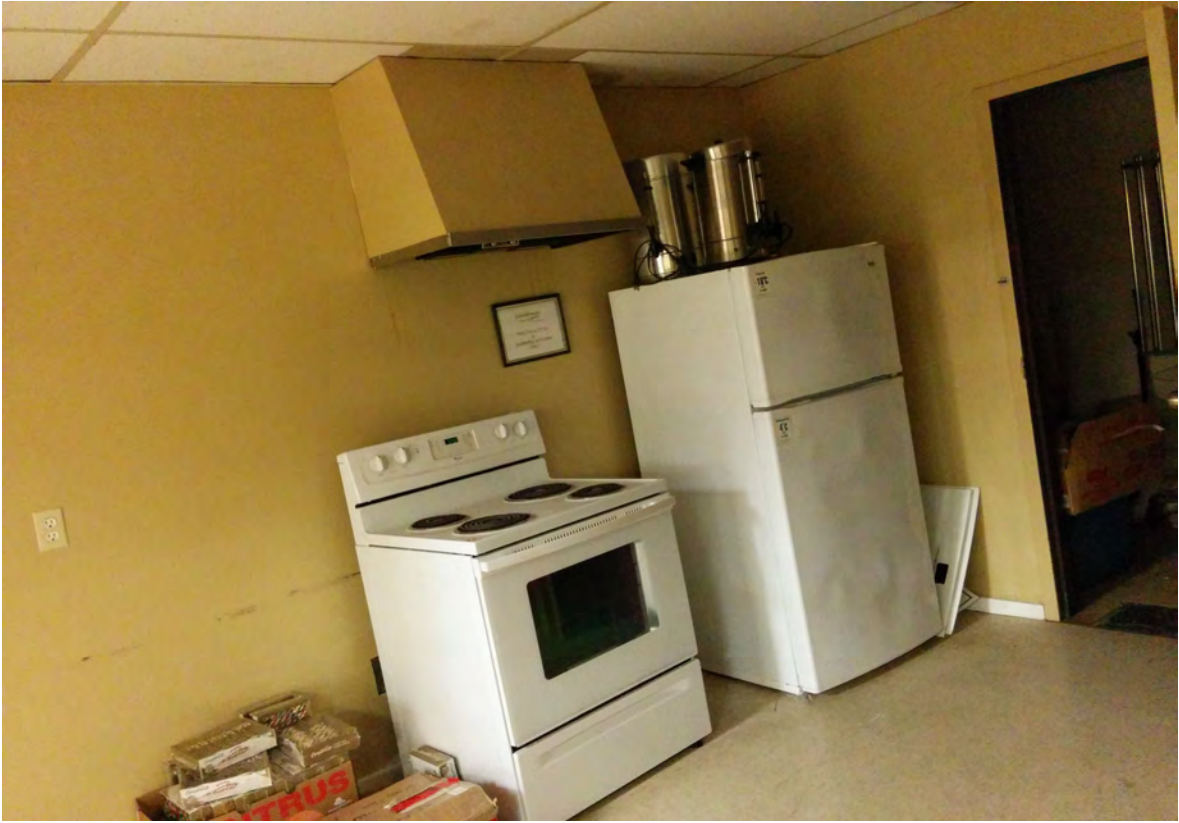
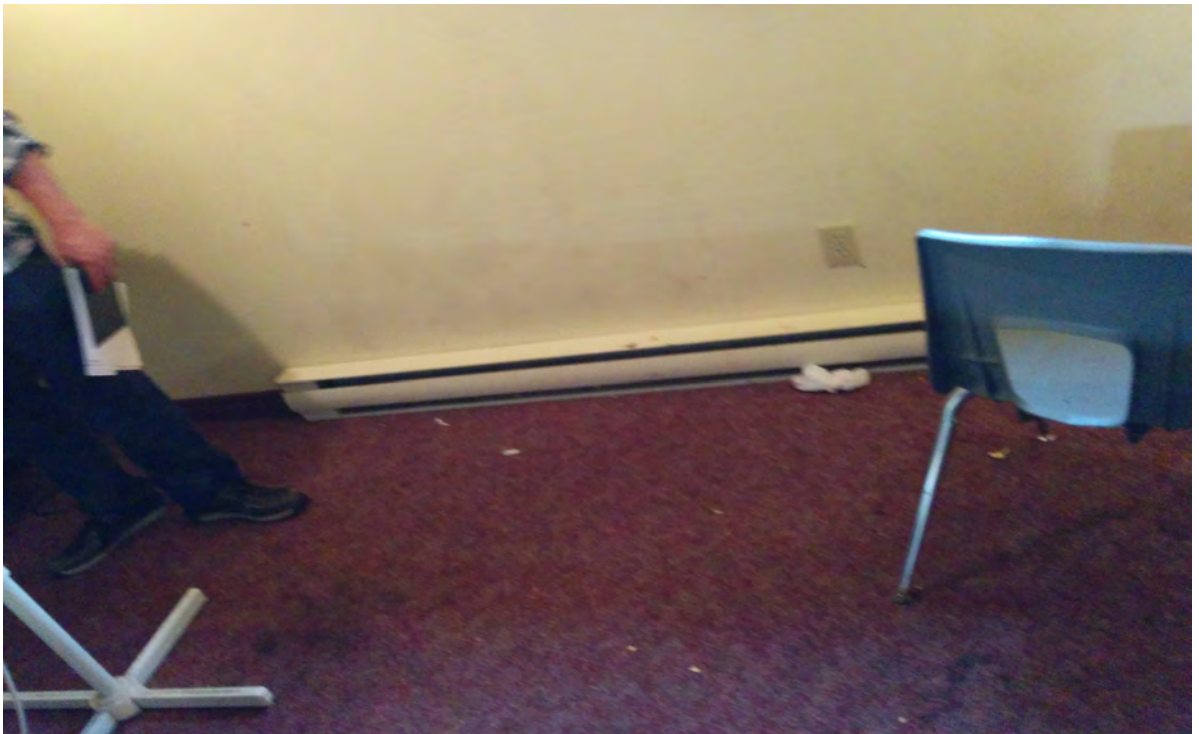
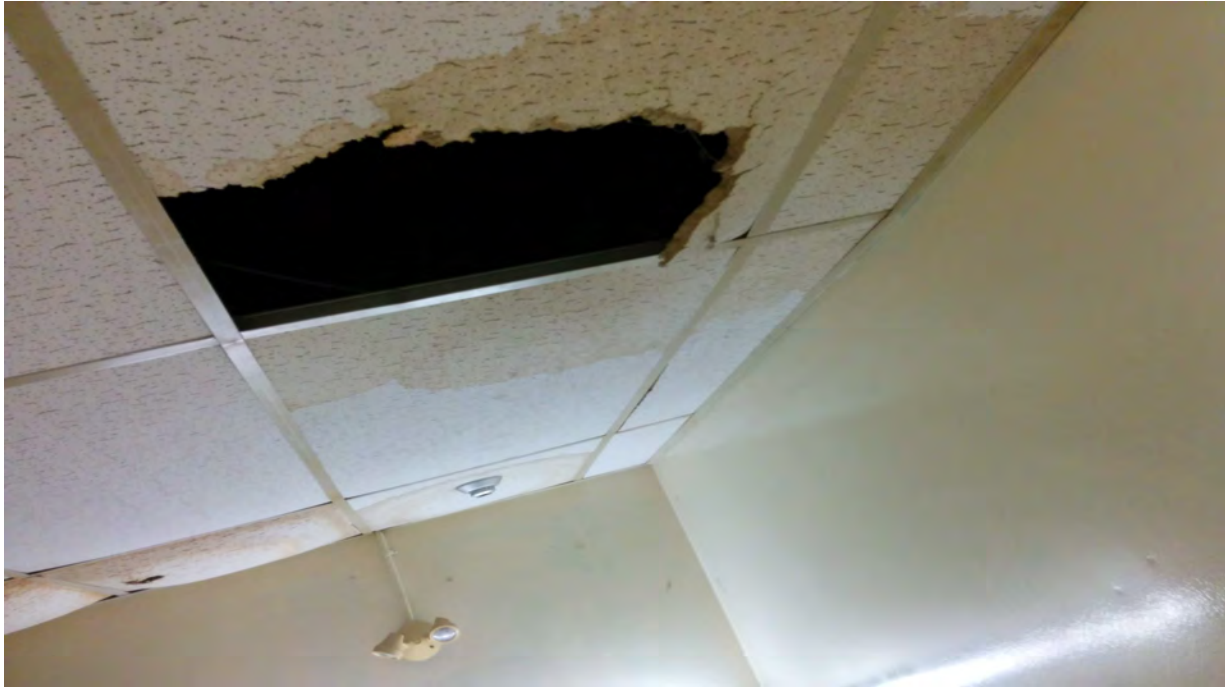
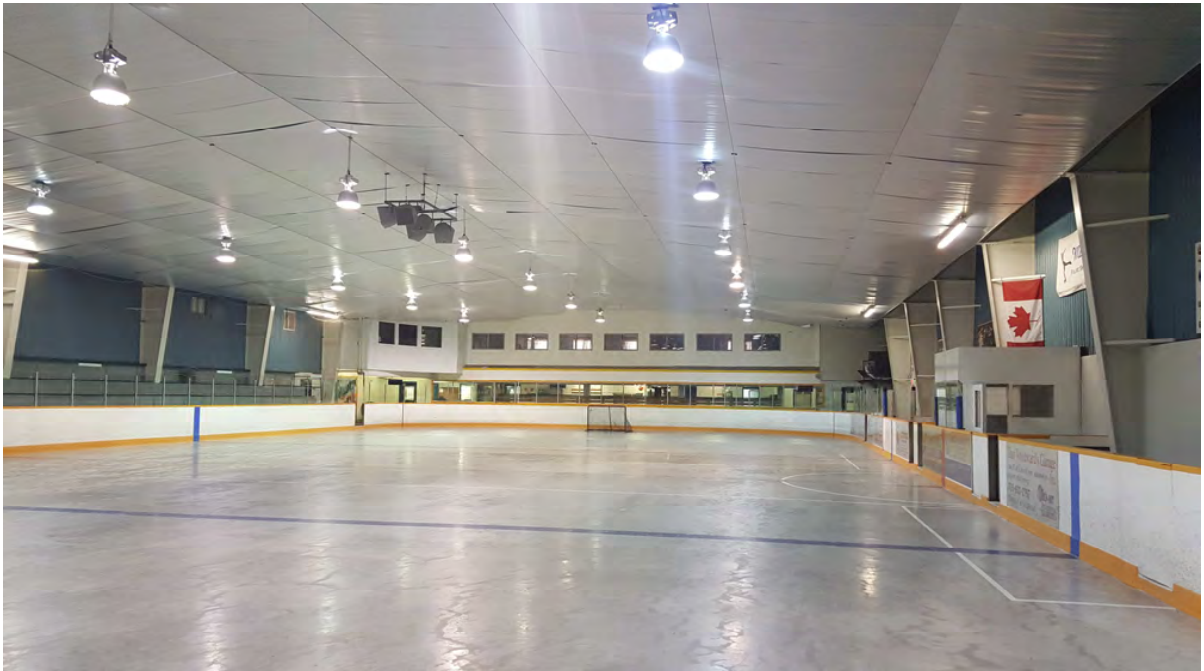
- 5.1** The exhaust air systems from washrooms, change rooms were not provided with exhaust fans or ducts as required by codes.
- 5.2** There is no heat recovery system for ventilation in the mechanical room.
- 5.3** The building roof is in bad condition with many leaks so that the mechanical system cannot work efficiently.
- 5.4** The range hood for the stove is not installed as required by codes and standards.
- 5.5** The Second-Floor room was heated with a base board electrical heater without any ventilation or exhaust fan.
- 5.6** The building has no fire suppression system.
- 5.7** The building has no automated control system for the mechanical or electrical system.
- 5.8** There are many spaces in the building that have no heating, cooling or ventilation.
- 5.9** No water treatment for the water in the mechanical room.
