**BARRY BRYAN  
ASSOCIATES**

Re: **Consulting Services to Update Our Structural Investigation Report to Assess the Feasibility of Renovating the Millbrook Arena or Utilizing the Space in Other Ways**  
**4 Needlers Lane, Millbrook, Ontario**  
**BBA Project No. 22059 (REVISED)**

Barry Bryan Associates (BBA) was requested by the Township of Cavan Monaghan to provide an updated review of the Millbrook Arena located at 4 Needlers Lane in Millbrook, Ontario.

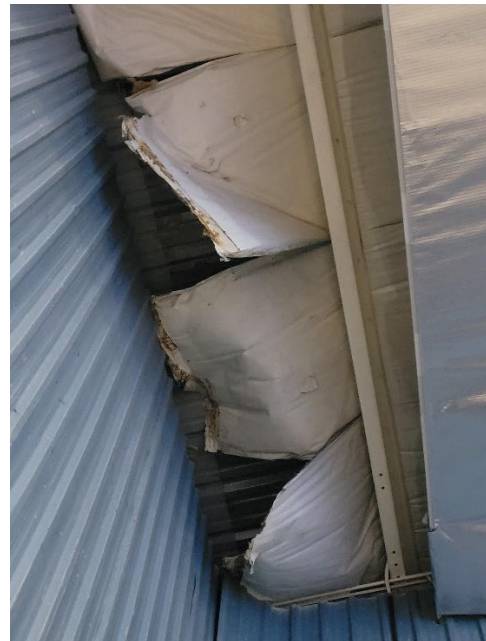
Photo 04 – Damaged Roof Insulation

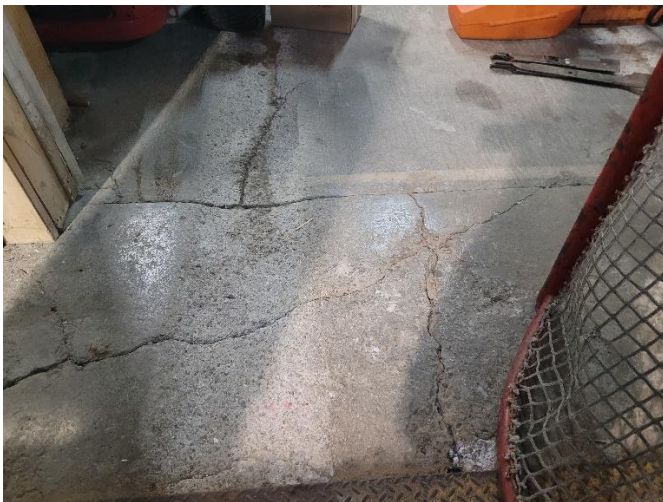
Photo 07 – Cracked Apron Slab

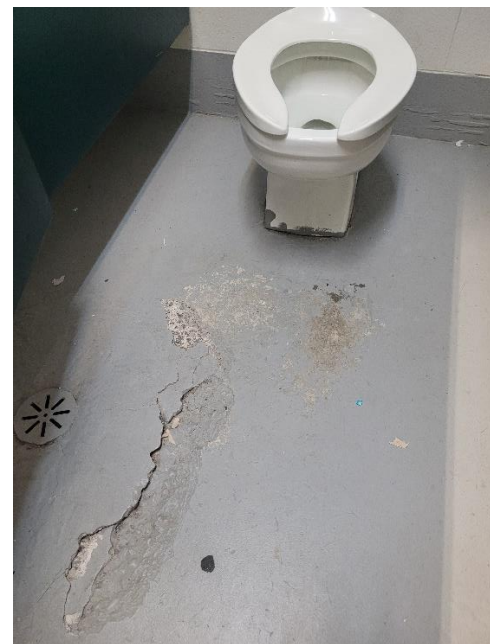
Photo 12 – Damaged Slab in Washroom

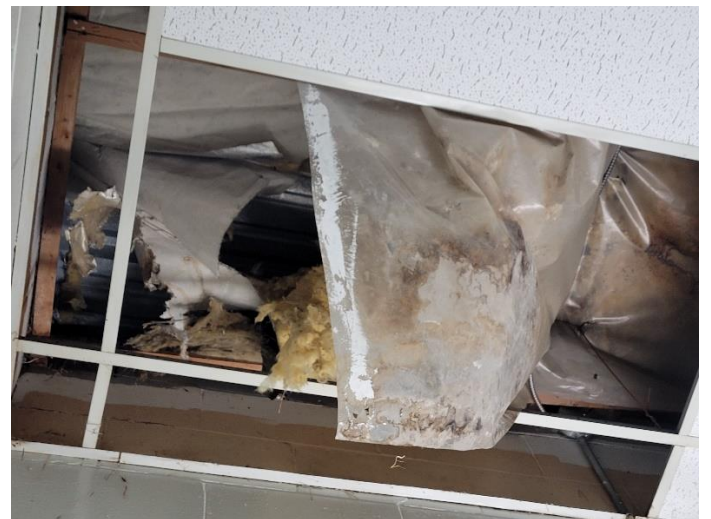
Photo 16 – Damaged Roof Insulation and Evidence of Moisture

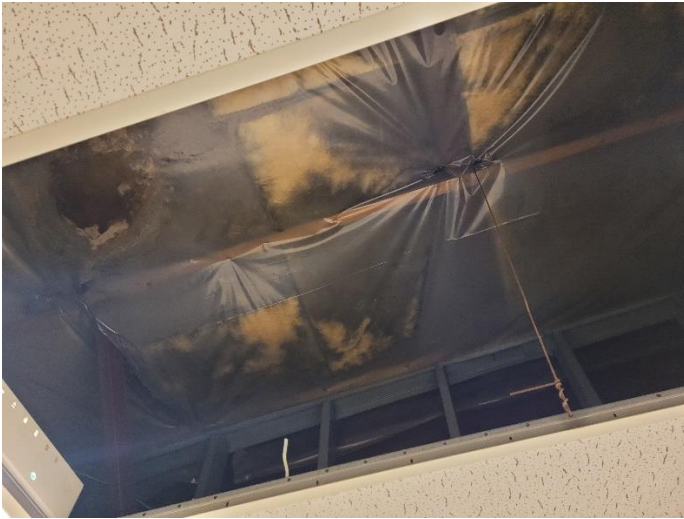
Photo 17 – Mould and Evidence of Moisture

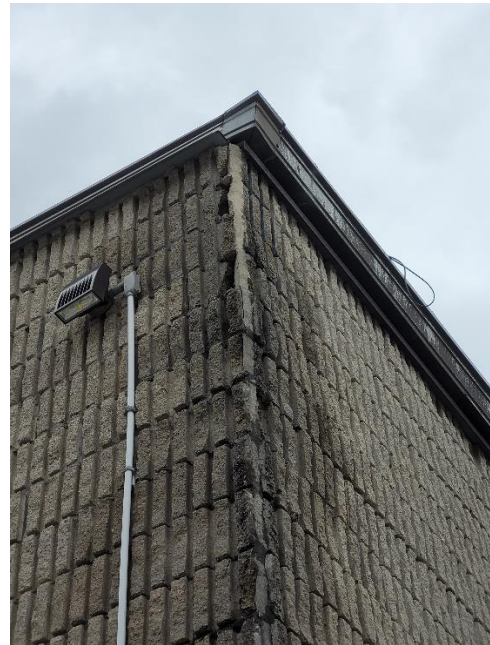
Photo 22 – Damaged Split Ribbed Block at Southeast Corner

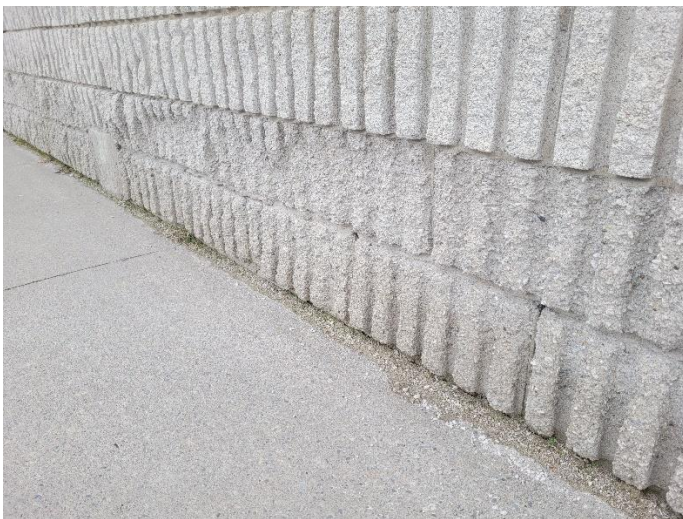
Photo 23 – Damaged Split Ribbed Block at Southeast Corner

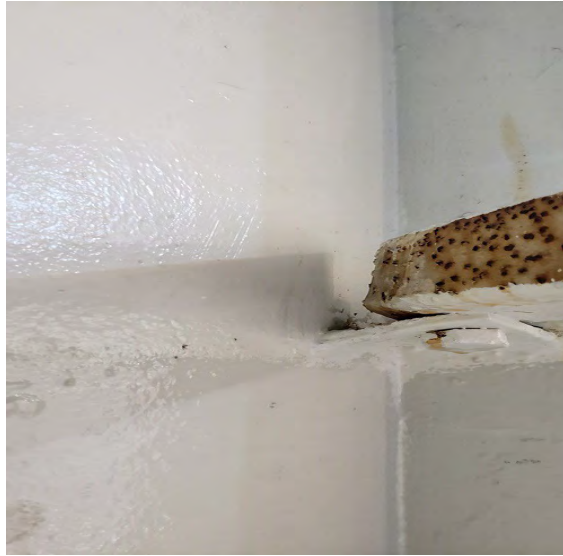
- Bolted connections at the braces appeared to be bent at several locations, effectively causing the nut to be displaced (Photo 005). This appears to be an original condition from the fabrication of the braced connections. Further, minor surface rusting was observed at several bolted connection locations (Photo 006). We recommend for the rusted areas be wire brushed clean to bare metal and an epoxy protective coating is applied.

Photo 005      Bent Connection

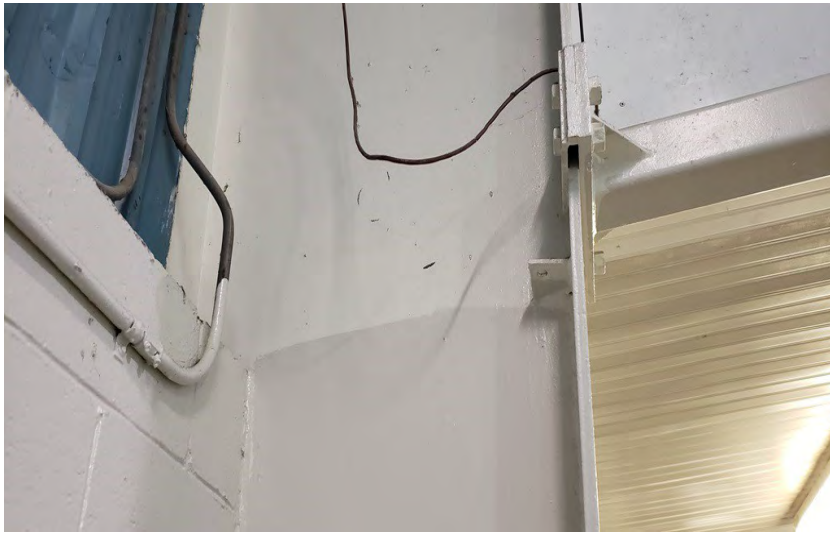
Photo 008      Missing Brace at Southmost Frame

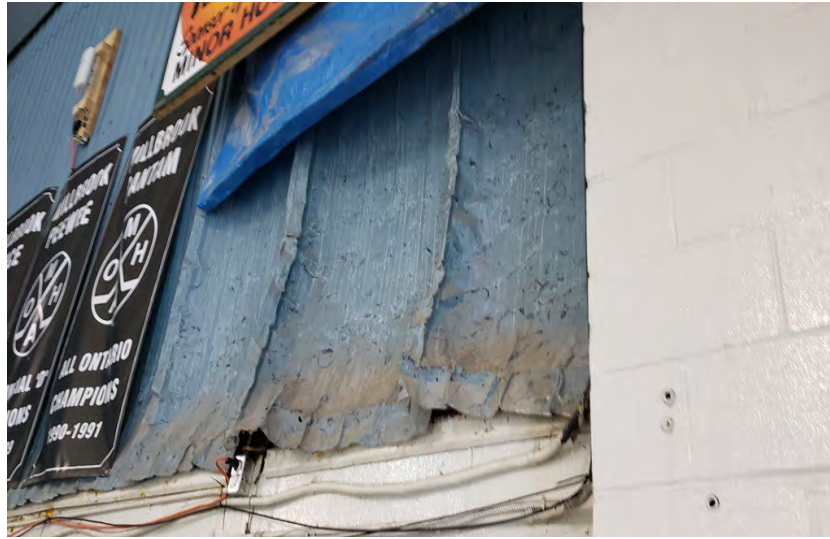
- Minor damage to the metal siding at the North-East corner was observed (Photo 012). This damage is likely a result of repeated impacts from pucks/balls within the arena. For aesthetics purposes, we recommend that the cladding is cleaned and painted as required to match original conditions.
- Significant damage to the metal cladding at the North Wall was observed (Photo 013). The cause of the damage is unclear. However, we recommend that the cladding be replaced at this location to restore to original conditions.
- The metal cladding at roof level along the North elevation appears to be separating from the adjacent cladding. We recommend that the cladding at the roof level be re-secured to match the existing conditions (Photo 014).

Photo 013      Significant Damage to Metal Cladding

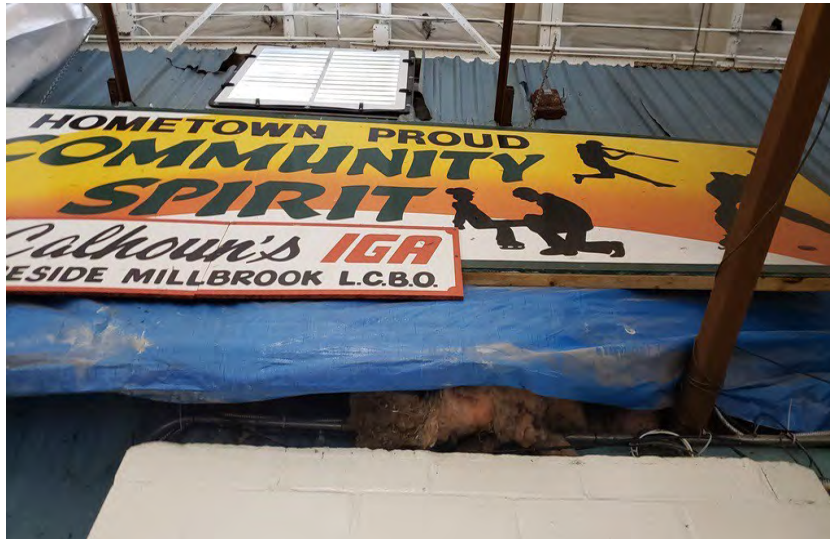
Photo 014      Metal Cladding Damage

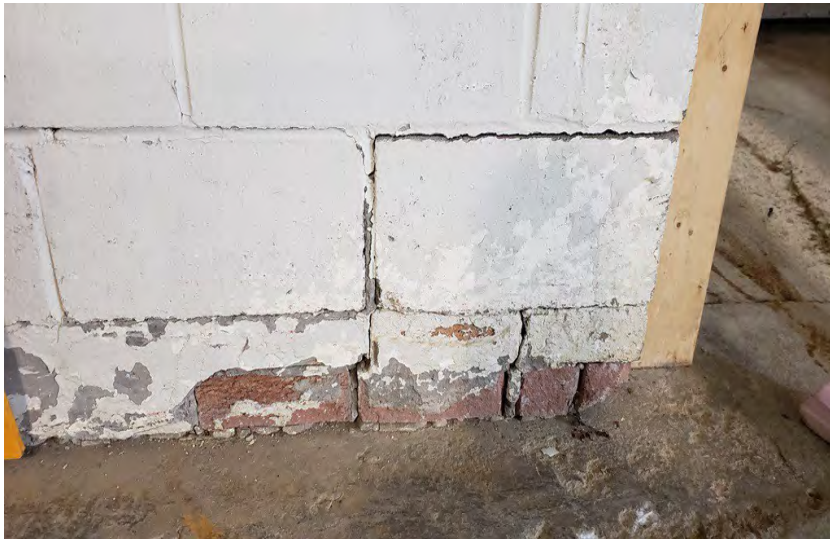
- Deterioration and displacement at the base of the concrete masonry block was observed at a localized area (Photo 038). We recommend that the deteriorated blocks be removed and replaced with concrete masonry blocks to match the existing condition.

Photo 038 Block and Joint Damage

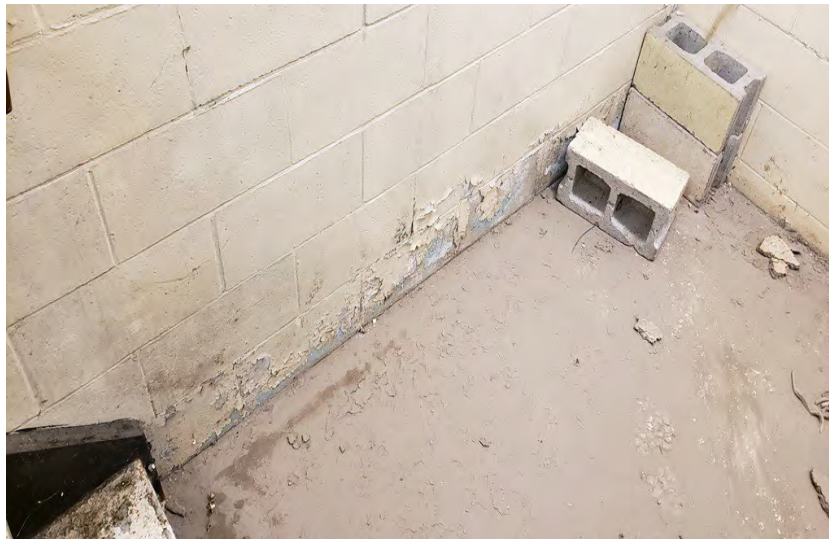
Photo 046      Paint Chipping and Moisture Damage

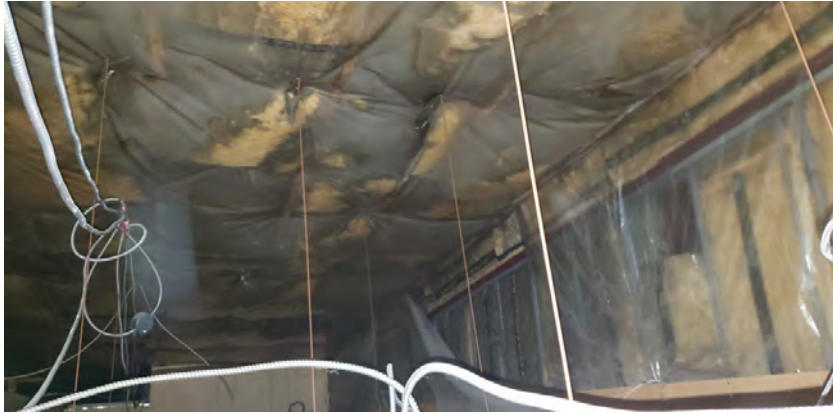
Photo 059      Moisture in Roofing System

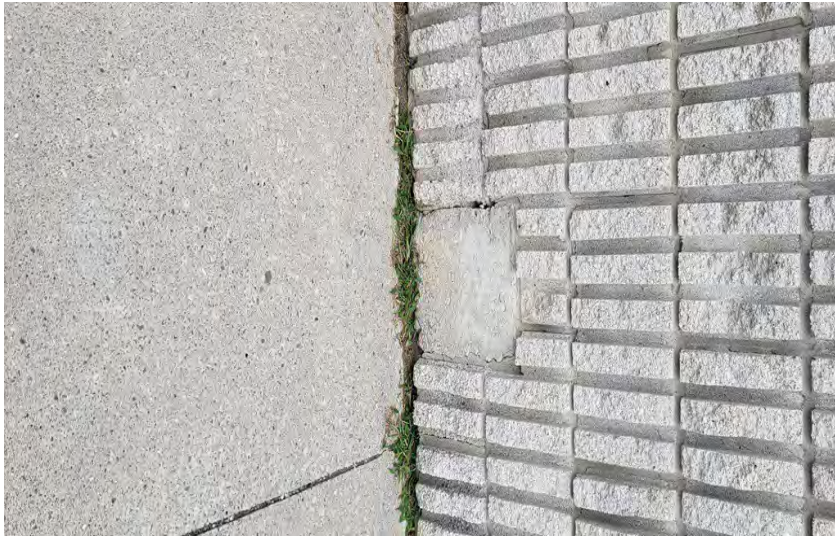
Photo 064      Cracking at Centre Foundation Wall

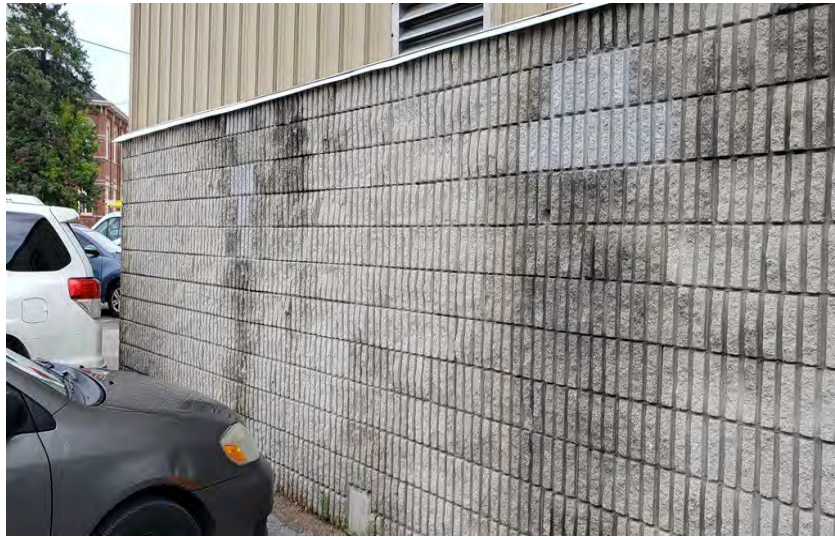
Photo 067      Localized Block Damage at South-East Corner

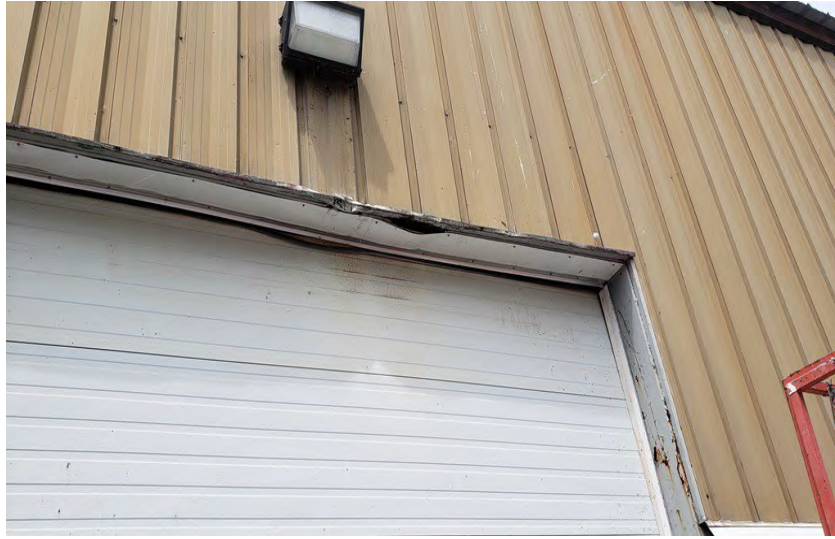
Photo 077      Damage to Garage Door Opening

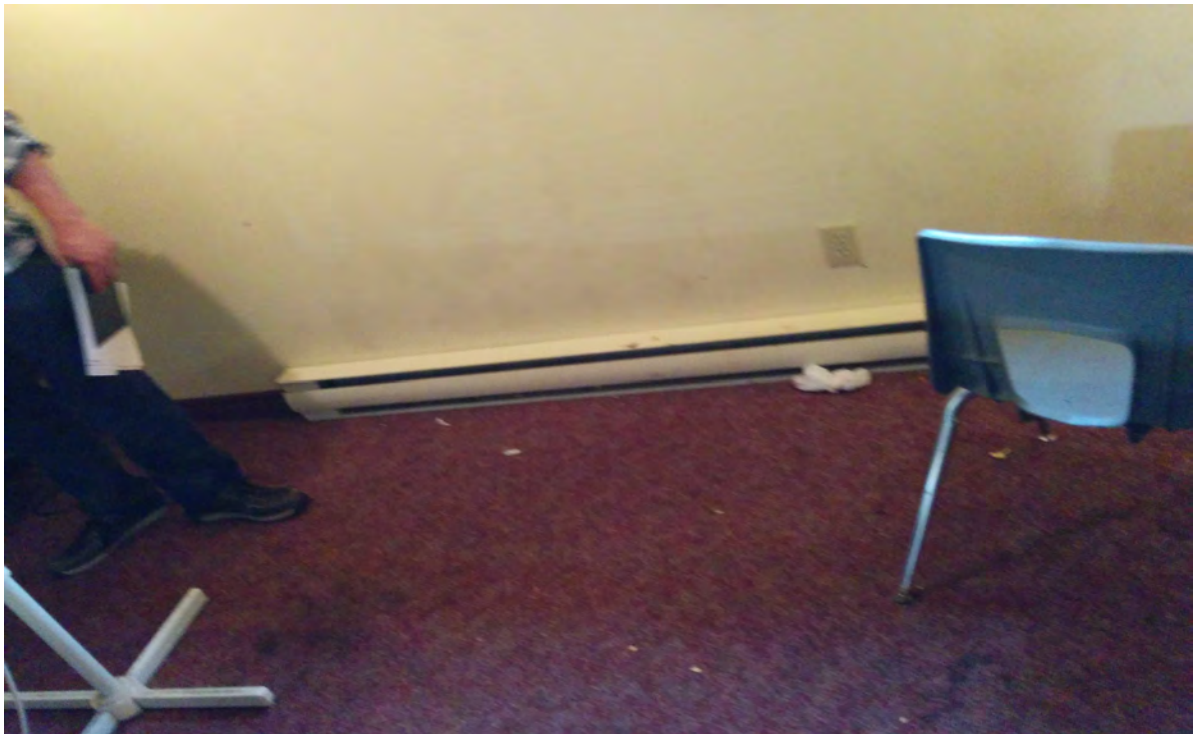
- 5.1** The exhaust air systems from washrooms, change rooms were not provided with exhaust fans or ducts as required by codes.
- 5.2** There is no heat recovery system for ventilation in the mechanical room.
- 5.3** The building roof is in bad condition with many leaks so that the mechanical system cannot work efficiently.
- 5.4** The range hood for the stove is not installed as required by codes and standards.
- 5.5** The Second-Floor room was heated with a base board electrical heater without any ventilation or exhaust fan.
- 5.6** The building has no fire suppression system.
- 5.7** The building has no automated control system for the mechanical or electrical system.
- 5.8** There are many spaces in the building that have no heating, cooling or ventilation.
- 5.9** No water treatment for the water in the mechanical room.
