Designated Substances Survey-4 Needlers Lane, Millbrook, Ontario

April 24, 2023

Prepared for: Township of Cavan-Monaghan

Cambium Reference: 17509-001

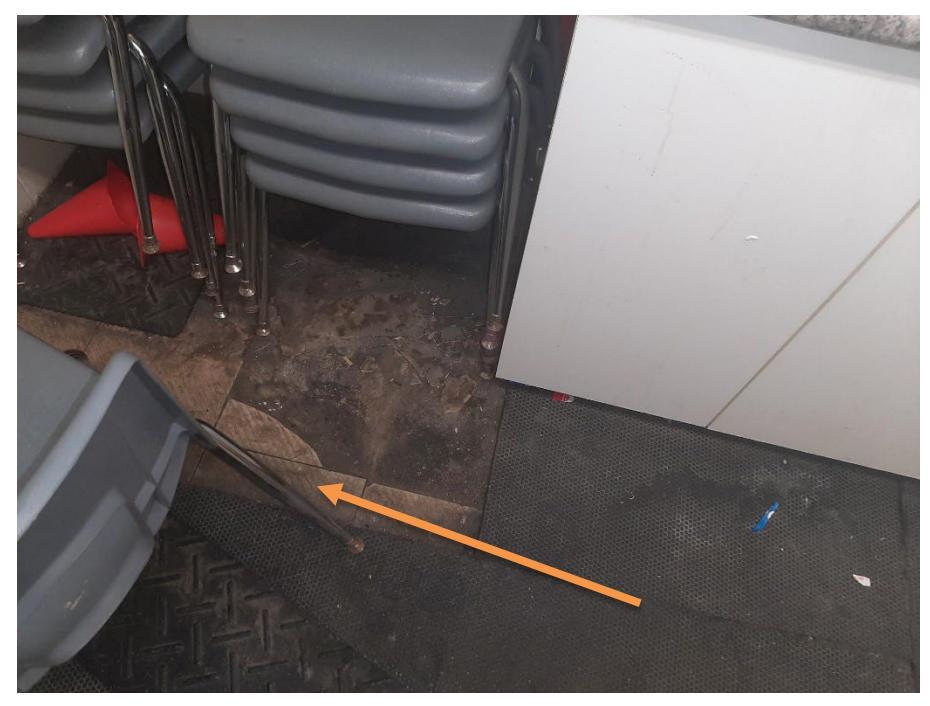
- Vinyl floor tiles, containing chrysotile asbestos, are present in various area throughout the building. If affected by planned maintenance activities, remove vinyl floor tiles using Type 1 procedures as outlined in O. Reg. 278/05.

Photo 1 – Asbestos-containing vinyl floor tiles in the canteen.

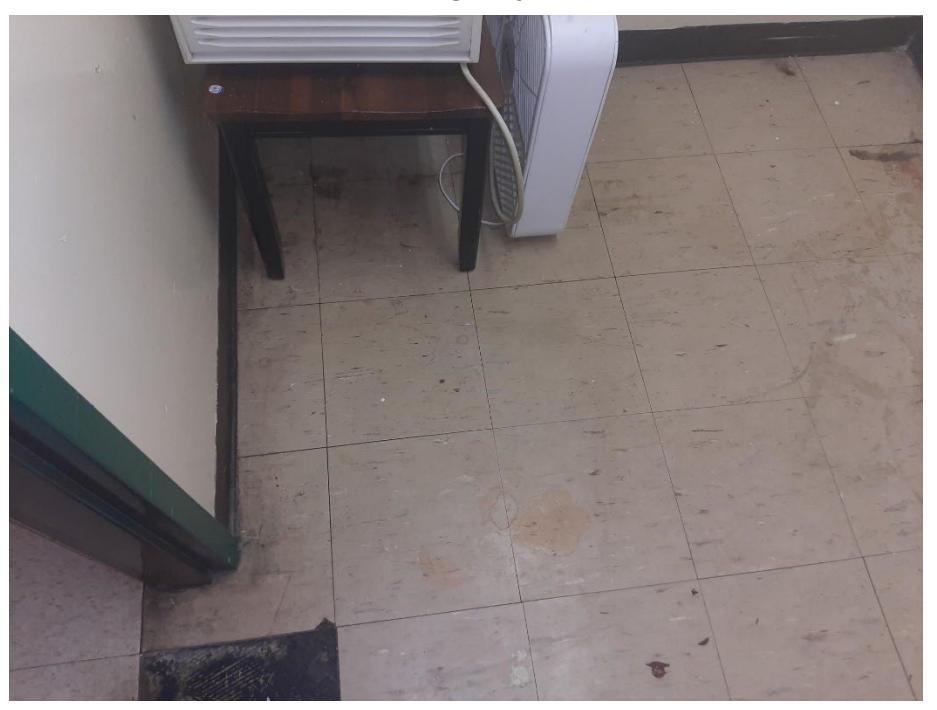
Photo 2 – Asbestos-containing vinyl floor tiles in the second floor.

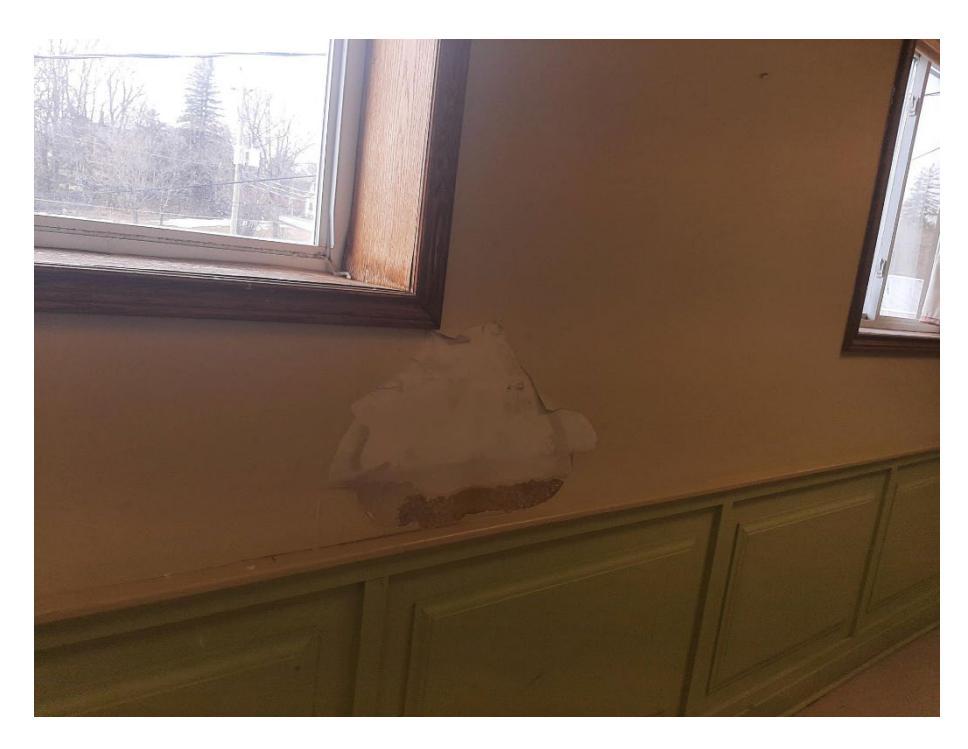
- Drywall joint compound, containing chrysotile asbestos, is present on gypsum walls and ceilings throughout the building. Remove/repair drywall joint compound in poor condition following type 1 procedures as outlined in O. Reg. 278/05. If affected by maintenance activities, remove one square meter or less of drywall joint compound following Type 1 procedures as outlined in O. Reg. 278/05. Remove more than one square meter or more following Type 2 procedures as outlined in O. Reg. 278/05.

Drywall joint compound, containing chrysotile asbestos, is present on gypsum wall and ceiling finishes throughout the building (sample ASB-101.1). There is approximately 5,000 square feet of gypsum with drywall joint compound and it was observed in good condition, with the

exception of approximately 15 square feet on the second floor which was observed in poor condition.

Photo 3 – Asbestos-containing drywall joint compound in poor condition.

- Remove/repair asbestos-containing drywall joint compound following Type 1 procedures as outlined by O. Reg. 278/05.
- If affected by maintenance activities:

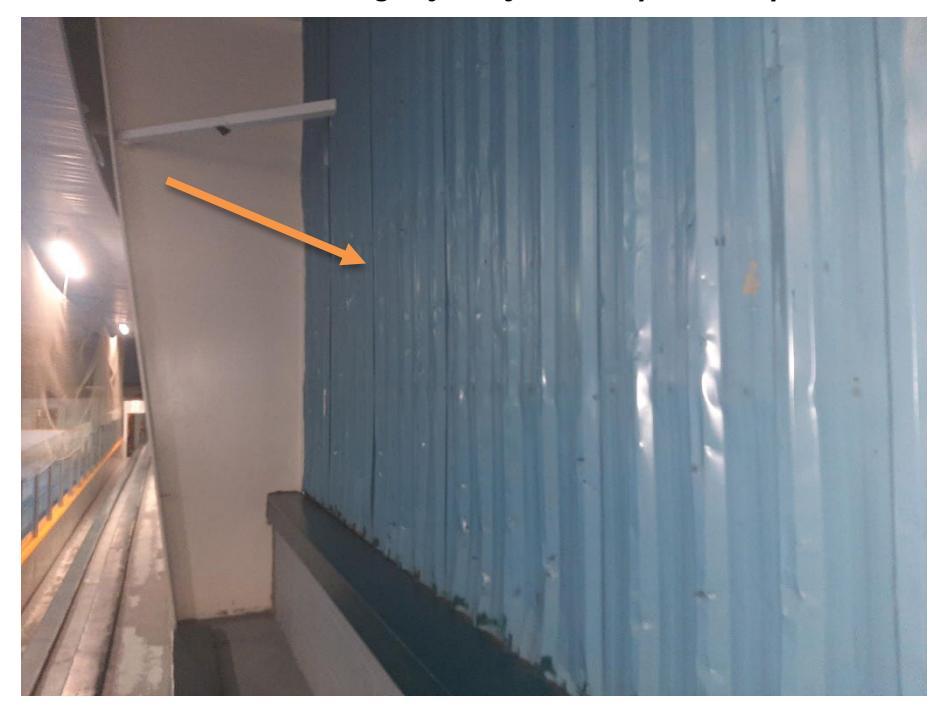
• Blue paint on metal is lead-based. If affected by planned maintenance activities, remove lead-based painted finishes using Class 1 procedures as outlined in the guideline, "Lead

The results of laboratory analysis indicated that blue paint on metal is lead-based. All remaining painted finishes contain low levels of lead and are not considered to be lead-based. Painted finishes were found to be in good condition.

Photo 4 – Lead-based blue paint on metal in the main arena.

- If affected by maintenance activities, remove lead-based painted finishes following Class 1 procedures as outlined in the guideline, "Lead Guideline For Construction, Renovation, Maintenance or Repair" issued by EACC, dated October 2014.
- Any paints discovered during the course of maintenance activities that are not mentioned in this report shall be considered to be lead-based until sampling and analysis indicates otherwise.

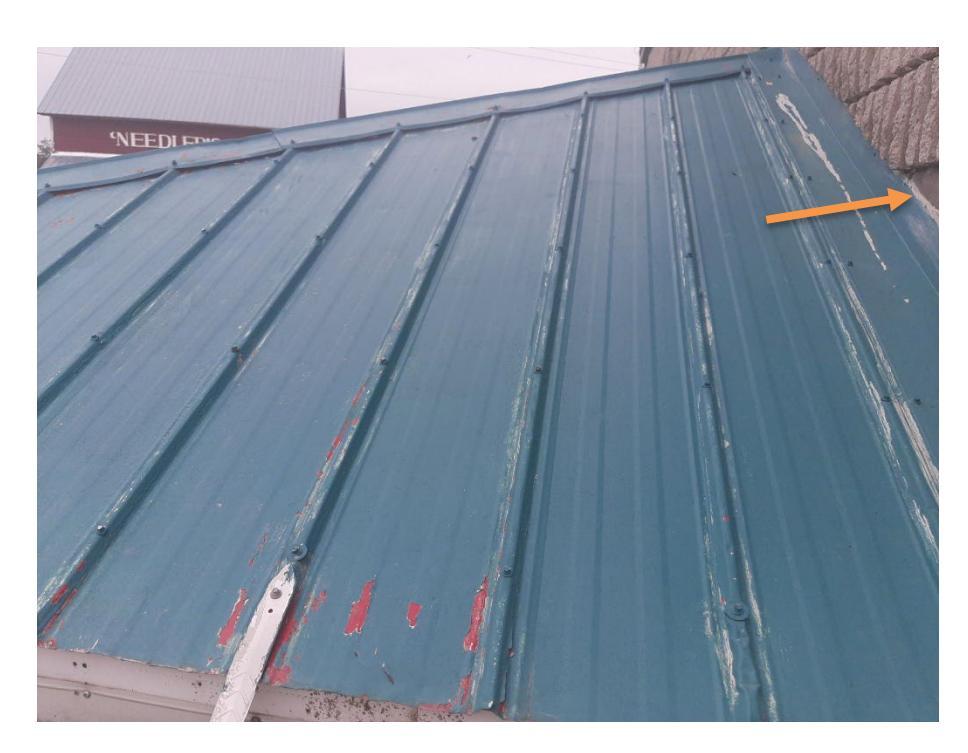
- White caulking, containing chrysotile asbestos, is present around exterior seams of the building. If affected by planned maintenance activities, remove caulking using Type 1 procedures as outlined in O. Reg. 278/05.

Photo 5 – Asbestos-containing white exterior caulking.
