Structural Investigation and Report for the

MILLBROOK ARENA

Township of Cavan Monaghan

AUGUST 7, 2019

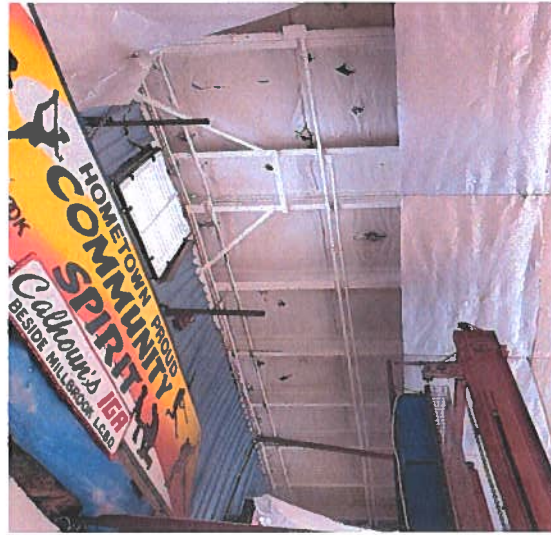
- The roof deck generally appeared to be in fair condition with no evidence of water/moisture damage (Photo 001). However, at the area exposed behind the net, there were visible minor damage due to puck impacts. For aesthetics purposes, we recommend that the damaged areas are cleaned and painted as required to match original conditions.
- The cold formed steel z-purlins was generally observed to be in fair to good condition.

Photo 001 Hidden Roof Deck & Z-Purlins

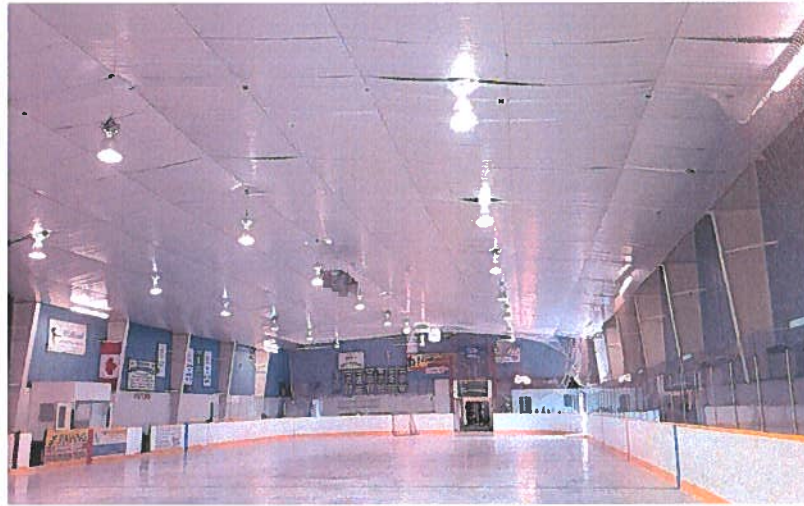
The main structure of the arena consists of a pre-engineered structural frame system with tapered steel girders supporting the steel purlins. The steel frames span approximately 90'-0" and are spaced at approximately 21'-1" centre to centre. We were unable to complete a detailed review of the entire extents of the tapered girders as this framing was enclosed by the existing insulation system (Photo 002). Our observations are as follows:

Photo 002 Roof Deck Insulation covering Pre-Engineered Frames

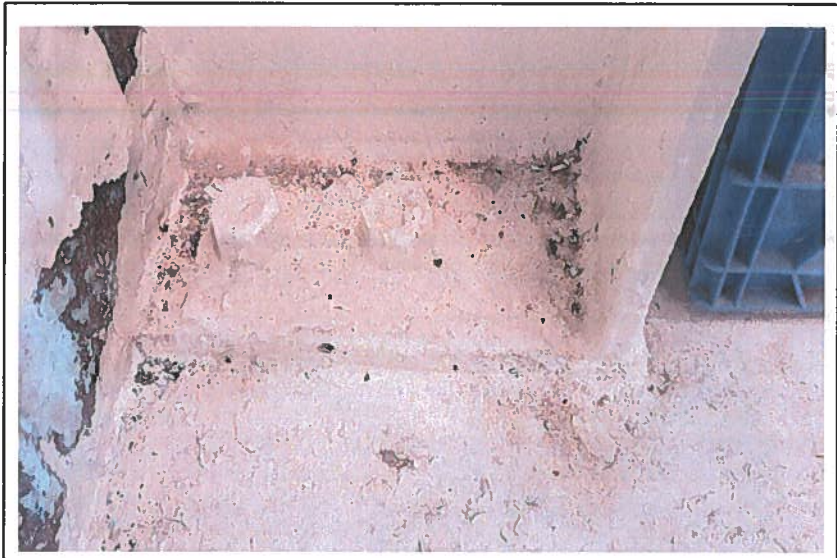
- Insufficient anchor bolt thread protrusion was observed at several locations. The threads at several bolted connections were not observed to extend past the nuts at the pre-engineered frame base connections (Photo 007). As this condition does not meet the minimum code requirements for thread protrusion past the nut, we recommend that the locations be plug welded to ensure connection to the foundation below is adequate.
- The lower set of braces were observed to be missing along the bleachers (Photo 008). This appears to be an as-built condition as the braces would interfere with the bleacher seating area. A single brace at the south side of the arena appears to be experiencing some deflection, this appears to be an as-built condition (Photo 009).

Photo 007 Pre-Eng Frame Base Connections

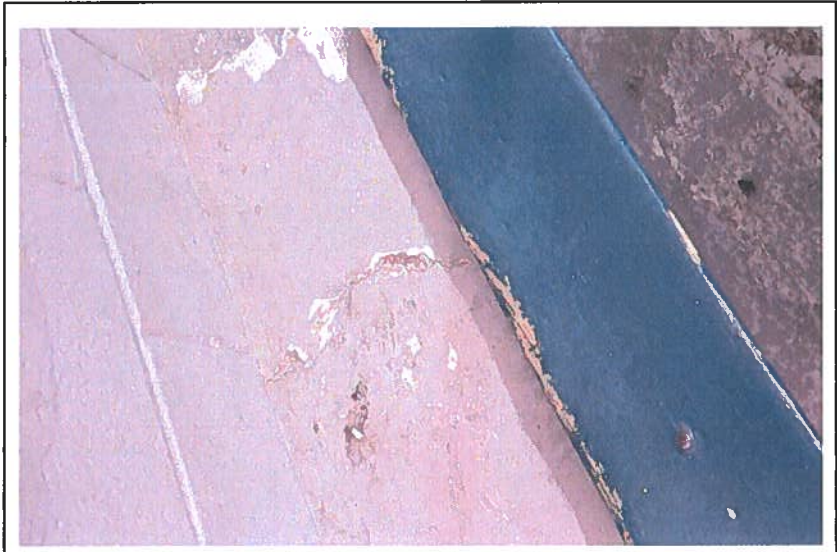
- The concrete topping was observed to experience localized minor cracking and paint chipping at localized locations (Photo 010). We recommend that all loose paint be scraped and repainted to match existing conditions.
- Minor cracking was observed at the precast concrete joint location (Photo 011). This cracking is typical for concrete joint locations and is not a structural concern. We recommend for the joints to be routed out and infilled with a flexible calking material.

Photo 010 Paint Chipping and Crack on Bleachers

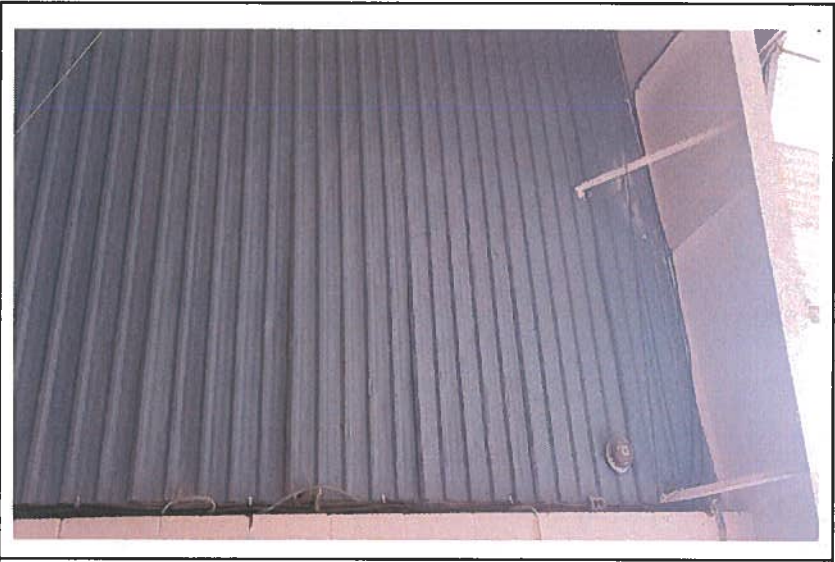
- Minor damage to the metal siding at the North-East corner was observed (Photo 012). This damage is likely a result of repeated impacts from pucks/balls within the arena. For aesthetics purposes, we recommend that the cladding is cleaned and painted as required to match original conditions.
- Significant damage to the metal cladding at the North Wall was observed (Photo 013). The cause of the damage is unclear. However, we recommend that the cladding be replaced at this location to restore to original conditions.
- The metal cladding at roof level along the North elevation appears to be separating from the adjacent cladding. We recommend that the cladding at the roof level be re-secured to match the existing conditions (Photo 014).

Photo 012 Localized damage to MetalCladding

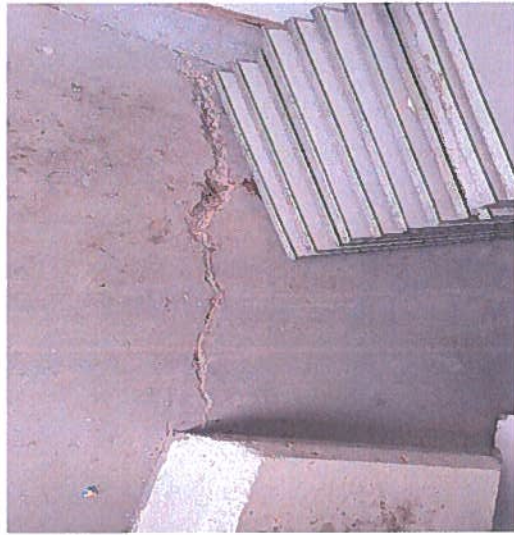
- Moderate cracking was observed near the entrance of the compressor room (Photo 017). We recommend to infill the void space with suitable mortar to match existing conditions.

Photo 017 Cracking Outside of Compressor Room

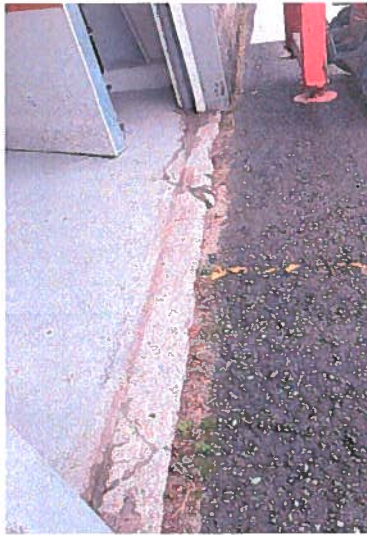
- Moderate cracking and spalling were observed underneath the exterior garage door on the East side of the building (Photo 018). We recommend for all loose and unsound concrete to be chipped out and removed and patched with a suitable repair mortar.

Photo 018 Apron Slab Under Garage Door

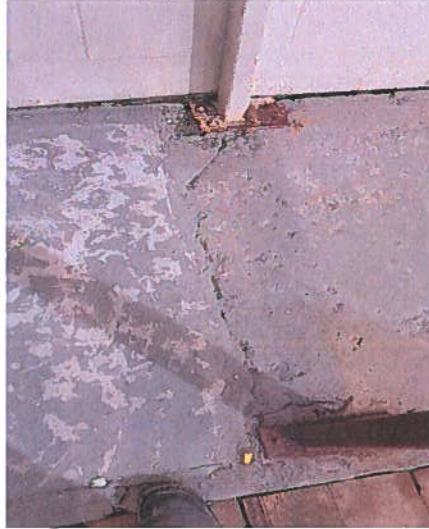
- Cracking was observed underneath the mechanical equipment stand supports at the North-West side of the arena (Photo 025). It appears as though a concrete levelling product has been implemented in the past, resulting in a slight transition between the floor elevations. We recommend that the transition be leveled, and the cracks be infilled with suitable mortar.

Photo 025 Crack Underneath Mechanical Equipment Stand

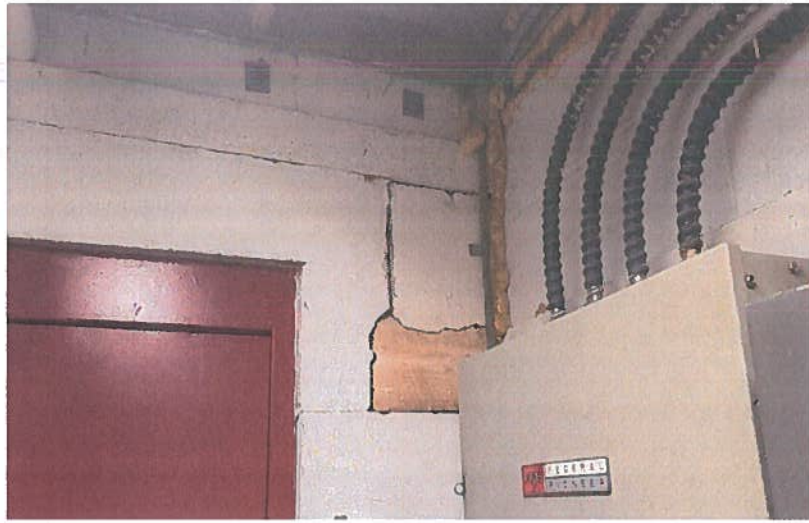
Photo 035 Wooden Block Replacement and Cracking

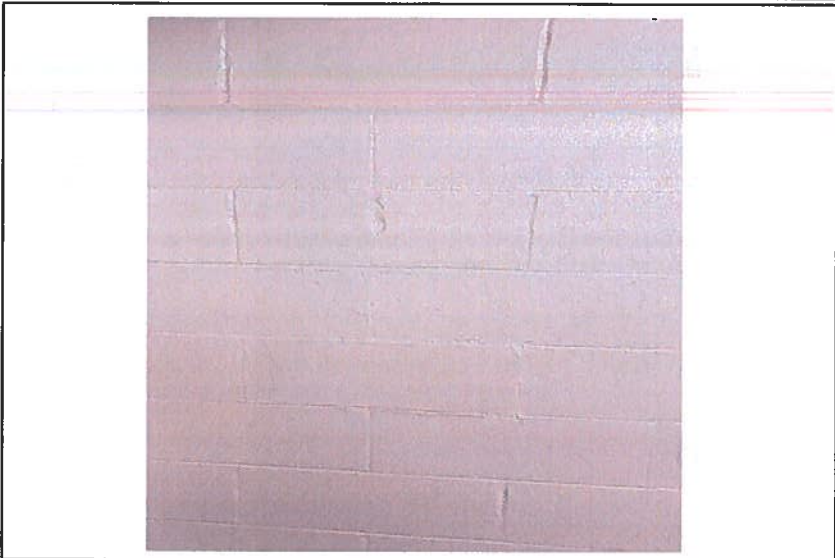
Photo 043 Localized Damage in Changeroom 3

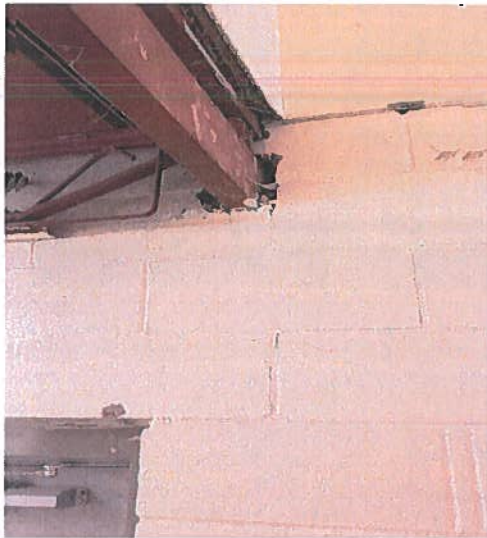
Photo 047 Localized Block Failure

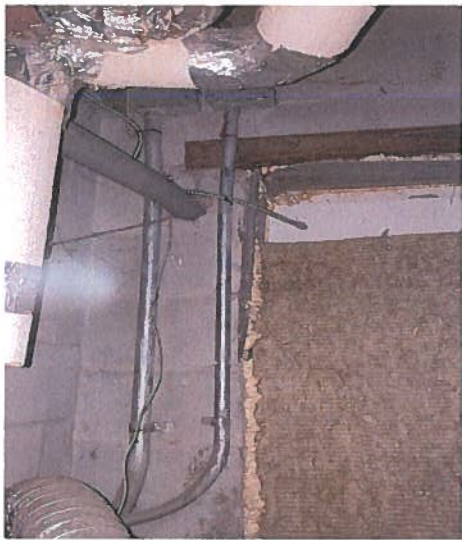
Photo 048 Localized Block Failure

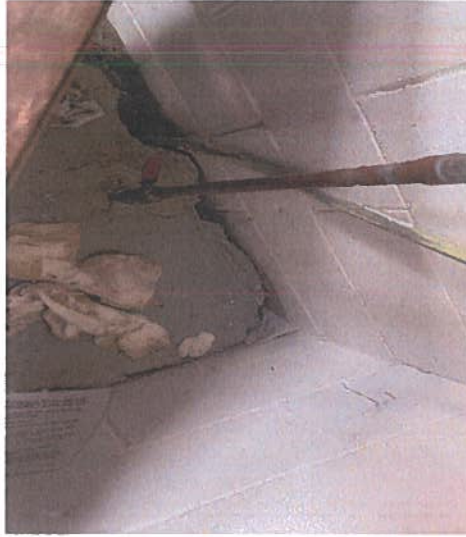
Photo 051 Slab-On-Grade to Wall Separation in Compressor Room

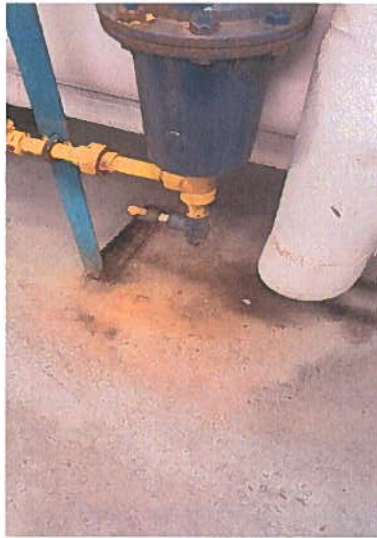
Photo 052 Concrete Staining in Compressor Room

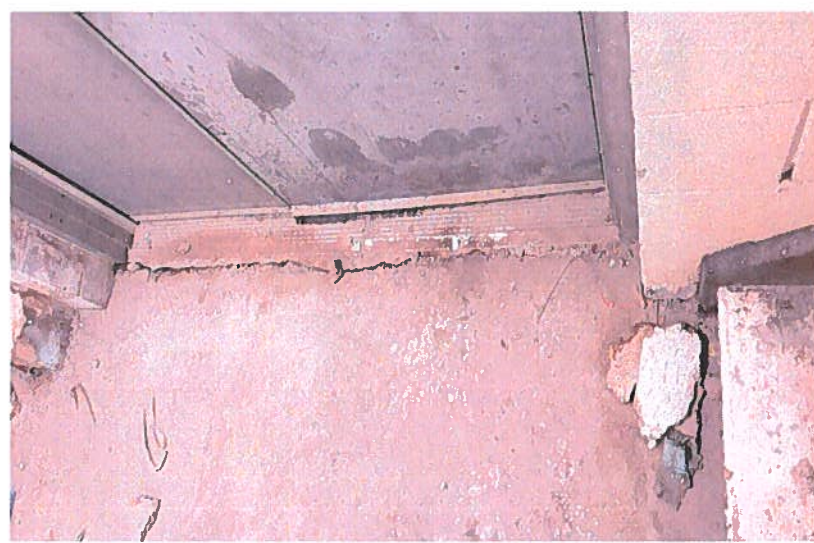
Photo 054 Slab-On-Grade Damage in West-Side Stairwell

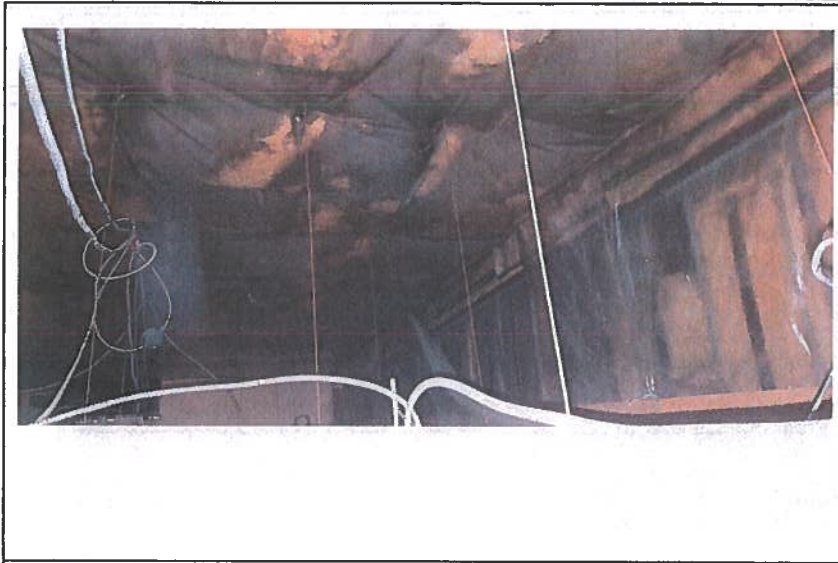
Photo 059 Moisture in Roofing System

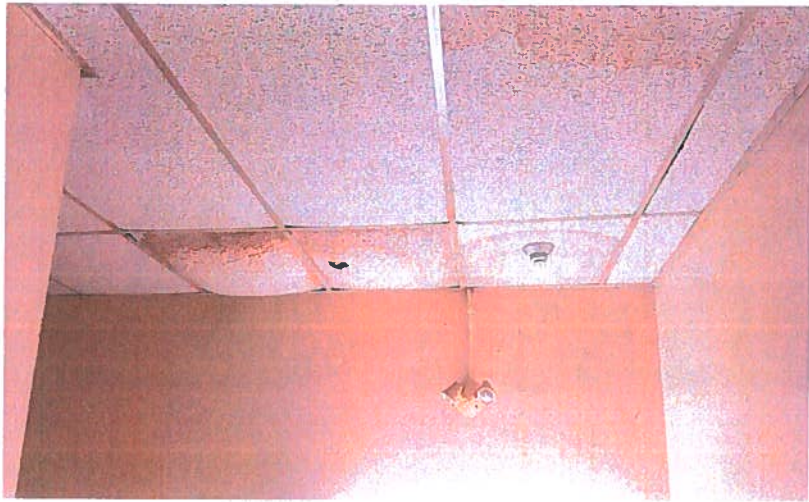
Photo 061 Signs of Moisture Damage

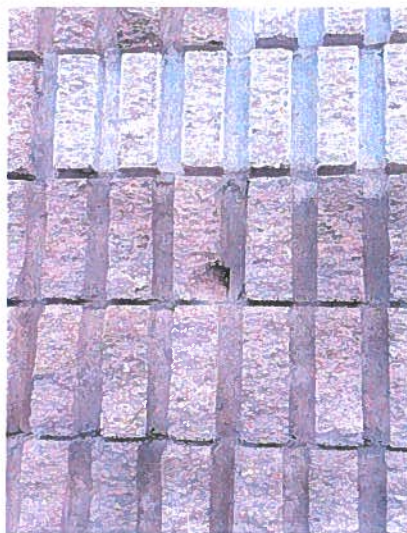
Photo 066 Localized Brick Damage

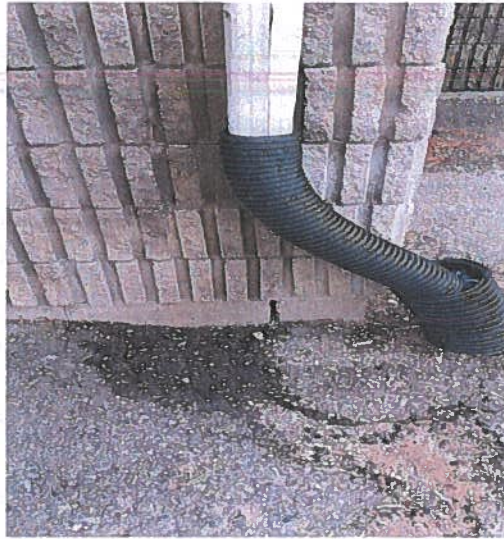
Photo 071 Gap in Foundation Wall

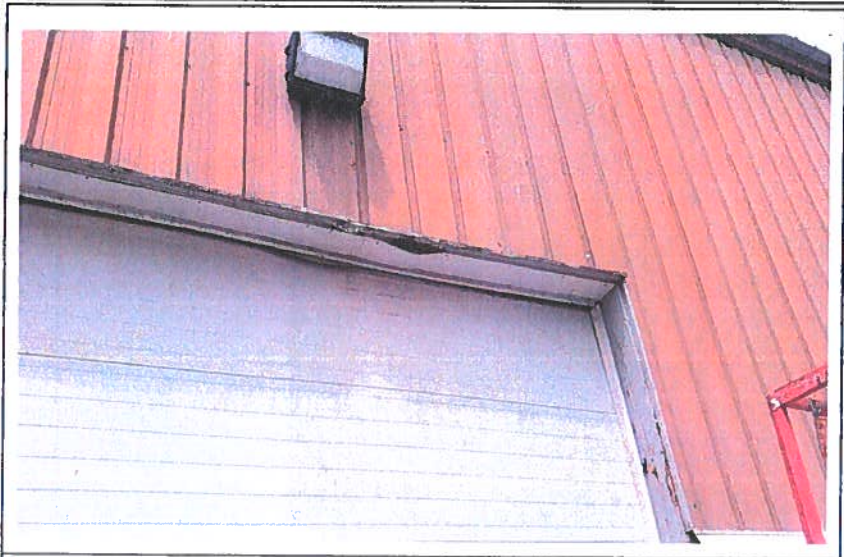
- Caulked panel joints along architectural precast concrete wall panels appear to be in good condition (Photo 075).
- Metal cladding above architectural precast concrete wall panels appears to be in good condition (Photo 076).
- Minor damage to the metal was observed above the garage door opening near the North side (Photo 077). A section of the steel lintel enclosed by the metal was visible at the damaged location and the lintel was observed to be in poor condition with significant rust accumulation and loss of cross-sectional area (Photo 078). We recommend that this lintel be exposed, removed and replaced with a new lintel to match existing conditions, and the damaged metal siding be repaired/replaced to restore to original conditions. to match the surrounding area.

Photo 077 Damage to Garage Door Opening

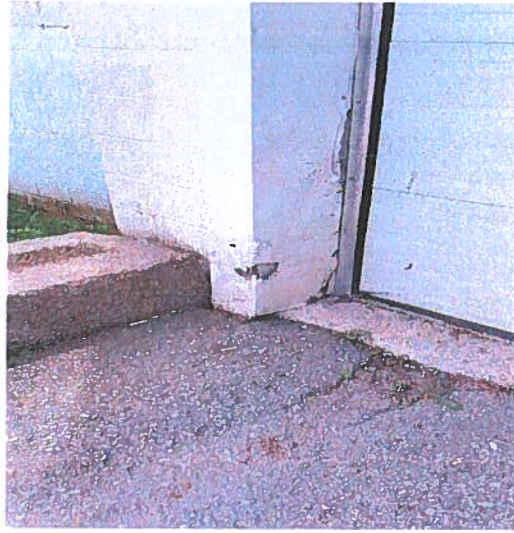
- The metal cladding was observed to be in fair to good condition (Photo 084).
- Minor damage to the base of the exterior of the garage door overhead jambs was observed (Photos 085 and 086). This is likely due to Zamboni impact while travelling in and out of the ice resurfacing room. We recommend that the enclosures are repaired to ensure more advanced damage does not occur.

Photo 085 Damage to Garage Door Entrance

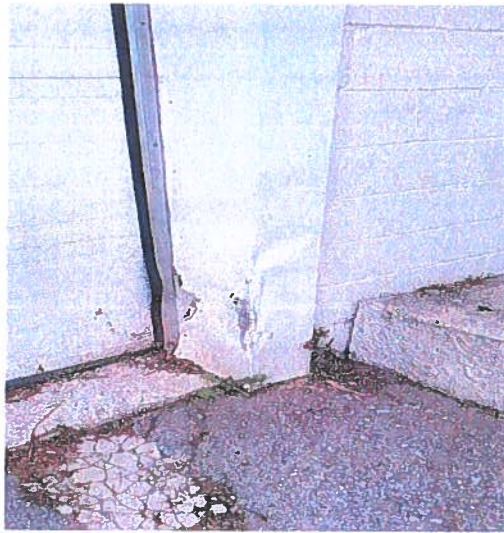
Photo 086 Damage to Garage Door Entrance

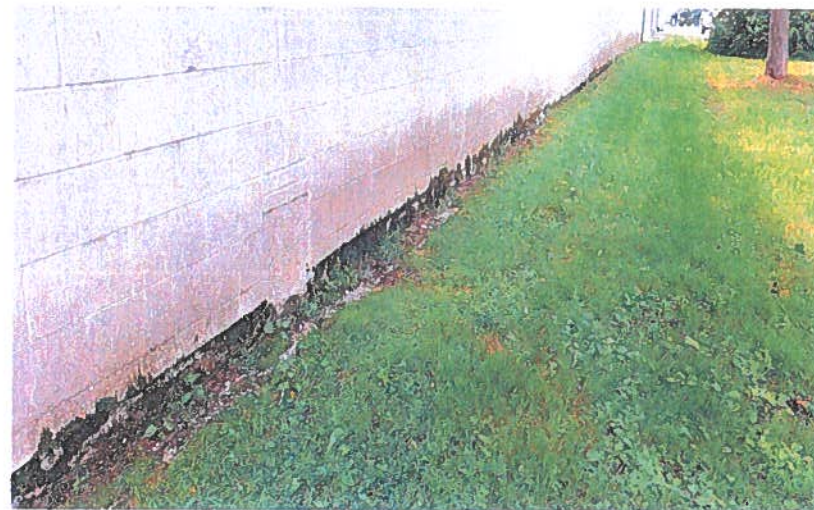
Photo 090 Mould Along West Side

- Mould accumulation was observed at the top of the foundation wall along the entire extents of the west elevation (Photo 090). We recommend that the base of the masonry wall/top of the foundation wall be cleaned and mould to be removed at these locations to prevent future more advanced deterioration.

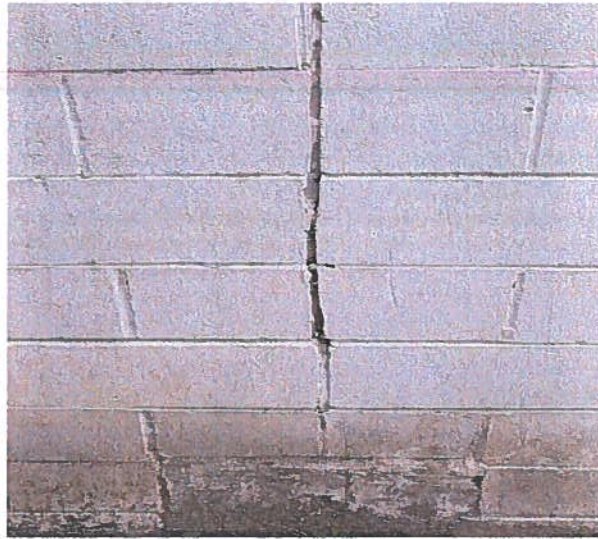
- One (1) of the masonry control joint locations was observed to be open (Photo 091). We recommend that this joint be cleaned and infilled with a suitable joint filler material to ensure moisture does not penetrate into the existing building envelope.

Photo 091 Damaged Wall Joint

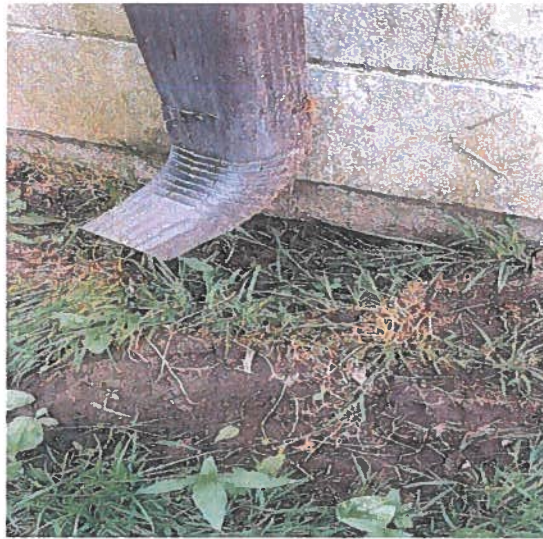
- Localized deterioration at the top of the foundation wall behind a rainwater leader location was observed (Photo 092). We recommend that this area be fixed with suitable repair mortar to ensure no further damage can be done to the structure.

Photo 092 Localized Foundation Wall Damage

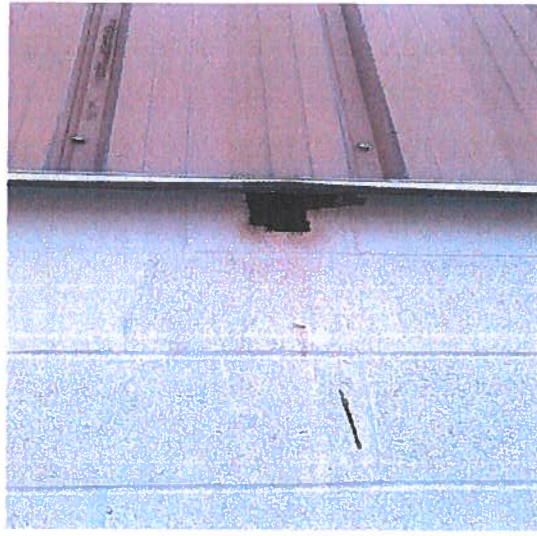
- An opening was observed at the top of the masonry block wall near the south side of the wall (Photo 093). We recommend that the damaged concrete block at this location is removed and replaced with new block to match existing condition to ensure further, more advanced deterioration does not occur to the building system.

Photo 093 Hole in Masonry Block
