**BARRY BRYAN  
ASSOCIATES**

Re: **Consulting Services to Update Our Structural Investigation Report to Assess the Feasibility of Renovating the Millbrook Arena or Utilizing the Space in Other Ways  
4 Needlers Lane, Millbrook, Ontario  
BBA Project No. 22059 (REVISED)**

This structural condition audit has been undertaken by Barry Bryan Associates, Architects, Engineers, and Project Managers, for the Millbrook Arena, on behalf of the Township of Cavan Monaghan. Authorization to undertake this study was received from Mr. Gerry Barker, Park and Facilities Manager for the Township of Cavan Monaghan.

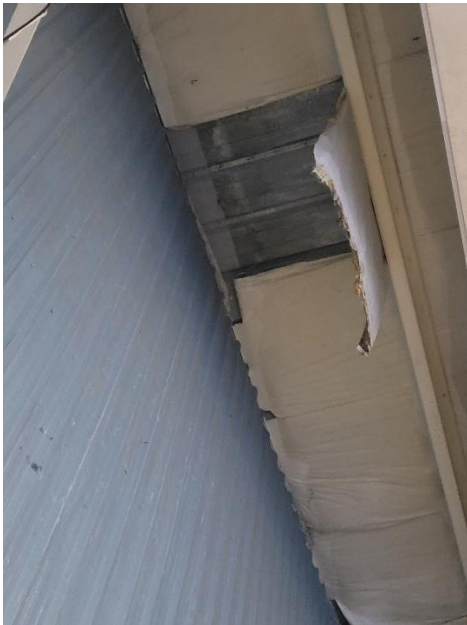
Photo 03 – Damaged Roof Insulation

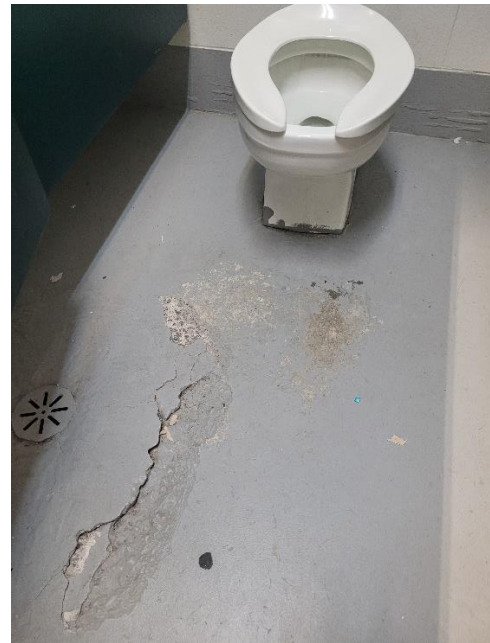
Photo 12 – Damaged Slab in Washroom

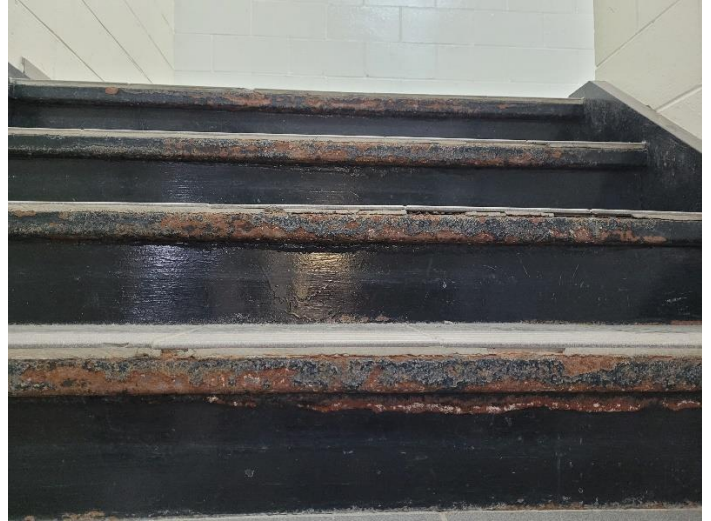
Photo 14 – Corroded/Damaged Stair Treads

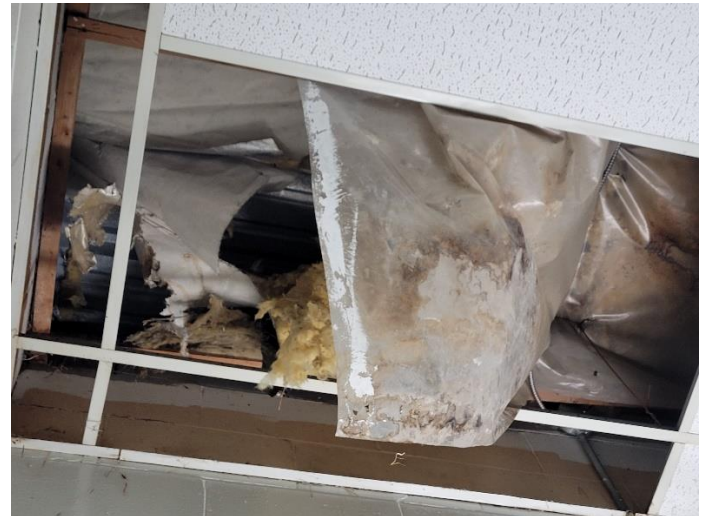
Photo 16 – Damaged Roof Insulation and Evidence of Moisture

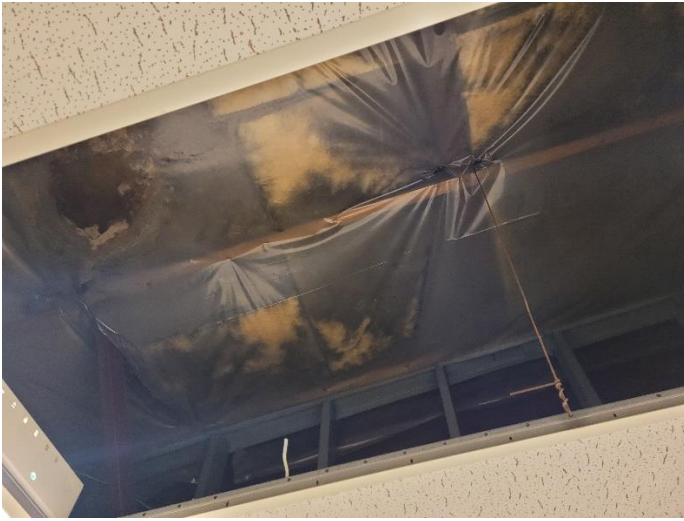
Photo 17 – Mould and Evidence of Moisture

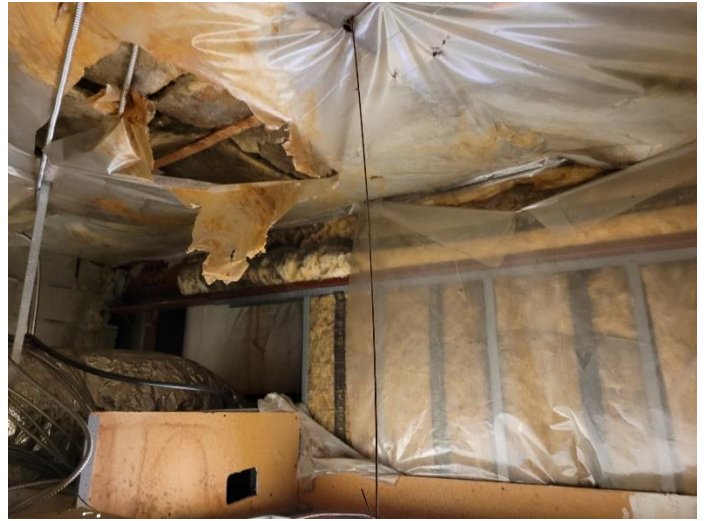
Photo 18 – Mould and Evidence of Moisture

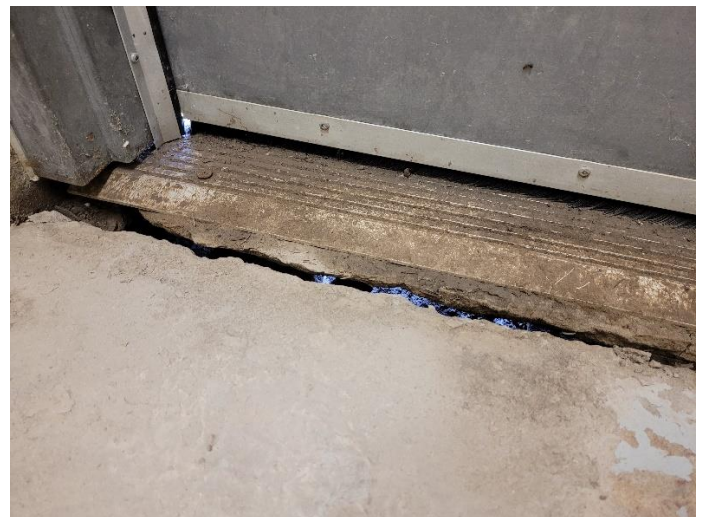
Photo 20 – Damaged Concrete Slab and Open Gap to Building Exterior

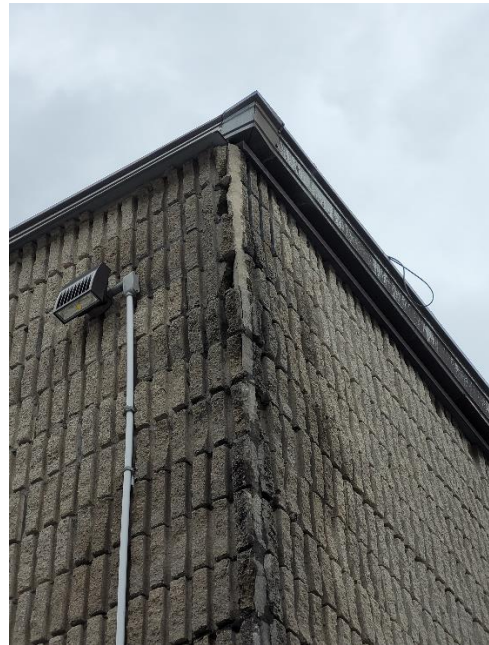
Photo 22 – Damaged Split Ribbed Block at Southeast Corner

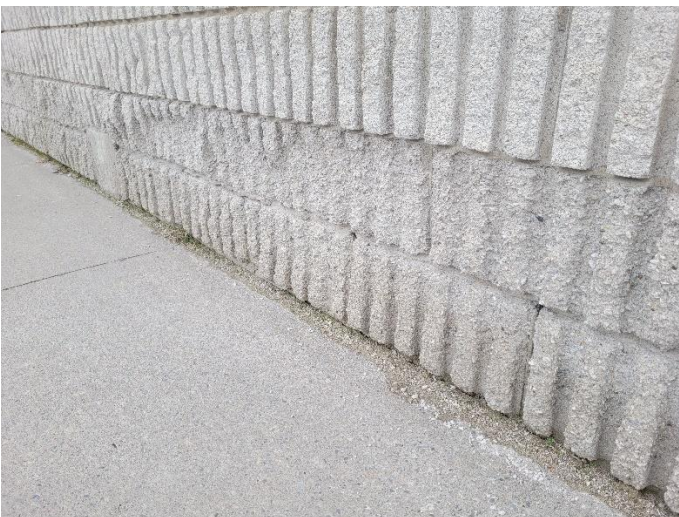
Photo 23 – Damaged Split Ribbed Block at Southeast Corner

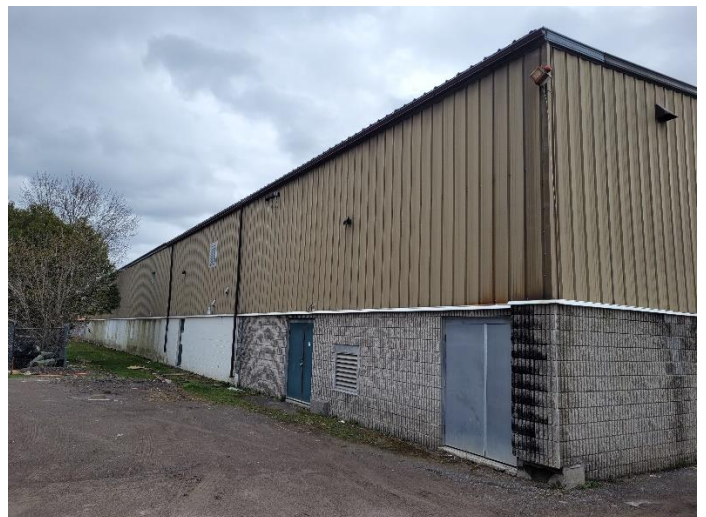
Photo 24 – Part West Elevation

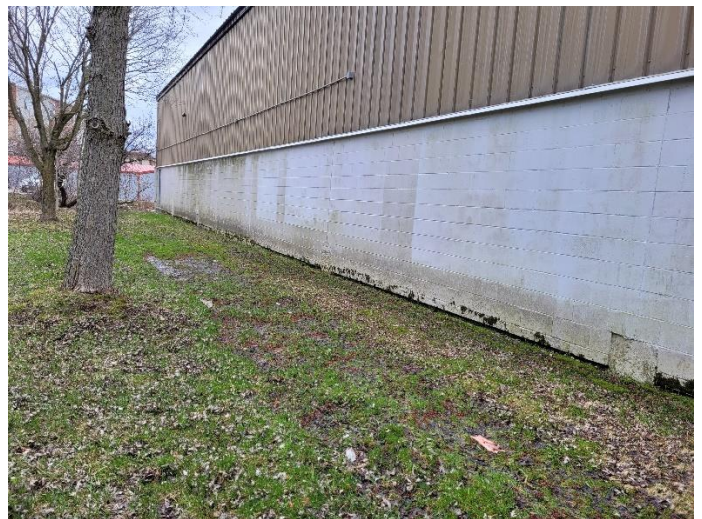
Photo 28 – Part West Elevation

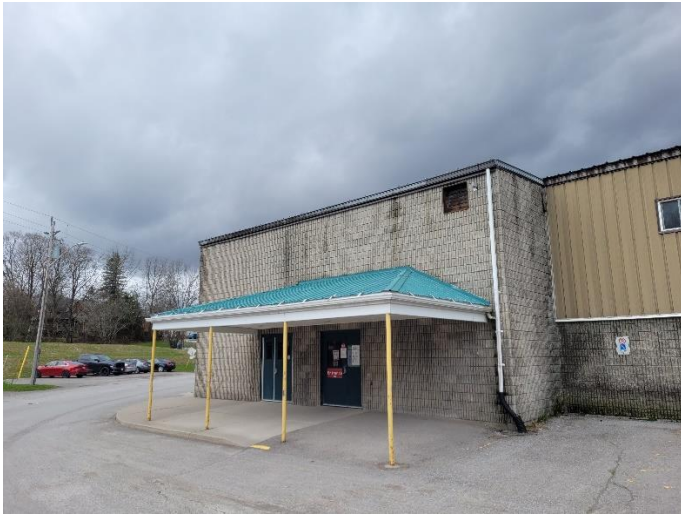
Photo 29 – Arena Entrance on East Elevation

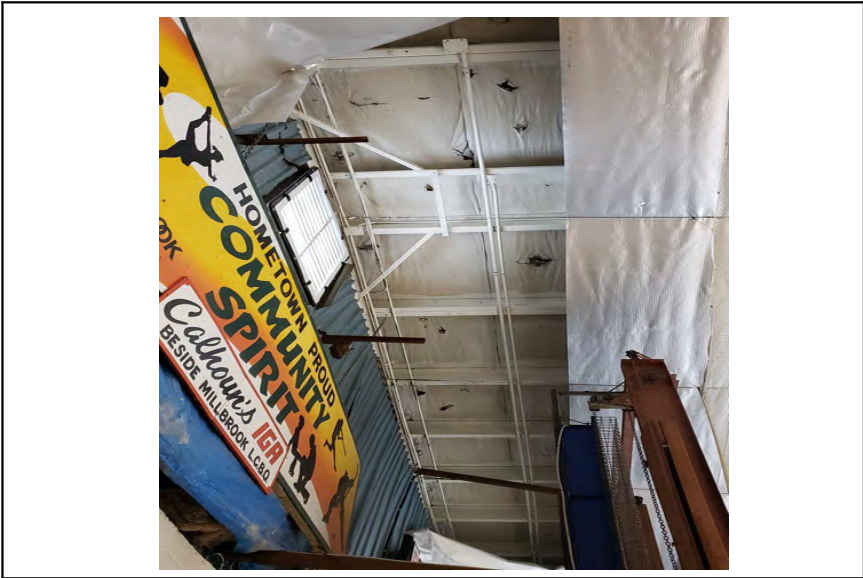
- The roof deck generally appeared to be in fair condition with no evidence of water/moisture damage (Photo 001). However, at the area exposed behind the net, there were visible minor damage due to puck impacts. For aesthetics purposes, we recommend that the damaged areas are cleaned and painted as required to match original conditions.
- The cold formed steel z-purlins was generally observed to be in fair to good condition.

Generally, the roof deck and purlins appeared to be in fair to good condition.

Photo 001 Hidden Roof Deck & Z-Purlins

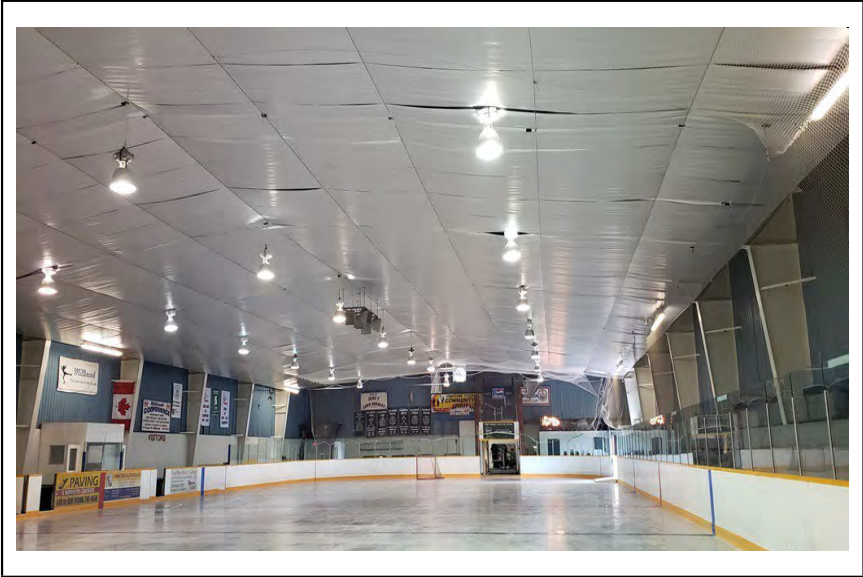
The main structure of the arena consists of a pre-engineered structural frame system with tapered steel girders supporting the steel purlins. The steel frames span approximately 90'-0" and are spaced at approximately 21'-1" centre to centre. We were unable to complete a detailed review of the entire extents of the tapered girders as this framing was enclosed by the existing insulation system (Photo 002). Our observations are as follows:

Photo 002 Roof Deck Insulation covering Pre-Engineered Frames

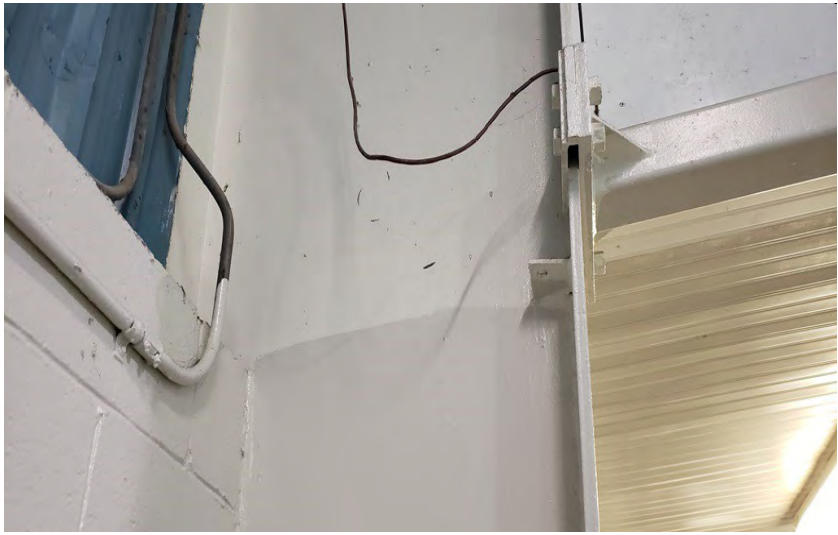
Photo 008 Missing Brace at Southmost Frame

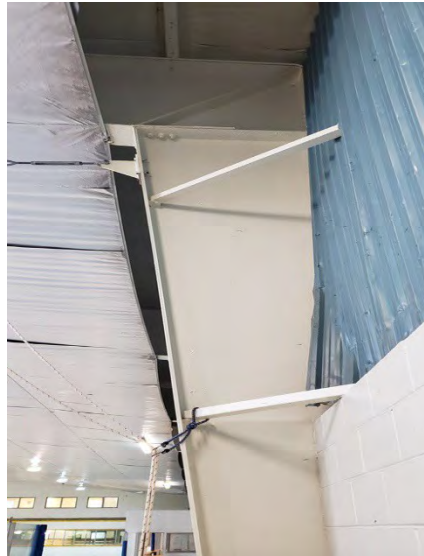
- Metal cladding appears to be separating from the wall at one of the frames along the west side of the arena (Photo 015). We recommend that the panel be re-secured to match the existing conditions.

Photo 015 Metal Cladding Along West Side

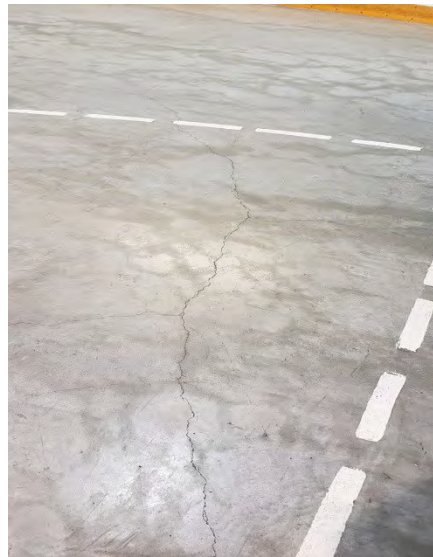
- Thermal cracking was observed throughout the entirety of the rink slab, the North side of the rink slab appeared to experience more cracking than the south side (Photo 016). This cracking is typical with age of concrete after years of pull-downs and thawing of the monolithic concrete slab.

Photo 016 Thermal Cracking on Rink Slab

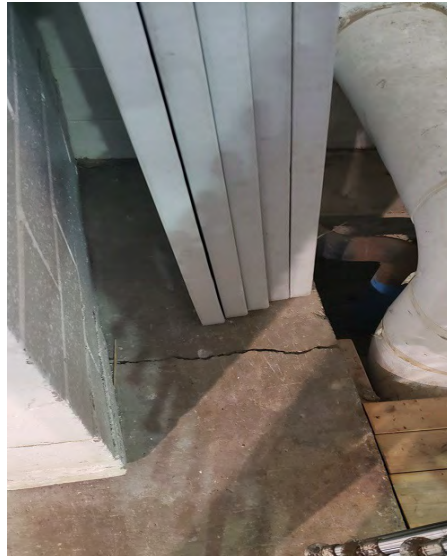
- Significant cracking was observed adjacent to the ice-surfacing room (Photo 019). This is likely due to previous differential settlement of the structure. We recommend for the slab to be repaired and patched with a suitable repair mortar to prevent further deterioration.

Photo 019 Major Crack in Apron Slab

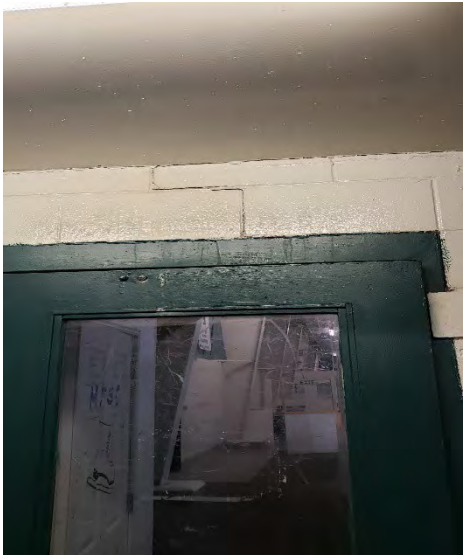
- Minor to moderate step cracking was observed at several localized areas within the arena (Photos 027, 028, 029, 030, 031, 032, 033 and 034). This is typical under the serviceability conditions for this type of structure and does not pose a structural concern. We recommend that all open/cracked joints be routed out and infilled with suitable mortar to prevent moisture from entering the building.

Photo 030 Step Cracking in Lobby

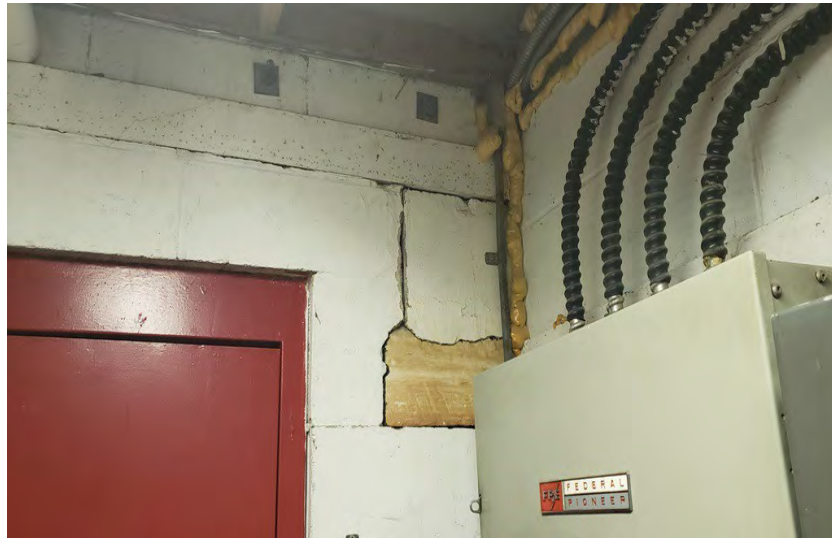
- Paint chipping and localized damage to masonry blocks was observed in the corridor leading to the compressor room. A section of one (1) masonry block appeared to be removed and infilled with wooden blocking (Photo 035). We recommend that this section be removed and replaced with new concrete masonry block to match existing and all joints be infilled with suitable mortar.

Photo 035 Wooden Block Replacement and Cracking

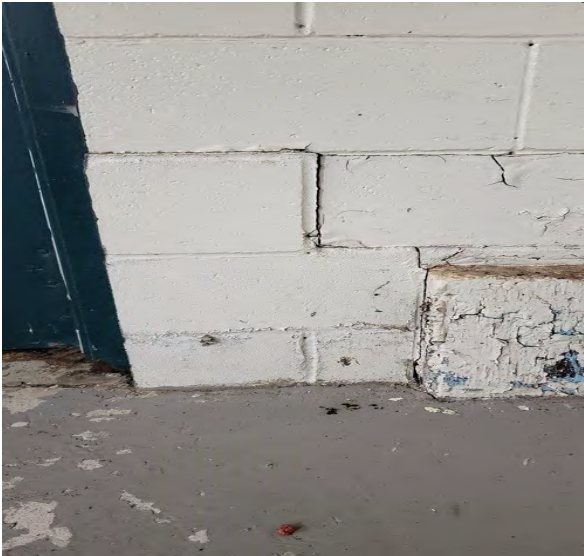
Photo 039 Step Cracking and Damage to West-Side Exit

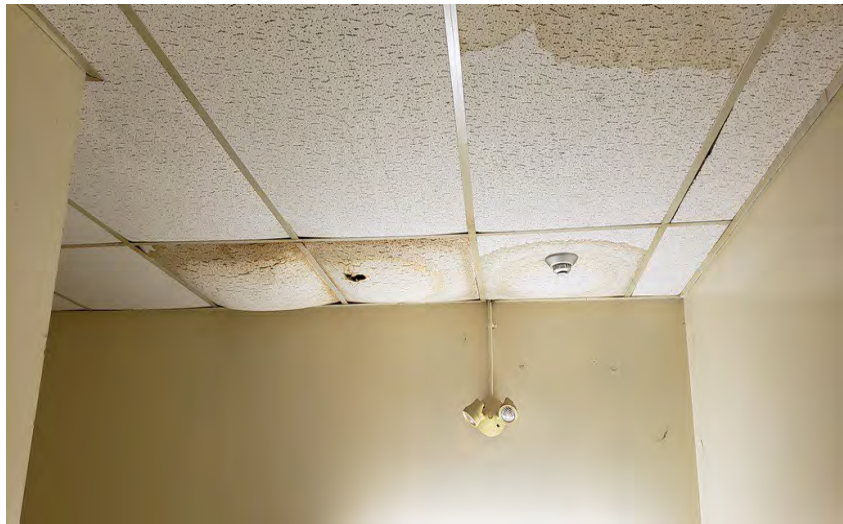
Photo 061      Signs of Moisture Damage

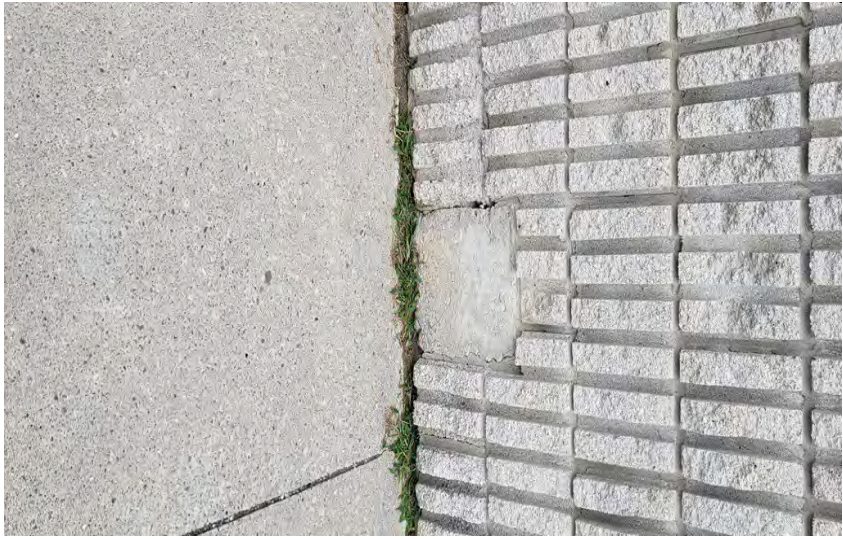
Photo 063 South-West Corner Foundation

- The foundation wall at the south-west corner of the building appeared to be experiencing localized cracking and spalling at the concrete surface (Photos 063 and 064). Cracking at the centre foundation wall was also observed. We recommend for the cracks to be routed out and infilled with a suitable repair mortar to restore original conditions.

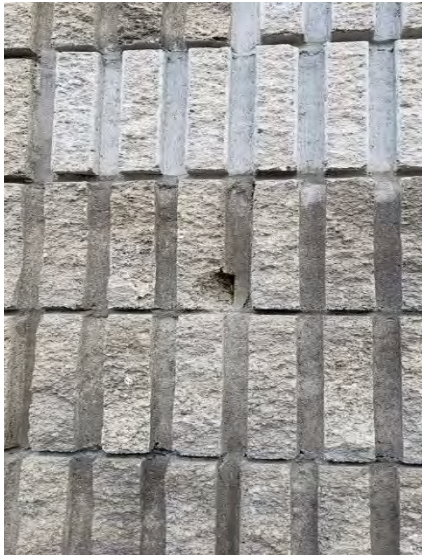
Photo 065 Architectural Block Mortar Cracks

- Minor cracking of the mortar joints was observed along the architectural precast concrete wall panels at localized areas (Photo 065).
- Localized damage to single brick in the architectural precast concrete wall panels was observed (Photo 066). We recommend for the architectural precast concrete wall panels to be repaired and patched with a suitable repair mortar to prevent further deterioration of the architectural wall.

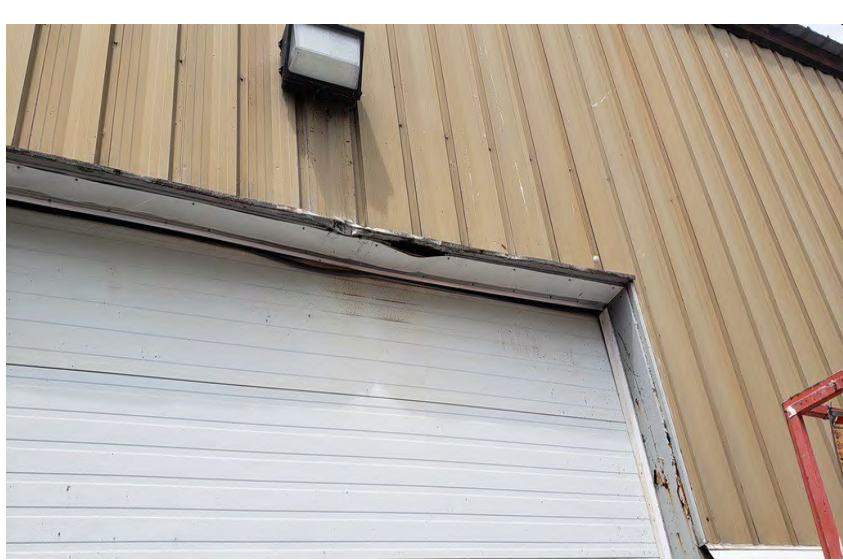
Photo 076 East Side Metal Cladding

- Caulked panel joints along architectural precast concrete wall panels appear to be in good condition (Photo 075).
- Metal cladding above architectural precast concrete wall panels appears to be in good condition (Photo 076).
- Minor damage to the metal was observed above the garage door opening near the North side (Photo 077). A section of the steel lintel enclosed by the metal was visible at the damaged location and the lintel was observed to be in poor condition with significant rust accumulation and loss of cross-sectional area (Photo 078). We recommend that this lintel be exposed, removed and replaced with a new lintel to match existing conditions, and the damaged metal siding be repaired/replaced to restore to original conditions. to match the surrounding area.

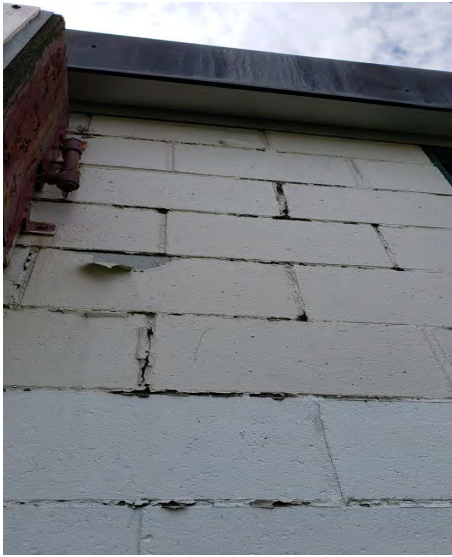
Photo 079 Step Cracking and Paint Peeling

- Localized step Cracking and paint-peeling was observed along the north elevation (Photos 079, 080 and 081). We recommend for all cracked mortar joints to be routed and re-pointed to restore to original conditions. All areas of peeled paint should be cleaned, and new paint applied to match adjacent wall areas.

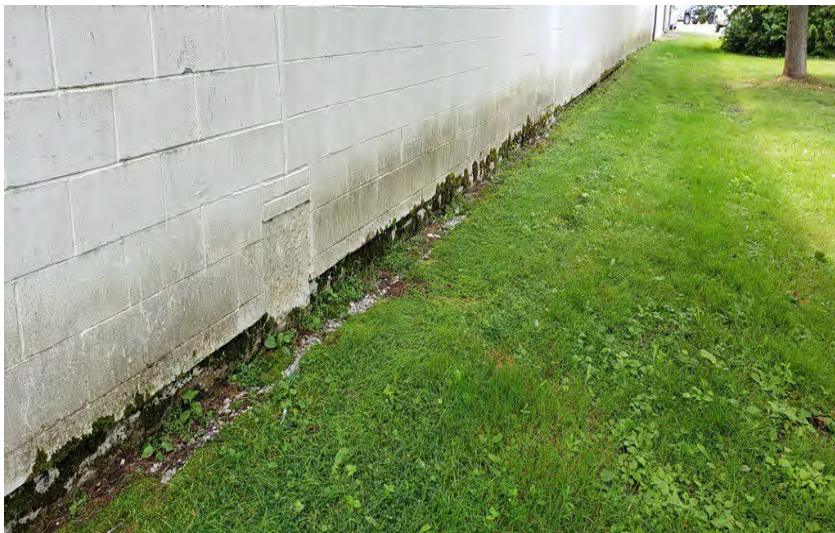
Photo 089 North-West Corner

- An open joint was observed between foundation walls and concrete pier at the north-west corner of the building (Photo 089). We recommend that the gap be cleaned and filled with suitable joint filler material to ensure that moisture cannot penetrate into the structure causing more advanced deterioration.

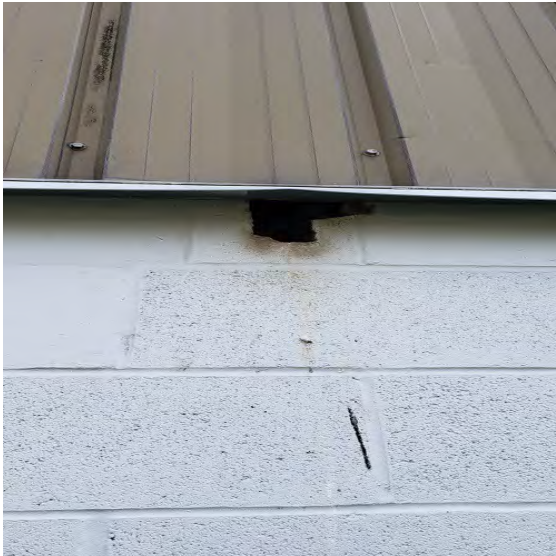
Photo 092 Localized Foundation Wall Damage

- Localized deterioration at the top of the foundation wall behind a rainwater leader location was observed (Photo 092). We recommend that this area be fixed with suitable repair mortar to ensure no further damage can be done to the structure.
