**BARRY BRYAN  
ASSOCIATES**

Re: **Consulting Services to Update Our Structural Investigation Report to Assess the Feasibility of Renovating the Millbrook Arena or Utilizing the Space in Other Ways**  
**4 Needlers Lane, Millbrook, Ontario**  
**BBA Project No. 22059 (REVISED)**

Barry Bryan Associates (BBA) was requested by the Township of Cavan Monaghan to provide an updated review of the Millbrook Arena located at 4 Needlers Lane in Millbrook, Ontario.

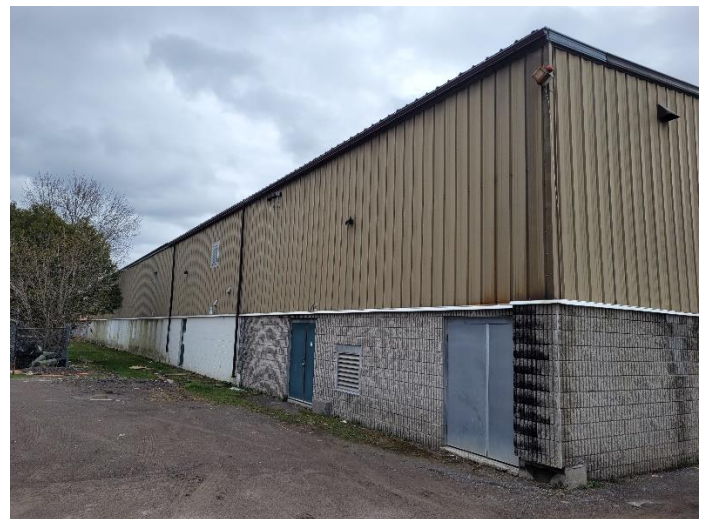
Photo 24 – Part West Elevation

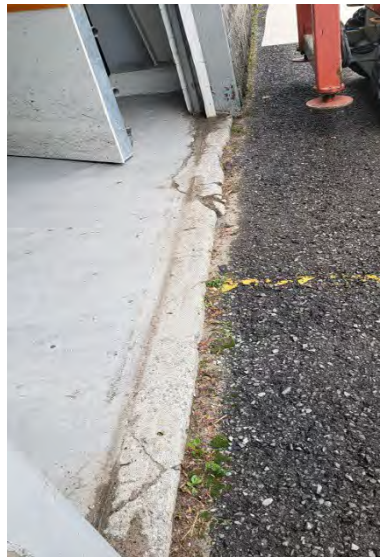
- Moderate cracking and spalling were observed underneath the exterior garage door on the East side of the building (Photo 018). We recommend for all loose and unsound concrete to be chipped out and removed and patched with a suitable repair mortar.

Photo 018      Apron Slab Under Garage Door

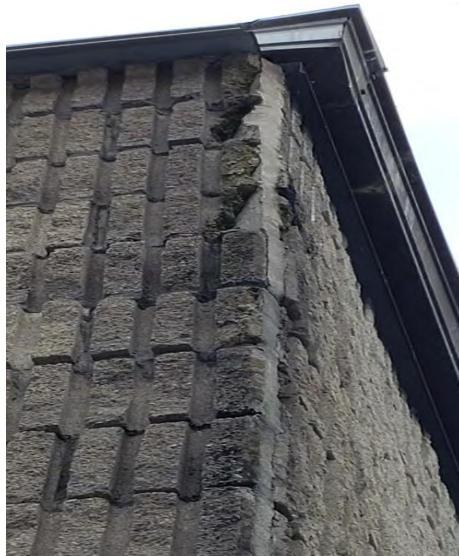
- Localized block damage was observed near the roof at the South-East Corner (Photo 067). We recommend for the architectural precast concrete wall panels to be repaired and patched with suitable repair mortar to prevent further deterioration of the architectural wall.

Photo 067      Localized Block Damage at South-East Corner

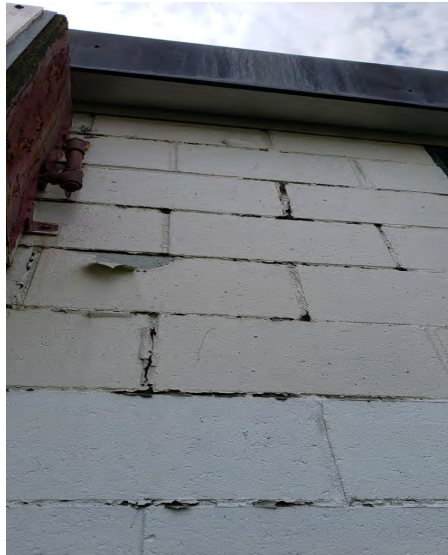
- Localized step Cracking and paint-peeling was observed along the north elevation (Photos 079, 080 and 081). We recommend for all cracked mortar joints to be routed and re-pointed to restore to original conditions. All areas of peeled paint should be cleaned, and new paint applied to match adjacent wall areas.

Photo 080      Step Cracking and Paint Peeling

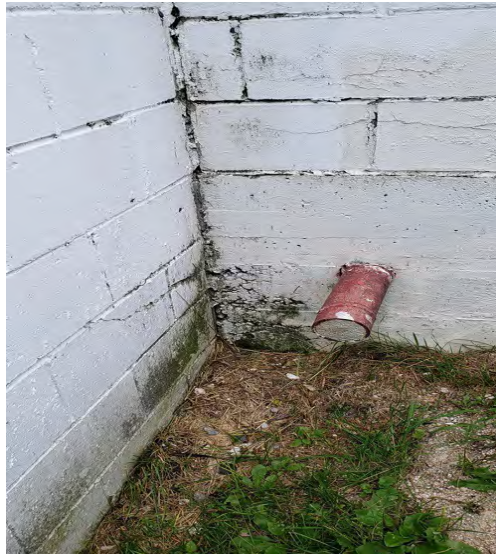
- Honeycombing at the foundation wall and mould growth was observed on the exterior of the ice-resurfacing room (Photos 082 and 083). We recommend for the block walls to be cleaned, mould accumulation to be removed at these locations. The honeycombing is likely a result from the pouring of the concrete at the time of constriction and does not pose a structural concern.

Photo 082      Honeycombing and Mould Growth
