Water Supply Summary Report - Kawartha Downs & Speedway, Fraserville, Ontario

October 14, 2021

Prepared for: Romspen Investment Corporation

Cambium Reference: 12579-001

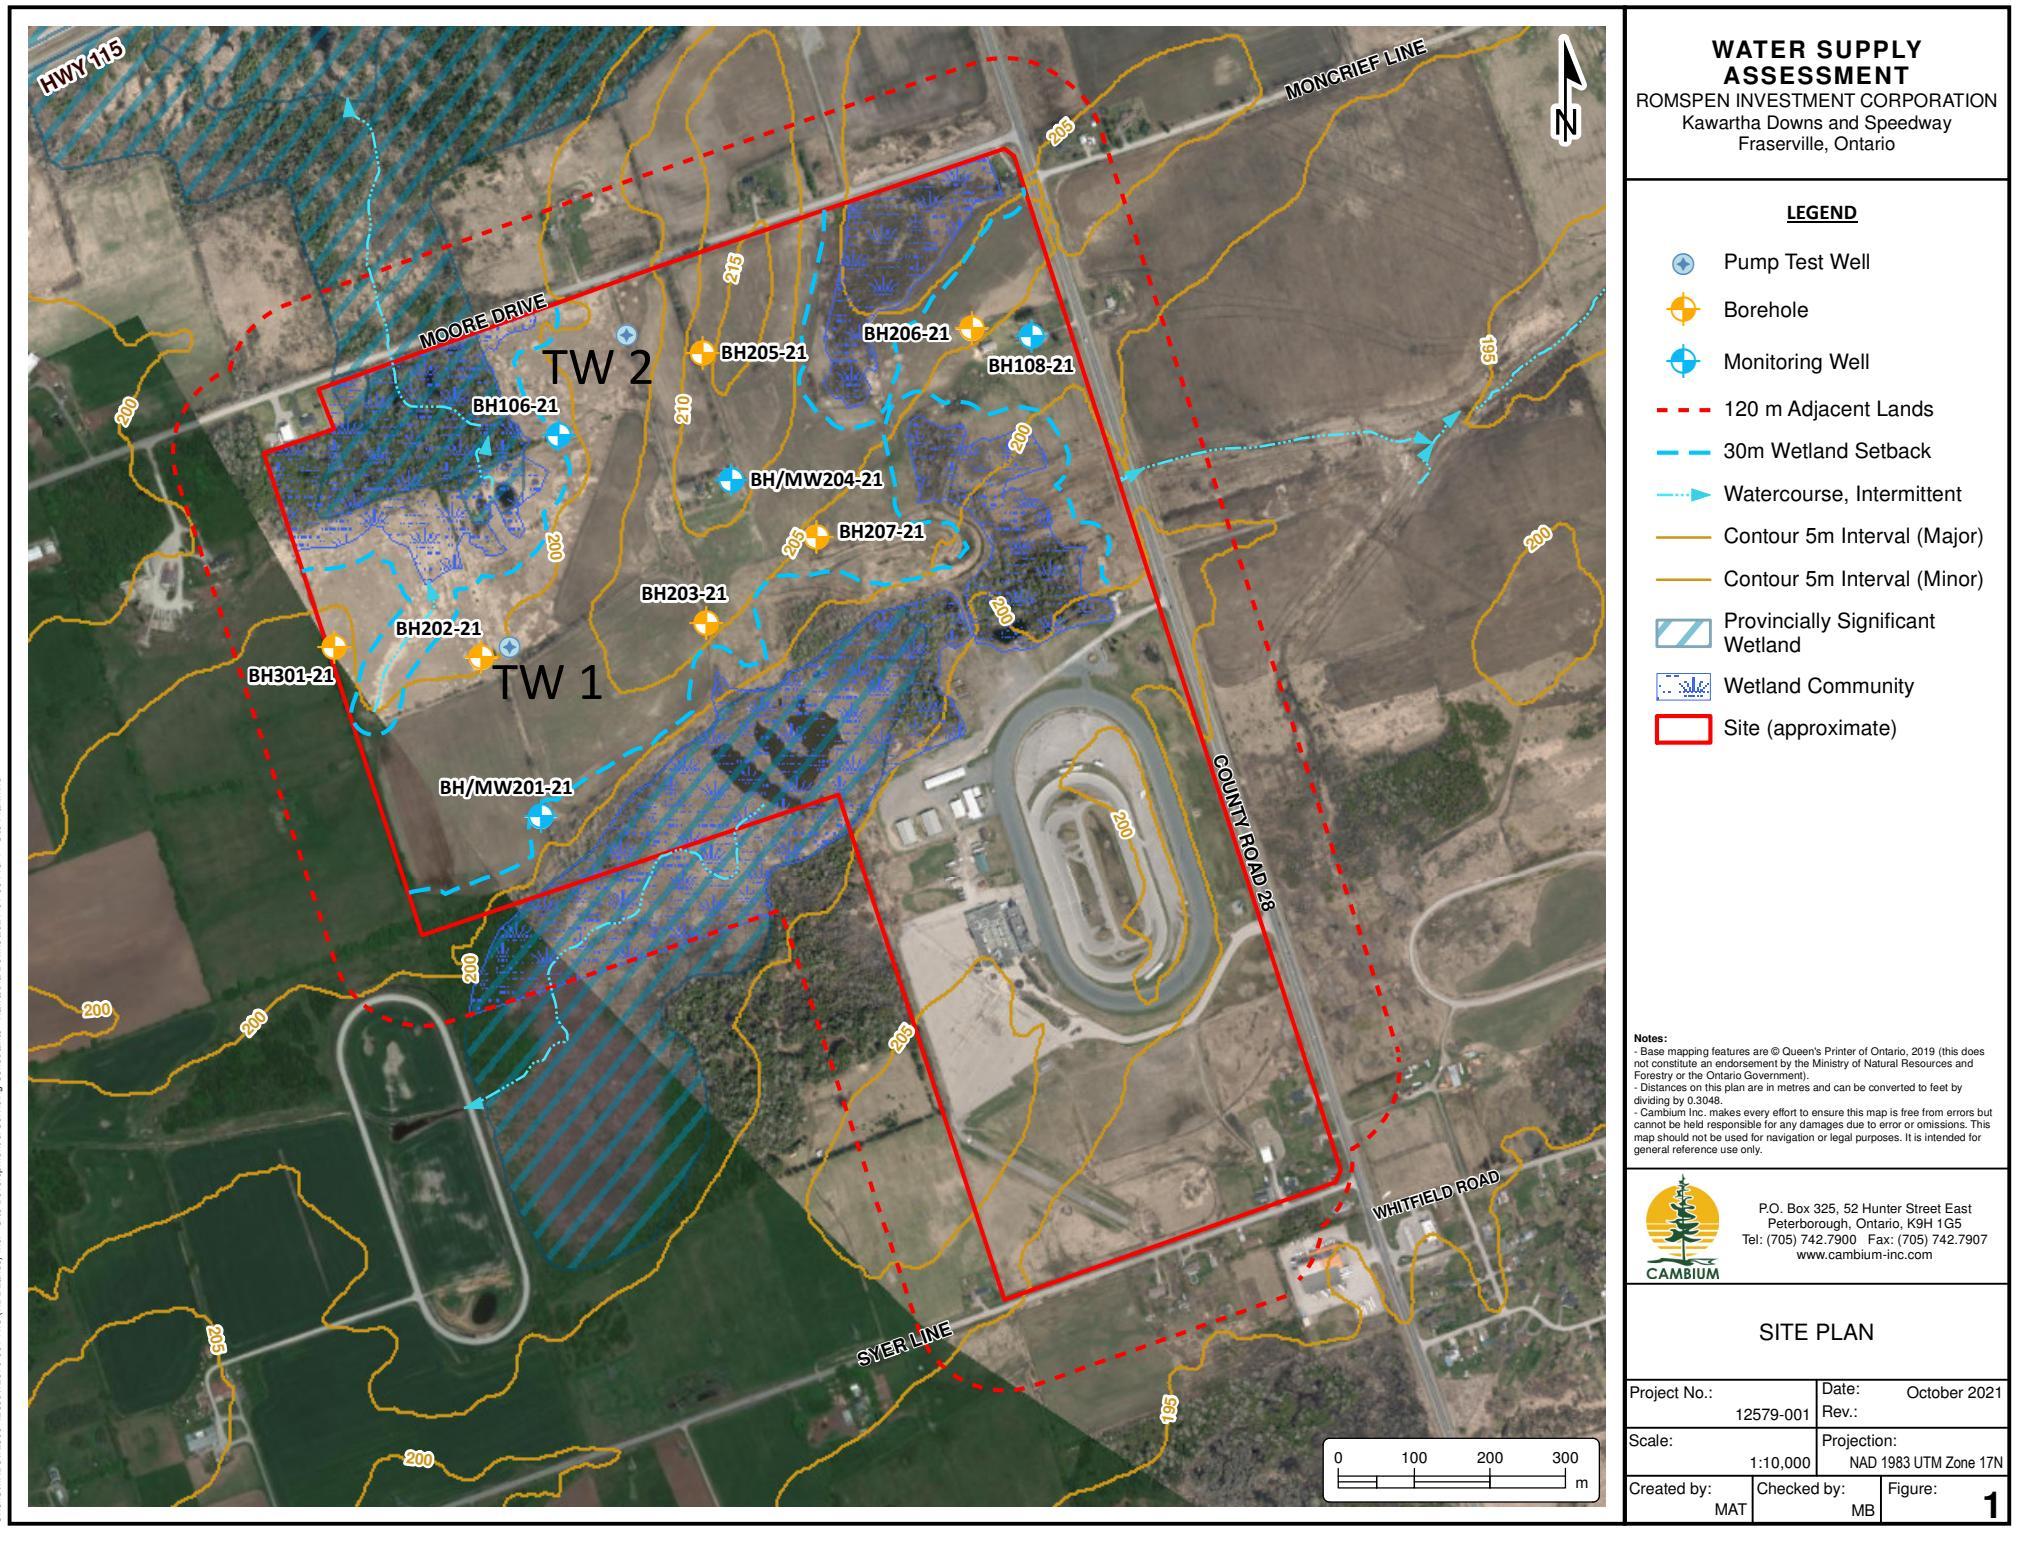
Well 1 (MECP Tag # 5119296) was installed on November 20, 2002, approximately 400 m southeast of the existing residential dwelling at 1627 Moore Drive, Fraserville, Ontario. Well 1 was installed to a depth of 22.86 mbgs, with an open bedrock hole extending from 14.48 mbgs to 22.86 mbgs. During installation, sediments were described as sandy clay transitioning into sandy clay with gravel and some boulders. A water-bearing gravel layer was encountered at the overburden – bedrock contact at 14.48 mbgs. Limestone bedrock continued until well termination at 22.86 mbgs. Static water level on the day on the well installation was 3.35 mbgs. The well driller's recommended pumping rate was 38 L/min.The location of Well 1 is provided on Figure 1.

with gravel. A water-bearing gravel layer was encountered at the overburden – bedrock contact at 11.58 mbgs. Limestone bedrock continued until well termination at 23.16 mbgs. Static water level on the day on the well installation was 3.05 mbgs. The well driller's recommended pumping rate was 45 L/min. The location of Well 2 is provided on Figure 1.

The present land-use for the middle and southern section of the Site is as a commercial raceway; the northern section of the site is presently rural residential with some agricultural uses (Figure 1). Cambium understands that the Client is exploring a subdivision development for the subject property.

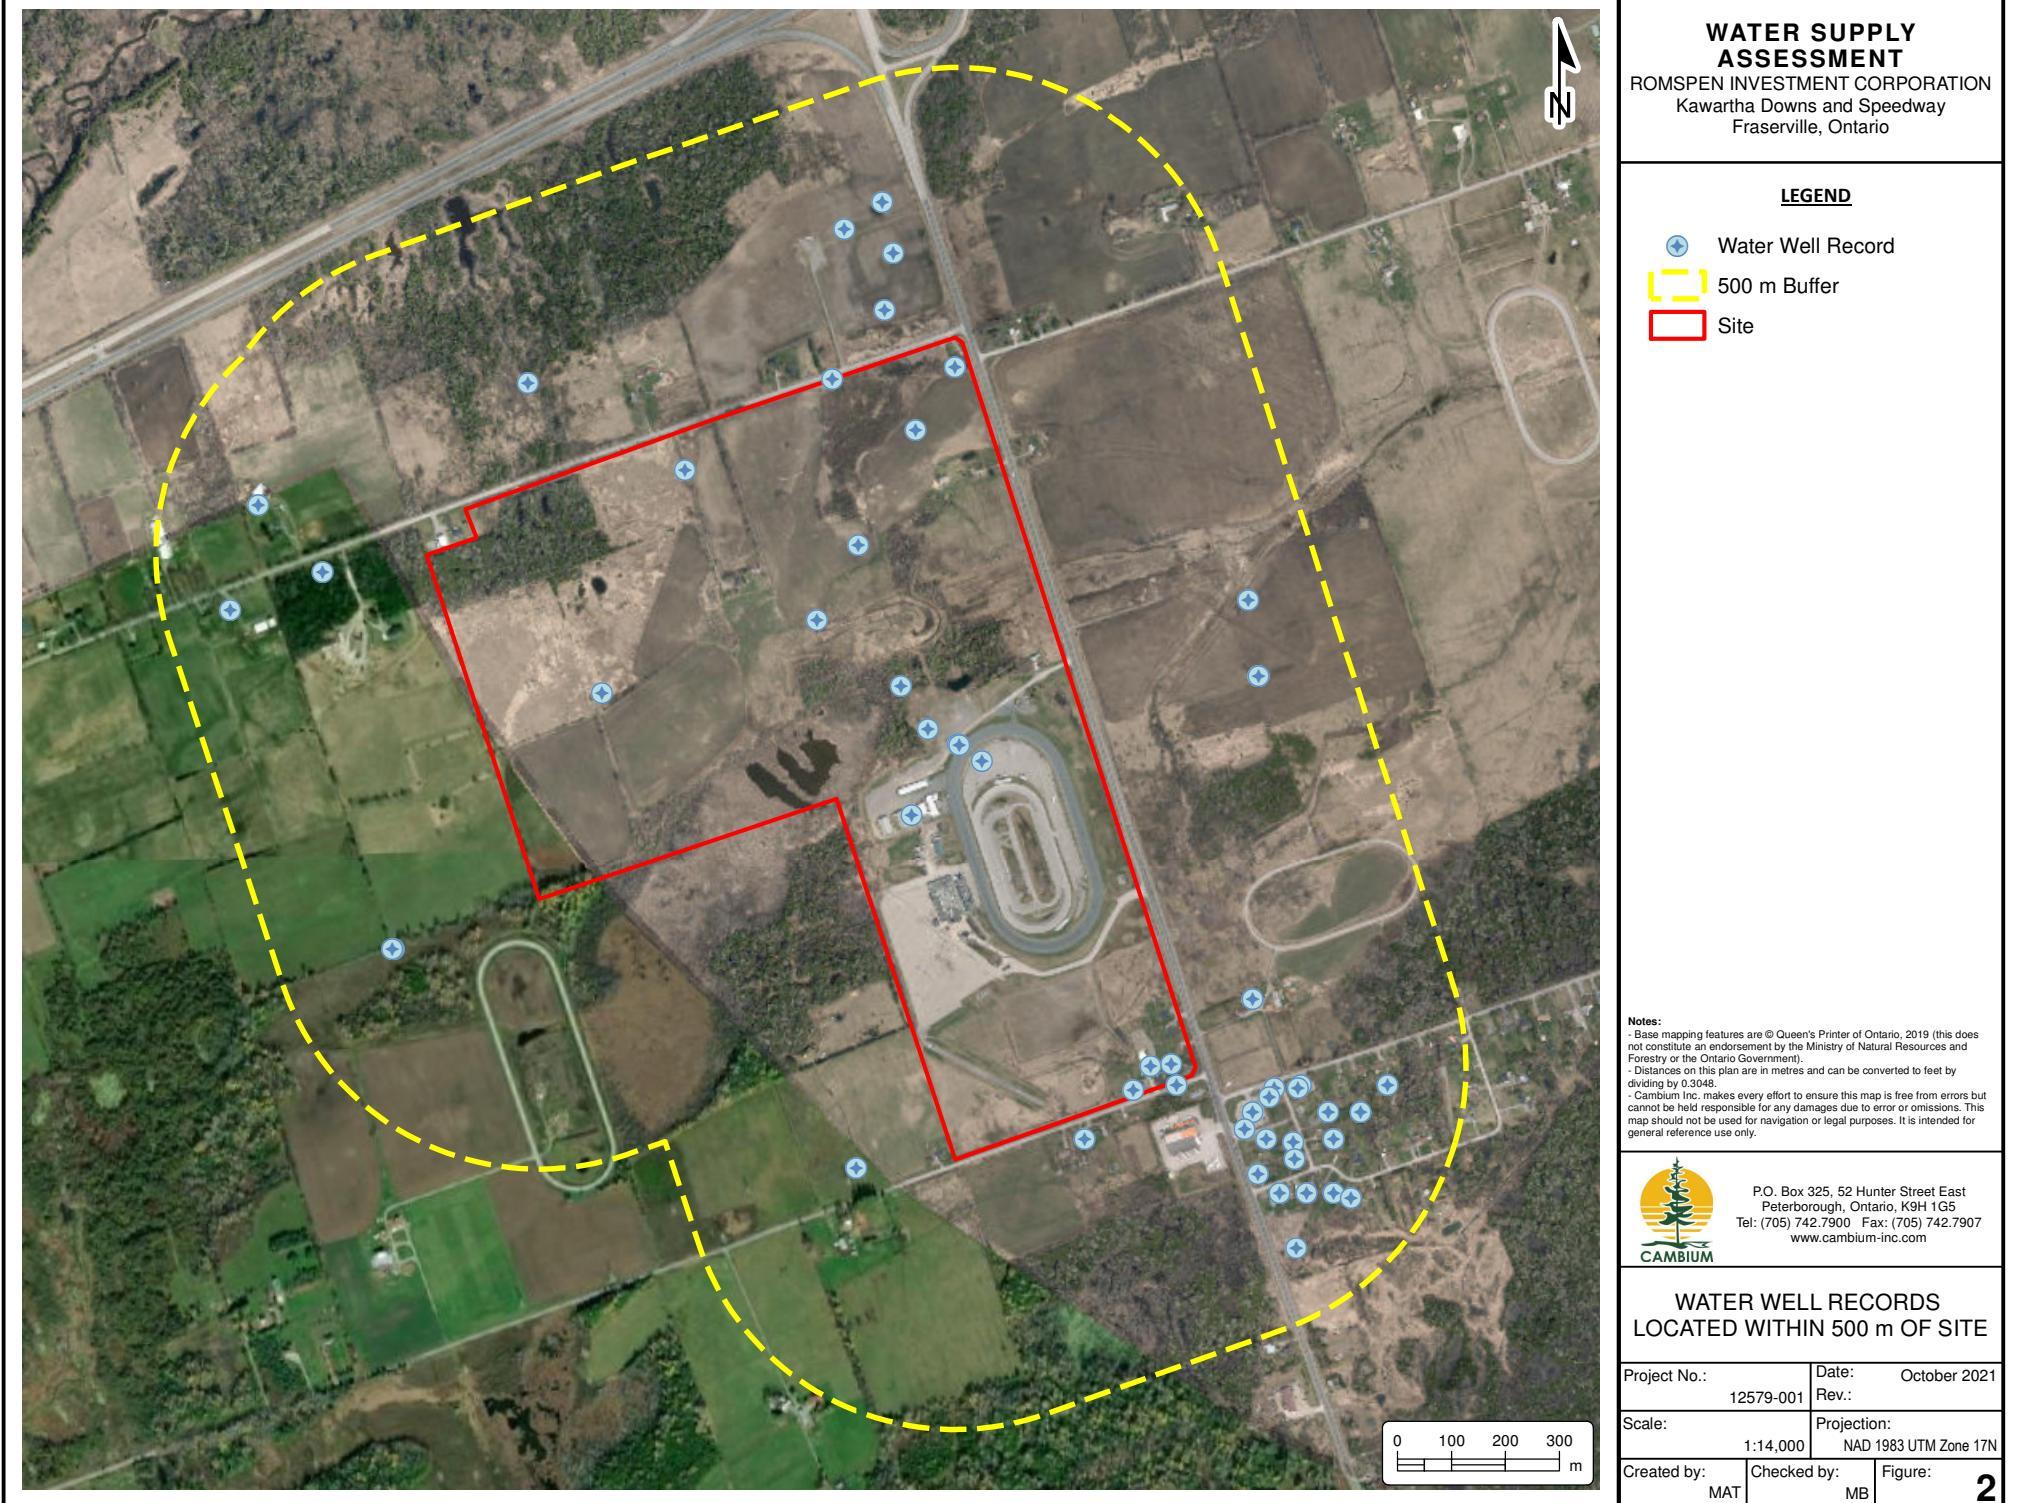
The Ministry of Environment Conservation and Parks (MECP) Water Well Information System (WWIS) was accessed to review water well records in the area of the Site. There were 48 water well records located within approximately 500 m of the borders of the Site (see Figure 2). The following water well records were identified:

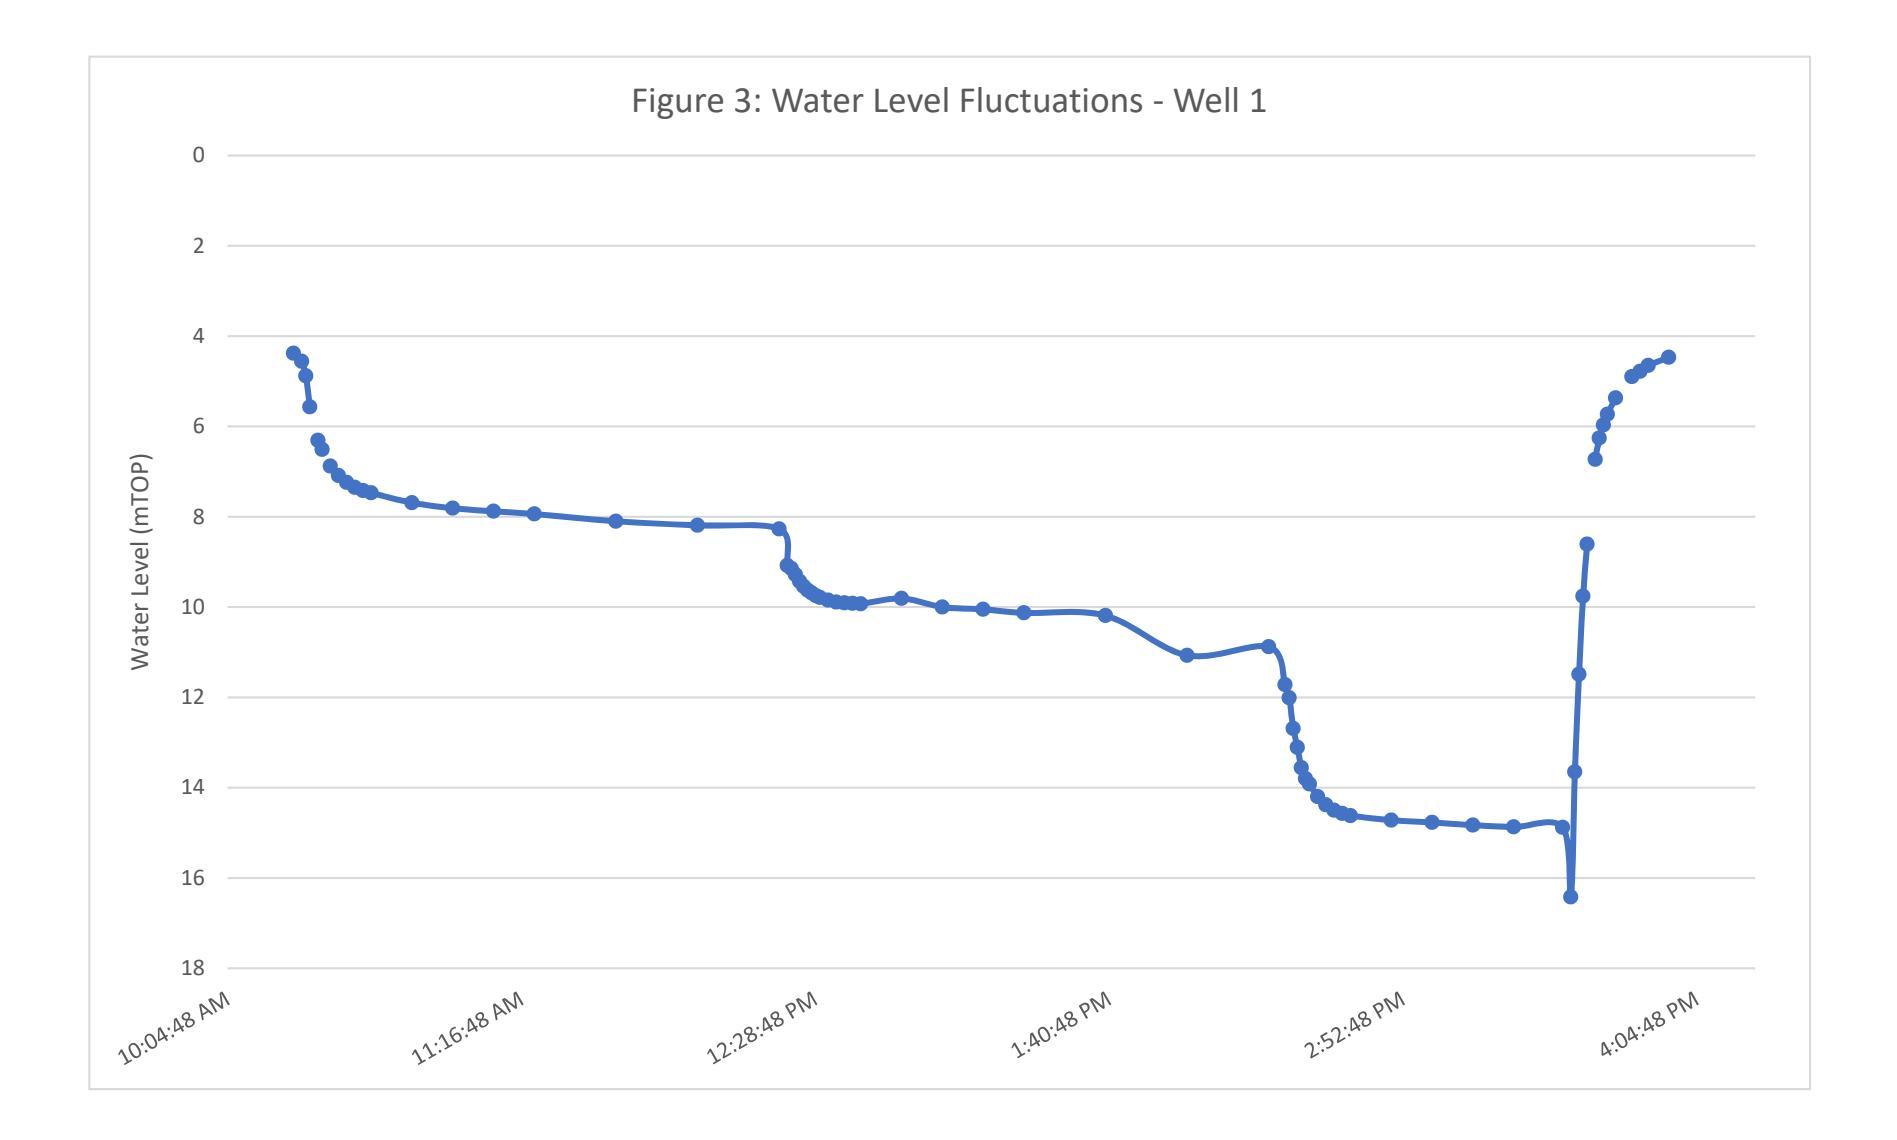
Upon completion of the pumping test the water level of Well 1 was allowed to recover. By 3:58 pm on August 16, 2021 the water level in Well 1 recovered to 4.47 mtop (or 86% recovery to pre-test static conditions). The water level responses of Well 1 during the pumping test are provided on a time/drawdown plot in Figure 3.

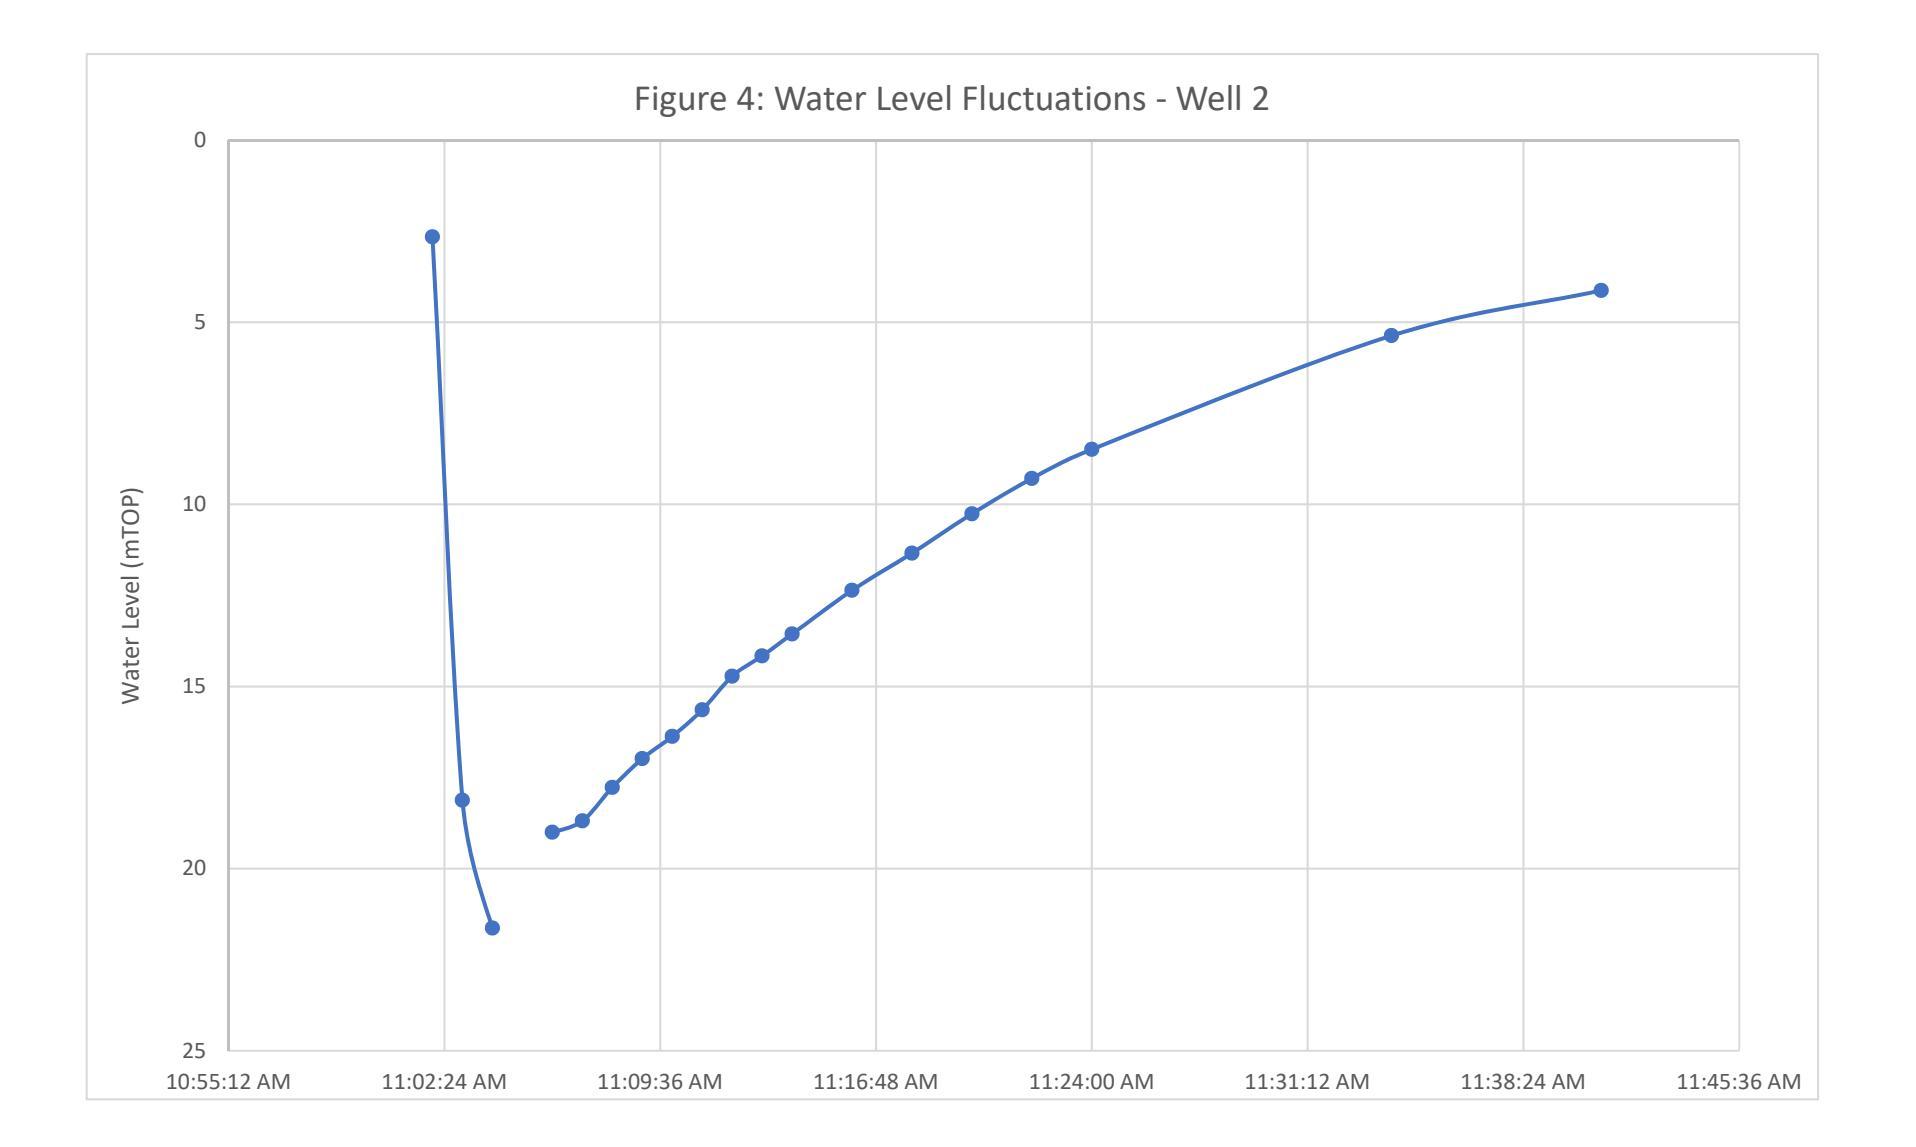
Upon completion of the pumping test the water level of Well 2 was allowed to recover. By 12:45 pm on August 16, 2021 the water level in Well 2 recovered to 4.12 mtop (or 92% recovery to pre-test static conditions). The water level responses of Well 2 during the pumping test are provided on a time/drawdown plot in Figure 4.

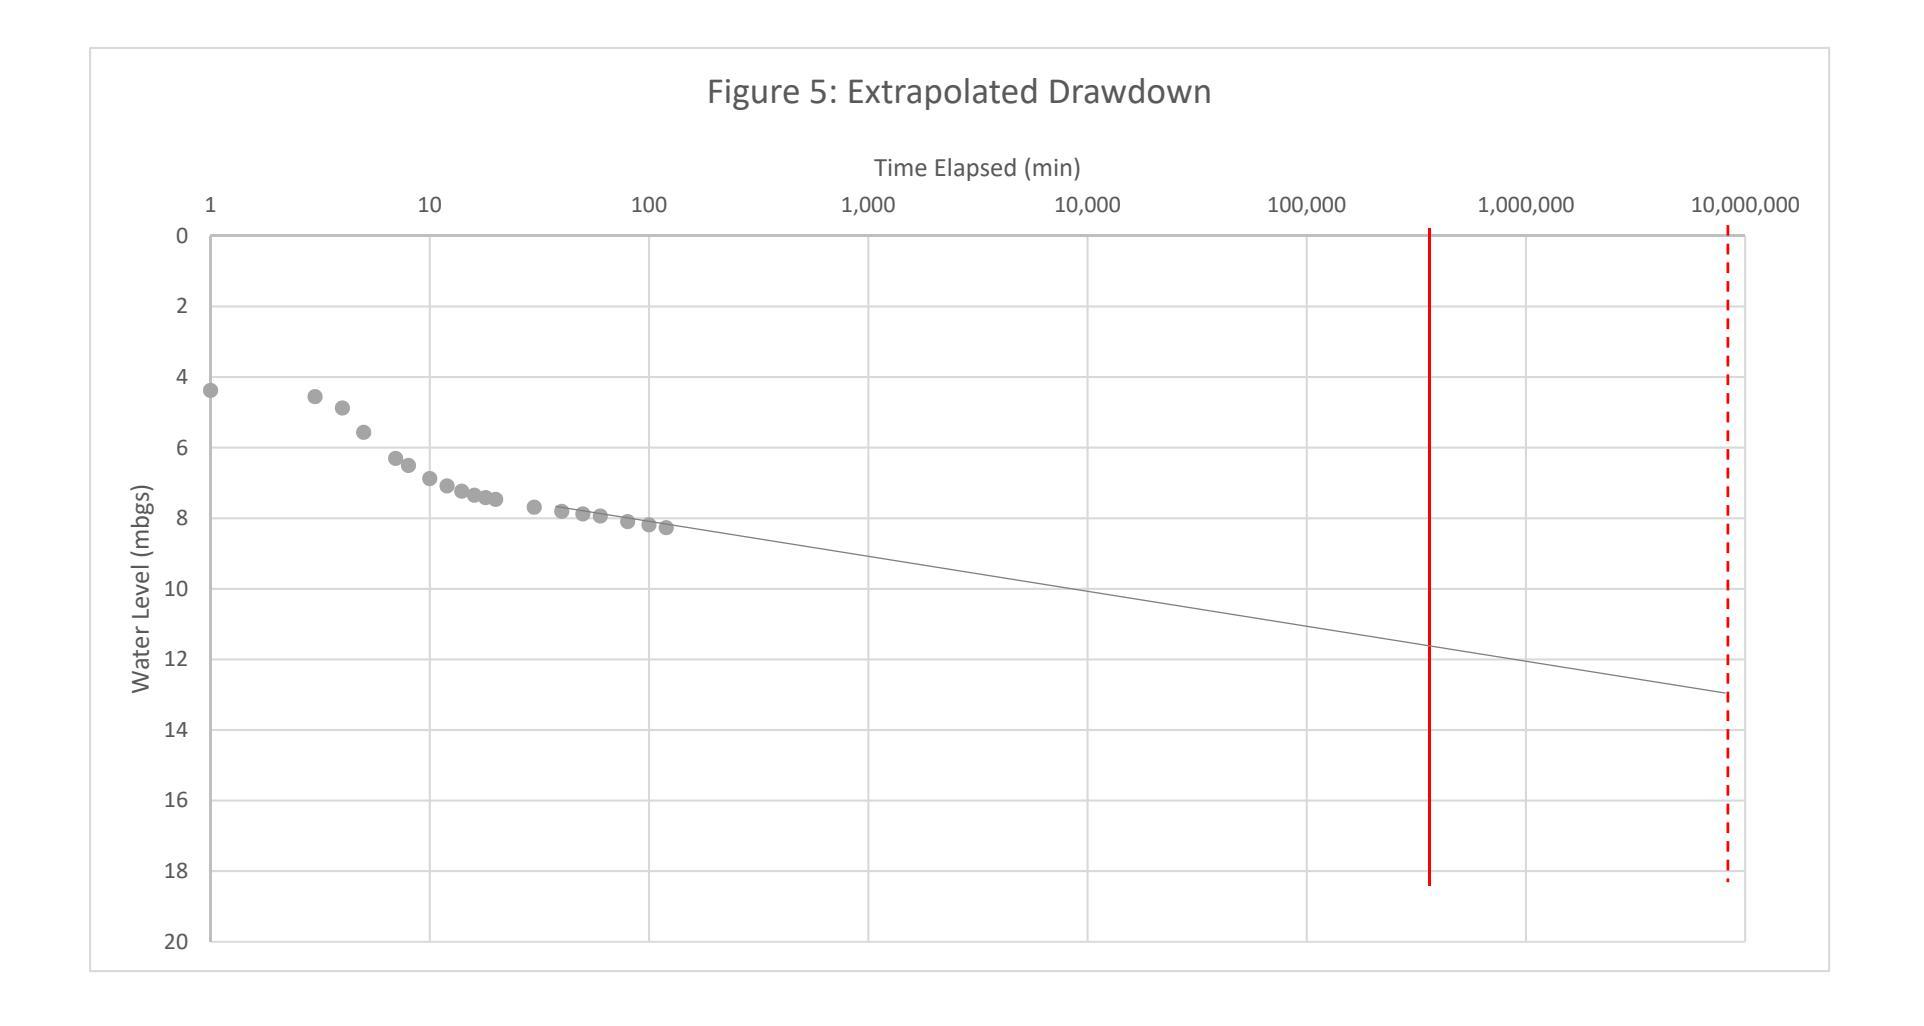
The lowering water levels trend recorded near the end of the pumping test for Well 1 (when a stable lowering was recorded) was extrapolated to 1 year and 20 years on a logarithmic time scale. Because it has to be assumed that the pumping rate would remain stable; only the extrapolated drawdown for the pumping rate of 30 L/min was viable as it was the pumping rate that started at static water level (Figure 5). Well 2 could not be analysed in this way as it never reached a stable lowering trend. This kind of assessment is valuable in estimating long-term impacts related to water withdrawal at a well. The results of the drawdown extrapolation for Well 1 are in Table 3:

The results of the extrapolated drawdown analysis indicate that if water withdrawal at the Well 1 is continued for 1 and 20 Years at 30 L/min, the depths of drawdown were estimated to be 11.80 m and 13.00 m, respectively. The corresponding depths of available drawdown for the 1 and 20 Year periods were estimated to be 8.99 m and 7.79 m, respectively.
