Structural Investigation and Report for the

MILLBROOK ARENA

Township of Cavan Monaghan

AUGUST 7, 2019

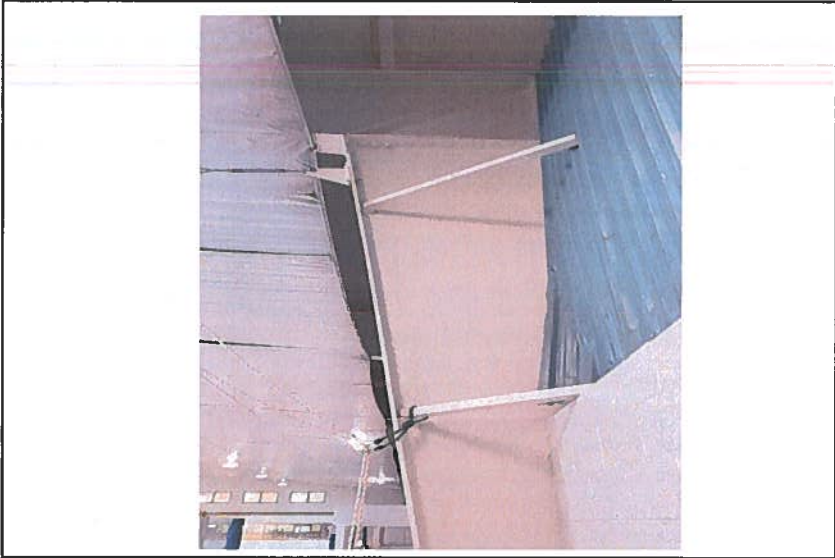
- Minor damage was observed at the surface of the frames resulting from repeated puck impacts (Photo 003). For aesthetics purposes, we recommend that the damaged area is cleaned and painted as required to match original conditions.

Photo 003 Pre-Engineered Frame

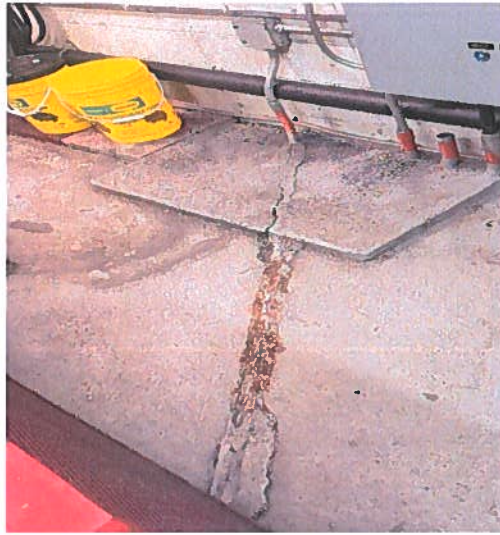
Photo 053 Concrete Damage at Electrical Equipment in Compressor Room

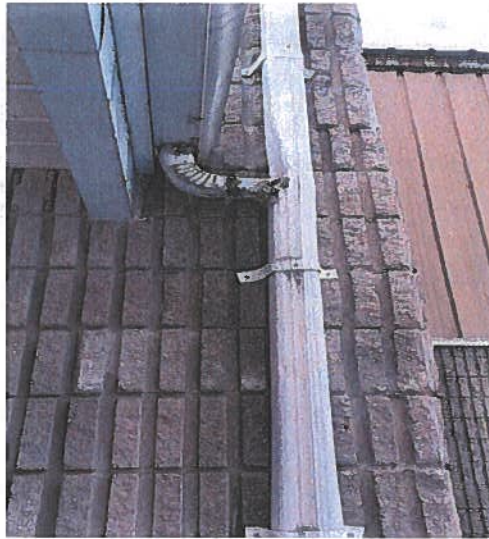
Photo 072 Damaged Eaves

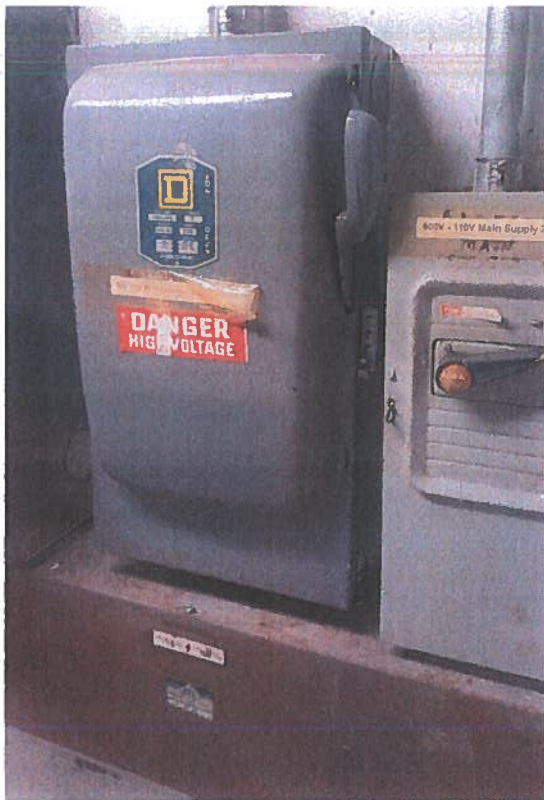
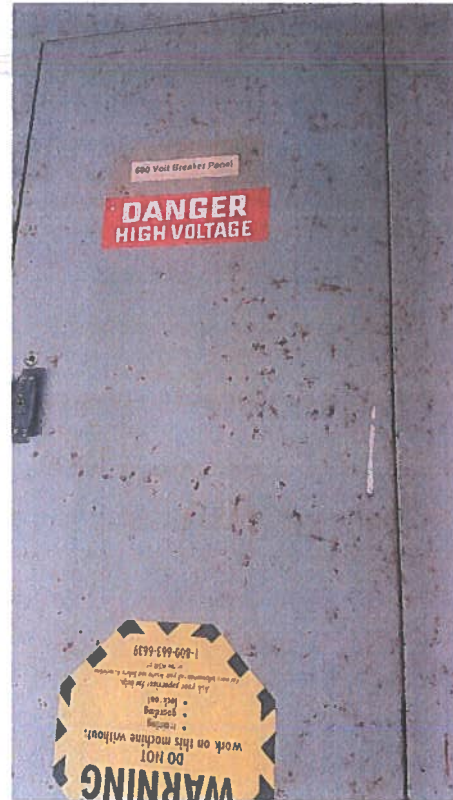
- 3.8 The Panel board, a federal pioneer NHDP 225A 3 phase 4 pole model, supplies the ice surface lighting, de-humidifiers and exhaust fans.
- 3.9 The 600V equipment appears to be all original and is all very dated with signs of many years of wear. The splitter is completely covered in rust caused by the high humidity in the area where the equipment is installed.

- 3.10 A 100A 120/240V panel is installed at the rear of the facility that is supplied from the Front Service for exit lights, lighting, receptacles, small fans and the timeclock.
- 3.11 It is recommended to conduct an inspection and preventative maintenance of the interior.

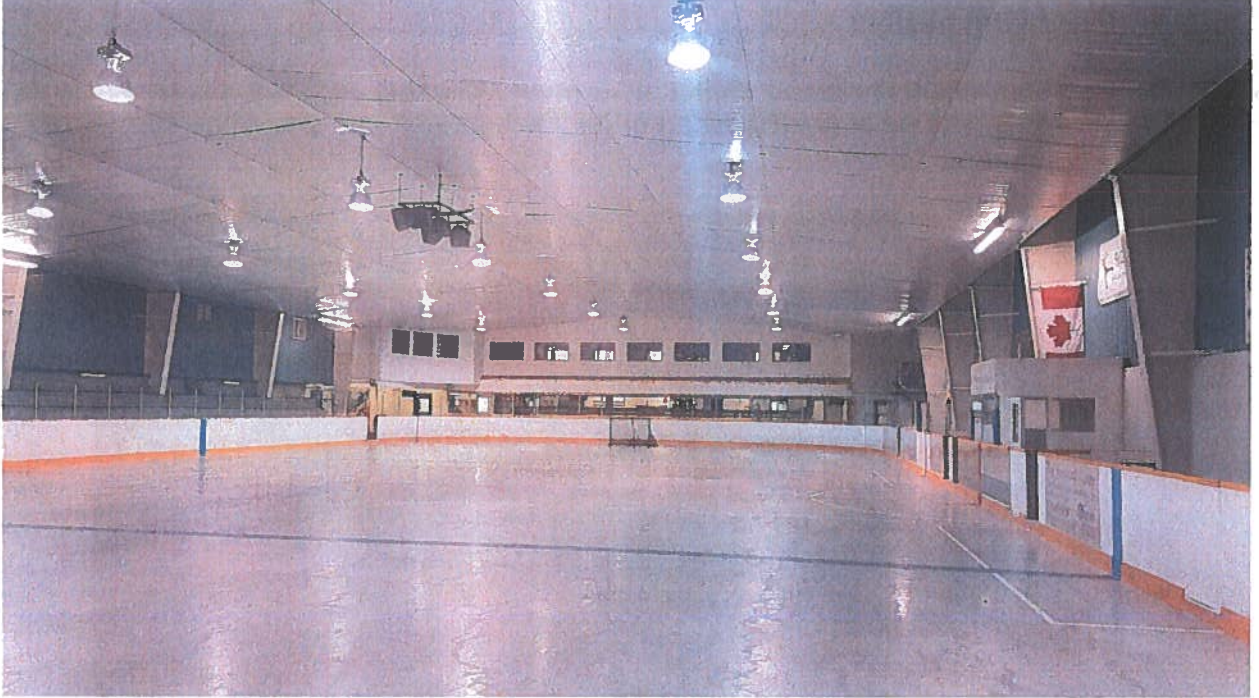
5.1 The ice surface lighting is 400W 347V Metal halide.

5.2 It is recommended to replace the existing metal halide fixtures with LED for improved control, instant on capability and longevity.

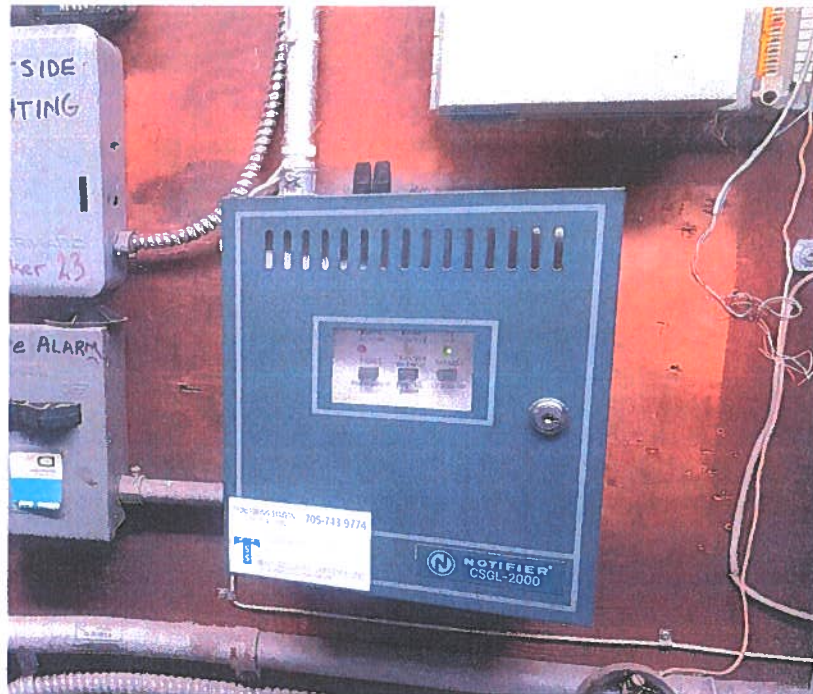
6.1 The existing fire alarm system is a single zone Notifier CSGL-2000. While it appears to be in good working order it is outdated and should be considered for upgrade.

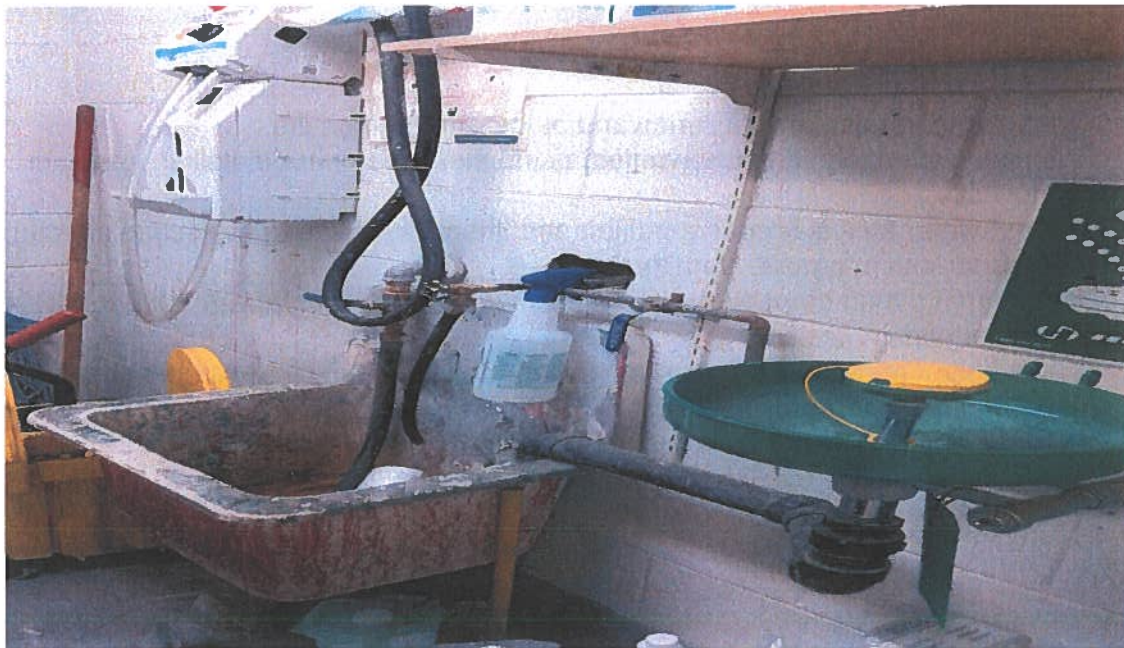
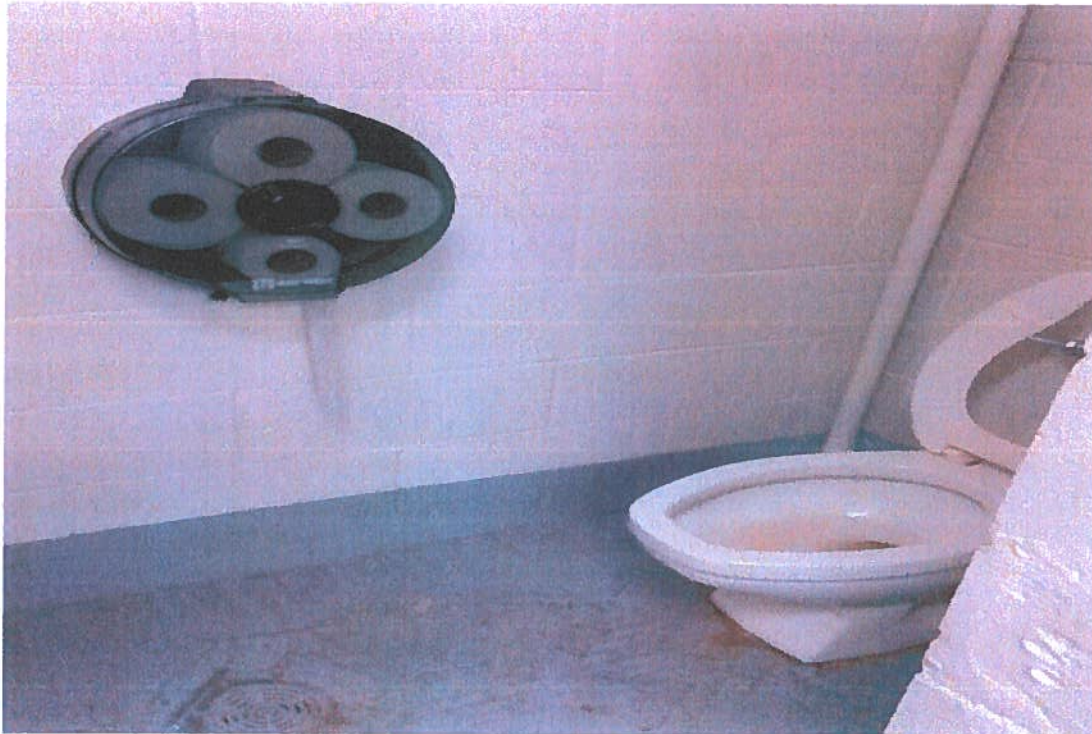
3.1 The fixtures as shown in the photos are in bad conditions and old.
