**BARRY BRYAN  
ASSOCIATES**

Re: **Consulting Services to Update Our Structural Investigation Report to Assess the Feasibility of Renovating the Millbrook Arena or Utilizing the Space in Other Ways  
4 Needlers Lane, Millbrook, Ontario  
BBA Project No. 22059 (REVISED)**

This structural condition audit has been undertaken by Barry Bryan Associates, Architects, Engineers, and Project Managers, for the Millbrook Arena, on behalf of the Township of Cavan Monaghan. Authorization to undertake this study was received from Mr. Gerry Barker, Park and Facilities Manager for the Township of Cavan Monaghan.

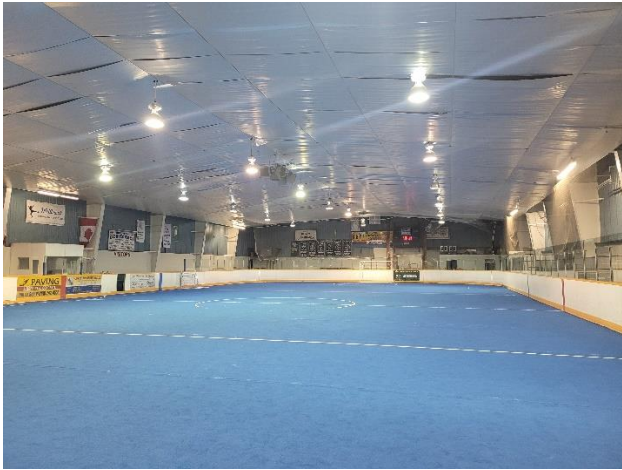
Photo 01 – Millbrook Arena

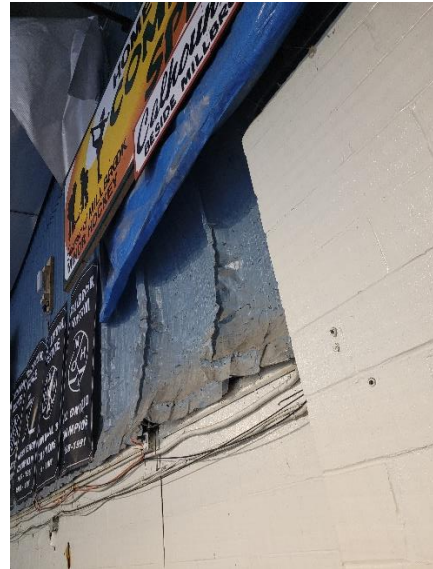
Photo 02 – Damaged Metal Siding

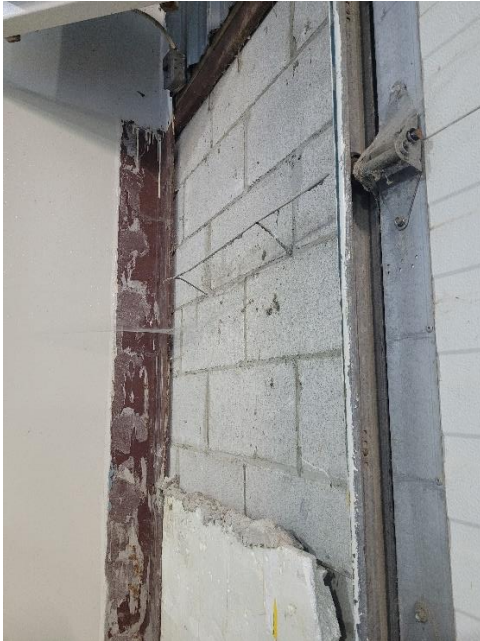
Photo 05 – Damaged Block Wall

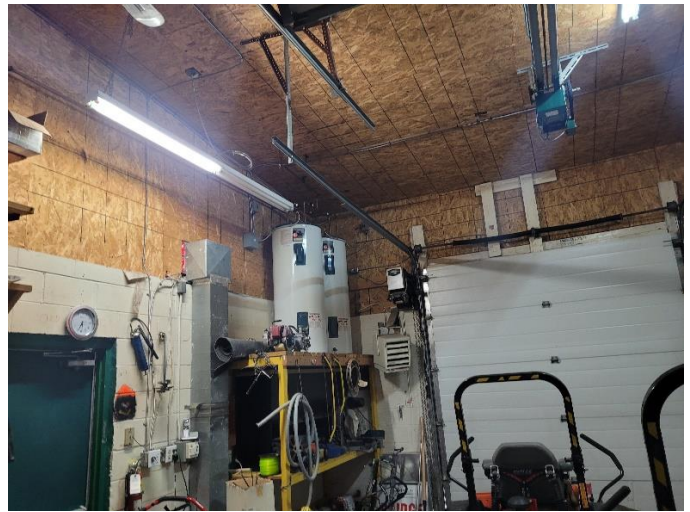
Photo 06 – Ice Resurfacing Room

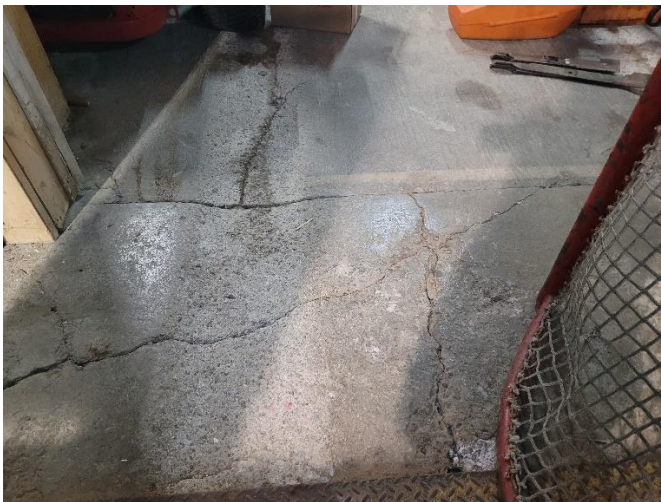
Photo 07 – Cracked Apron Slab

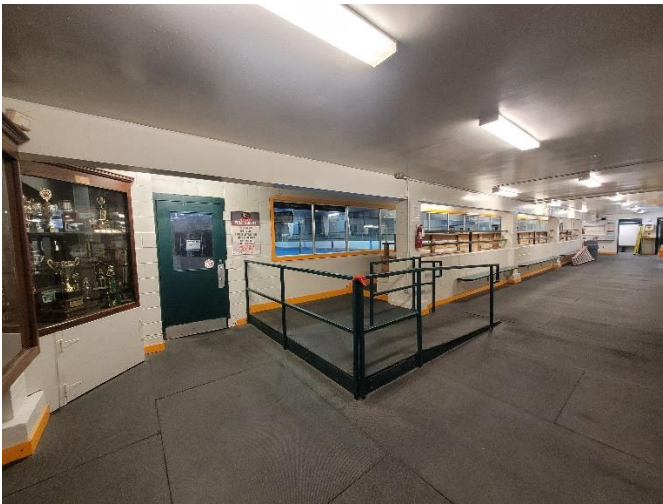
Photo 09 – Arena Viewing Area

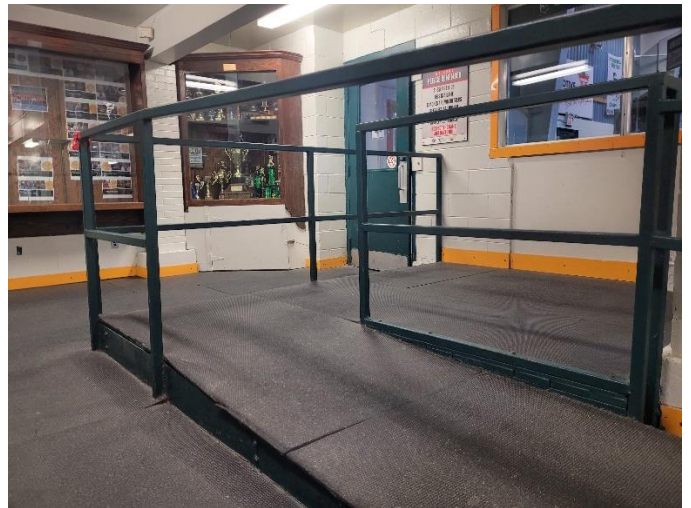
Photo 10 – Viewing Area Ramp/Rail Configuration

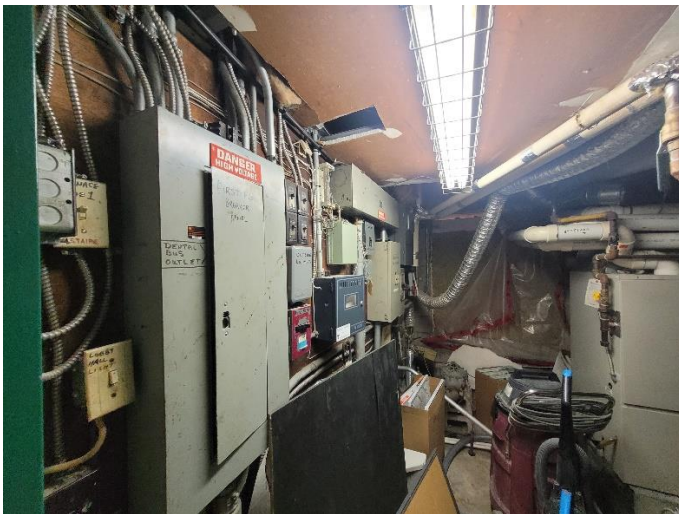
Photo 11 – Furnace/Electrical Room

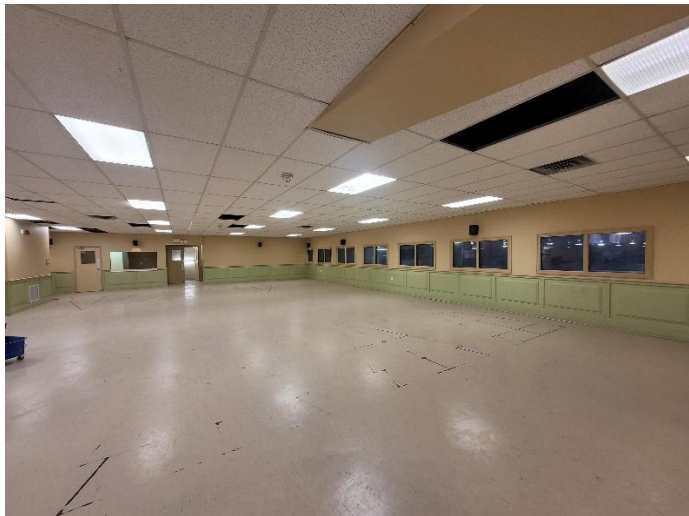
Photo 15 – Second Floor Community Area

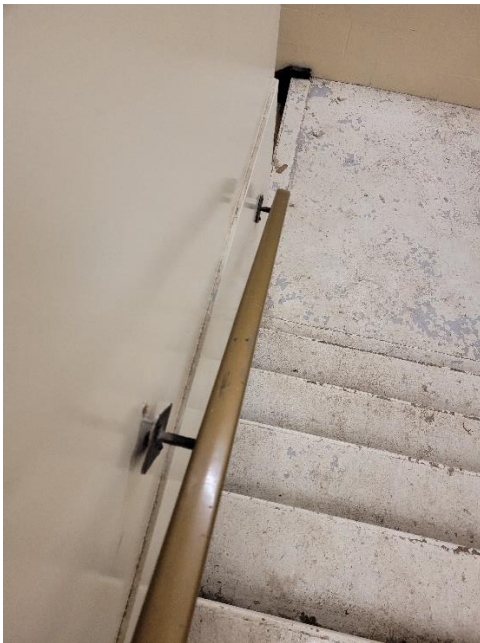
Photo 19 – Damaged Rail

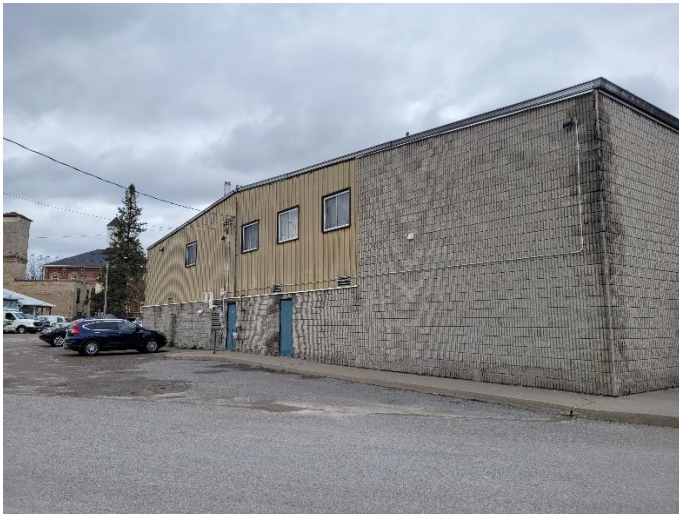
Photo 21 – South Elevation

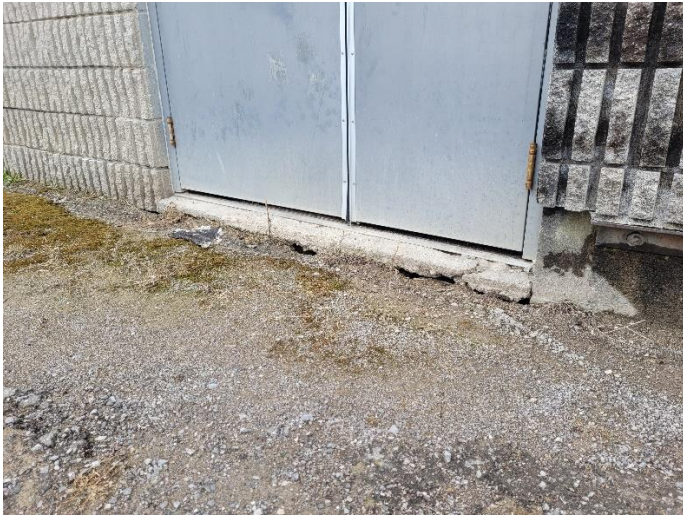
Photo 25 – Damaged Concrete Slab at Southwest Corner

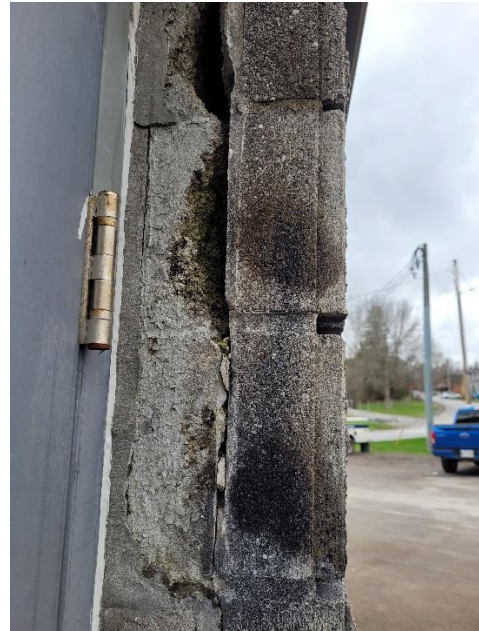
Photo 26 – Damaged Split Ribbed Block at Southwest Corner

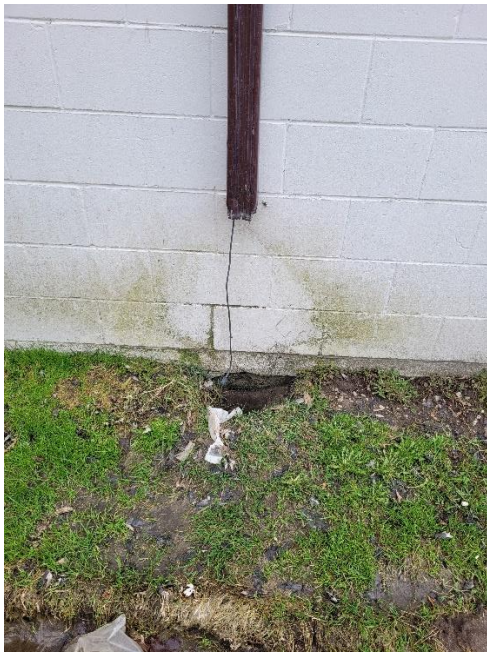
Photo 27 – Downspout at West Elevation

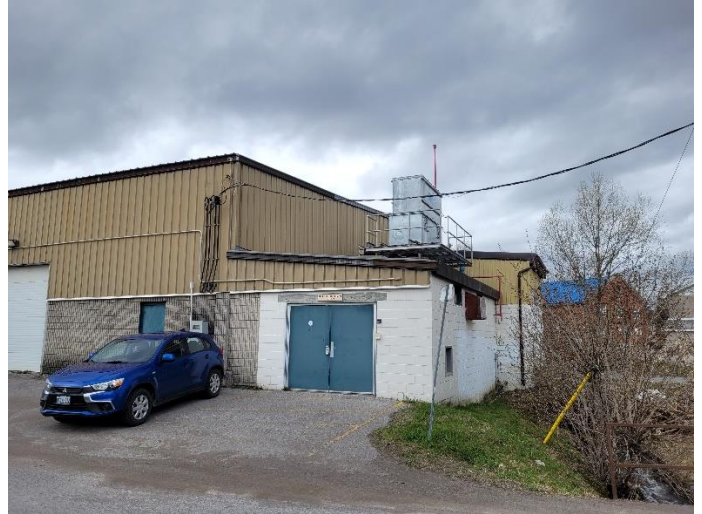
Photo 30 – Part East Elevation

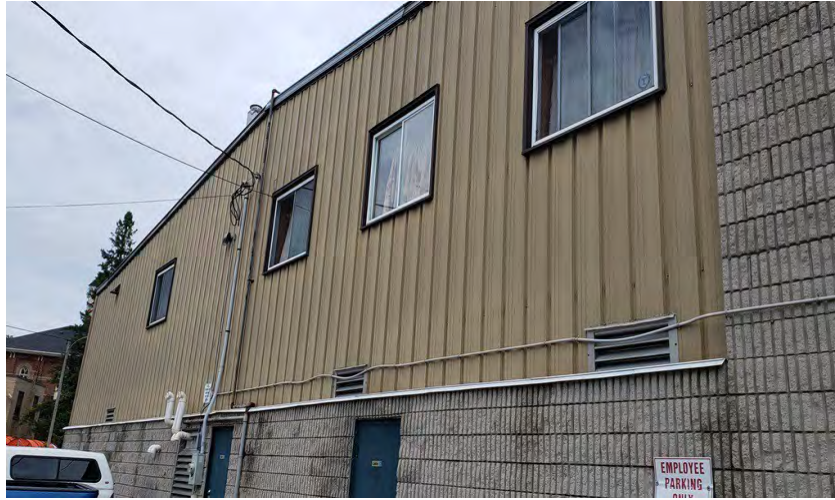
Photo 068 Architectural Precast Concrete Wall Panels

- The architectural precast concrete wall panels at the South Wall was observed to be in fair to good condition (Photo 068).
- The metal cladding above the Architectural block walls generally appeared to be in fair condition (Photo 069).

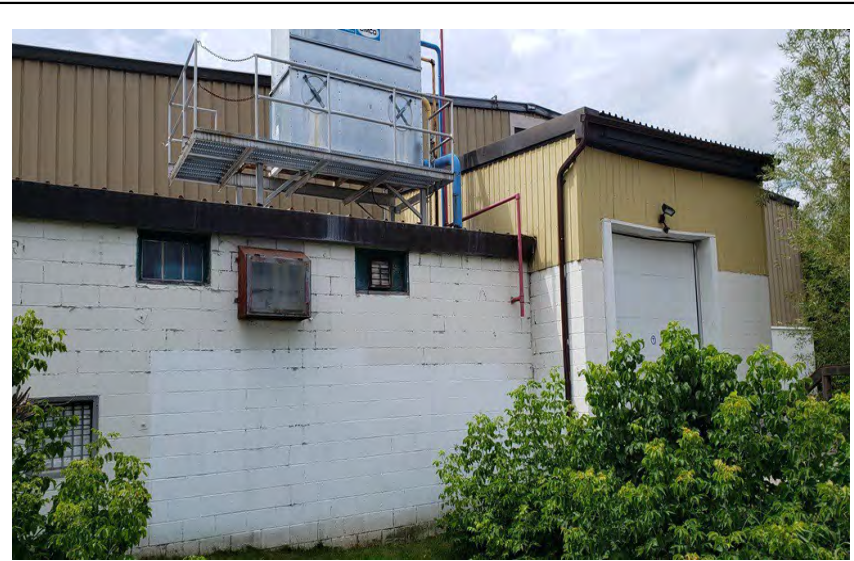
- Honeycombing at the foundation wall and mould growth was observed on the exterior of the ice-resurfacing room (Photos 082 and 083). We recommend for the block walls to be cleaned, mould accumulation to be removed at these locations. The honeycombing is likely a result from the pouring of the concrete at the time of constriction and does not pose a structural concern.

Photo 082 Honeycombing and Mould Growth

Photo 083      Honeycombing and Mould at Eastside of  
Ice-resurfacing Room

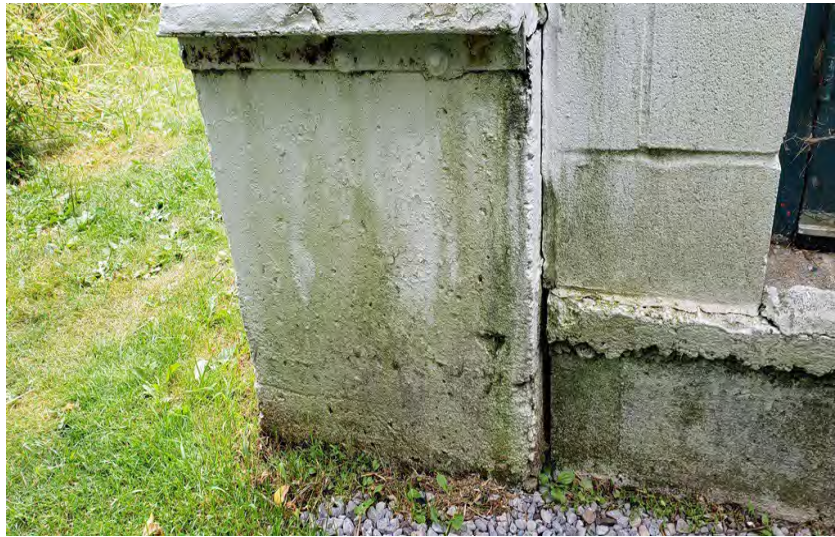
Photo 088      Mould and Moisture on Block Wal

- Moisture accumulation was observed along the north elevation (Photo 088). We recommend for the block walls to be cleaned to restore the original building condition.

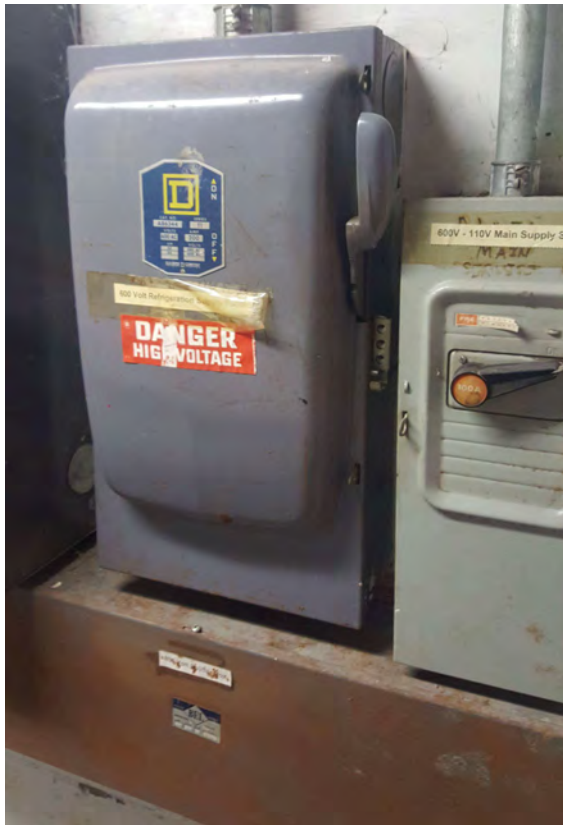
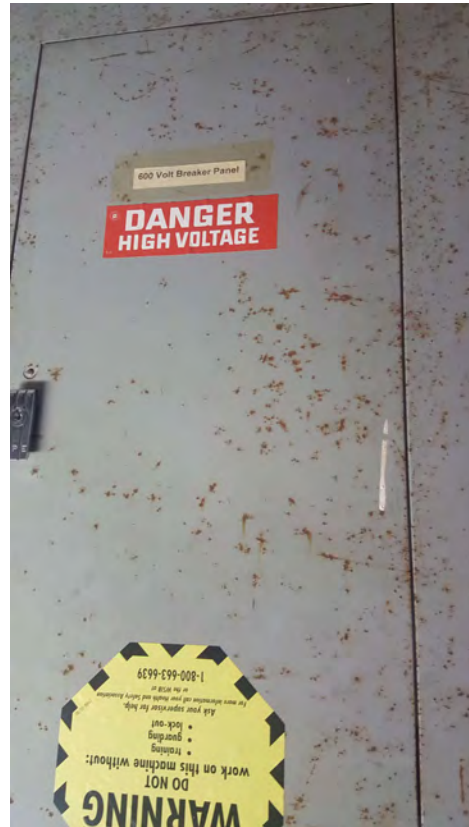
- 3.8 The Panel board, a federal pioneer NHDP 225A 3 phase 4 pole model, supplies the ice surface lighting, de-humidifiers and exhaust fans.
- 3.9 The 600V equipment appears to be all original and is all very dated with signs of many years of wear. The splitter is completely covered in rust caused by the high humidity in the area where the equipment is installed.

- 3.10 A 100A 120/240V panel is installed at the rear of the facility that is supplied from the Front Service for exit lights, lighting, receptacles, small fans and the timeclock.
- 3.11 It is recommended to conduct an inspection and preventative maintenance of the interior.

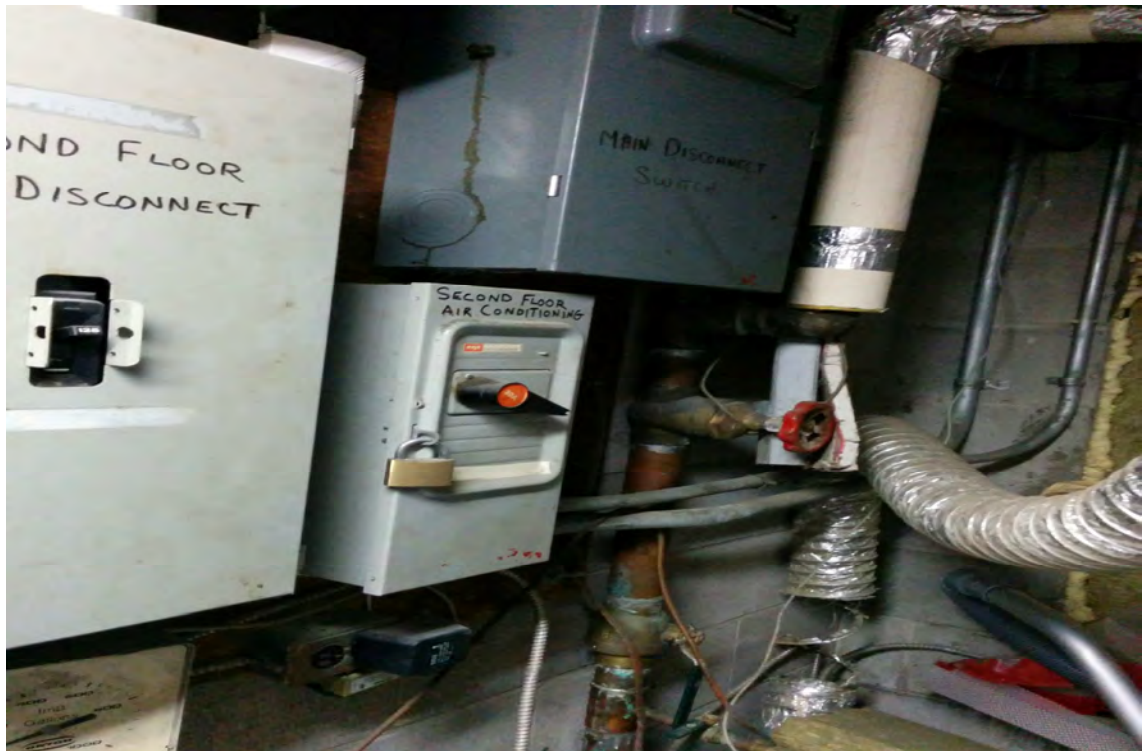
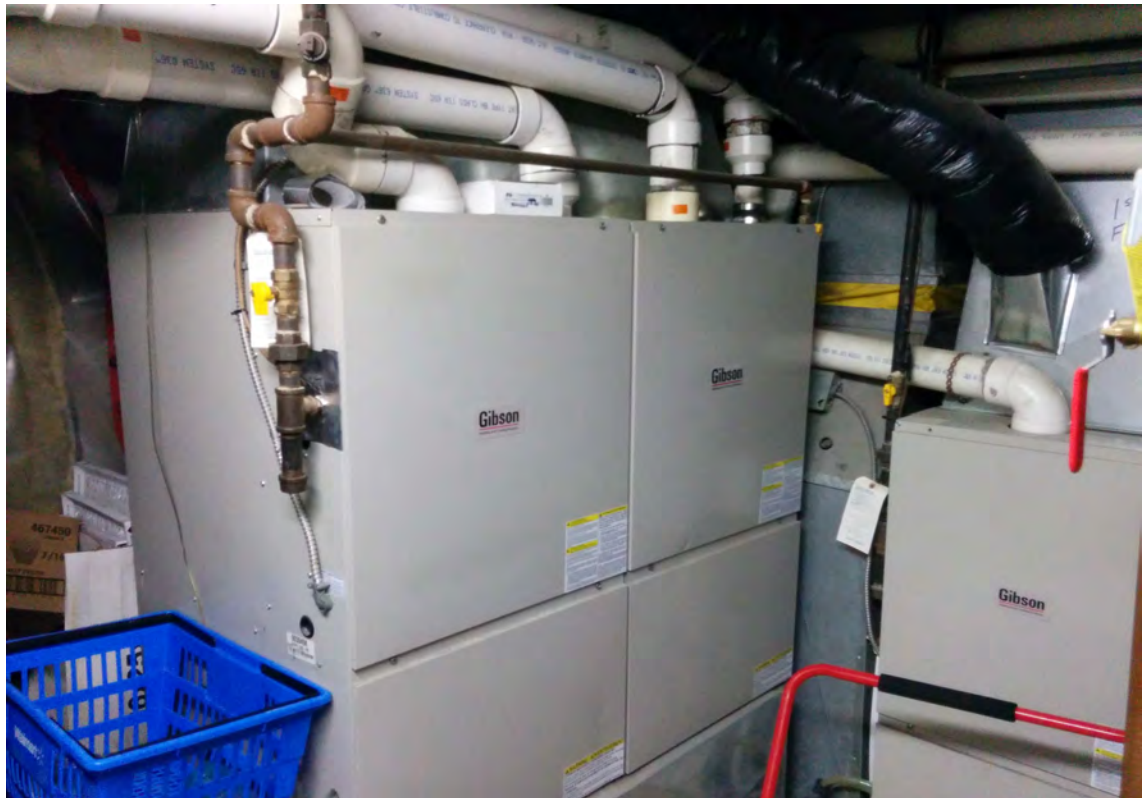
- 2.1 The building has four Gibson furnaces for heating only, each has a capacity of 110,000 Btu/hour with efficiency of more than 90%, natural gas fueled.
- 2.2 The building has no cooling as there is no direct expansion coils above the furnaces and a roof top unit could not be verified on the roof.
- 2.3 The building has no ventilation, no heat recovery or energy recovery units, no ventilation ducts and no exhaust duct from the ducting system.
- 2.4 There are no heating, cooling or ventilation calculations to verify if the furnaces are covering the heating load or the cooling capacity required and ventilation or outside fresh air required for the whole building.
- 2.5 The mechanical room is cramped, cluttered and very small for all the equipment in it.

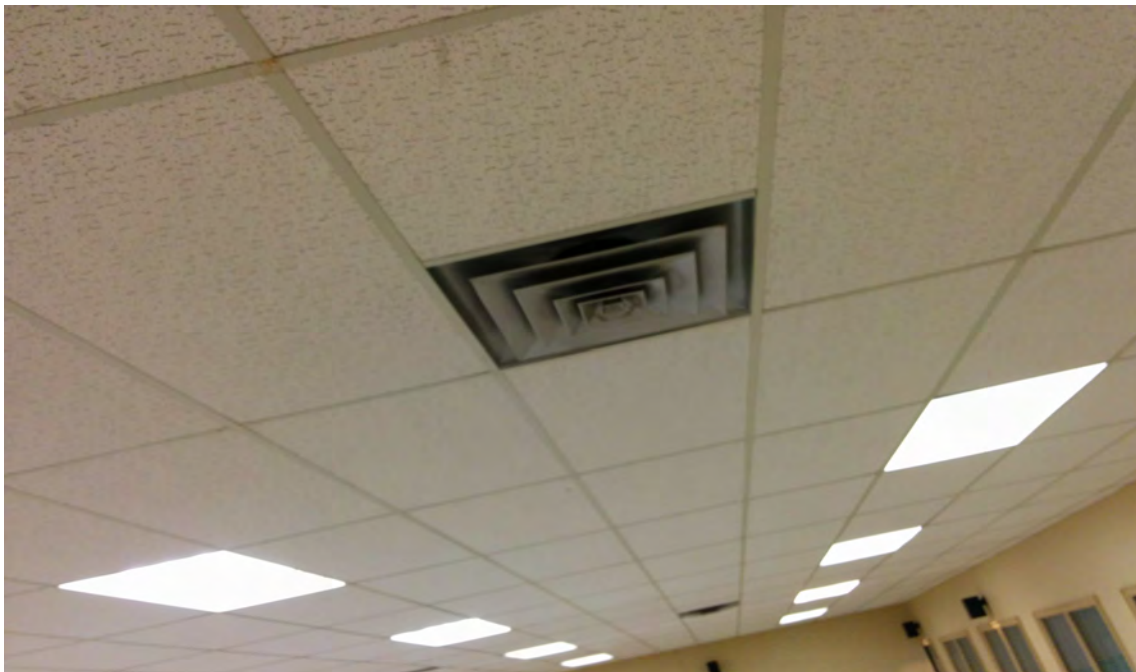
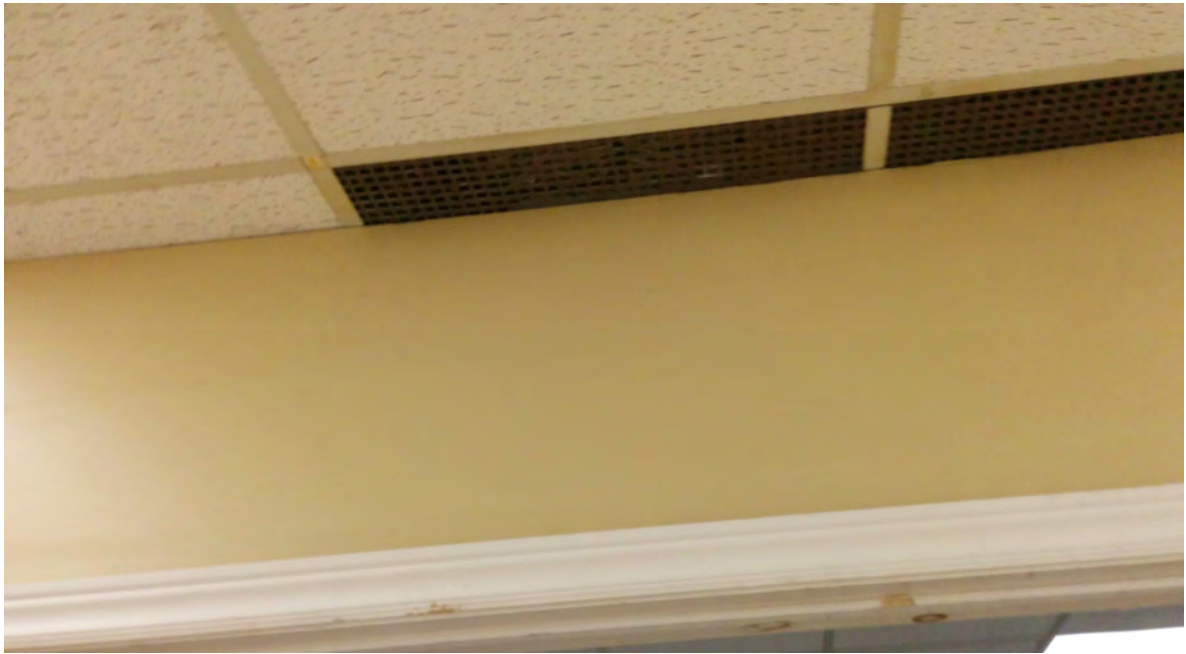
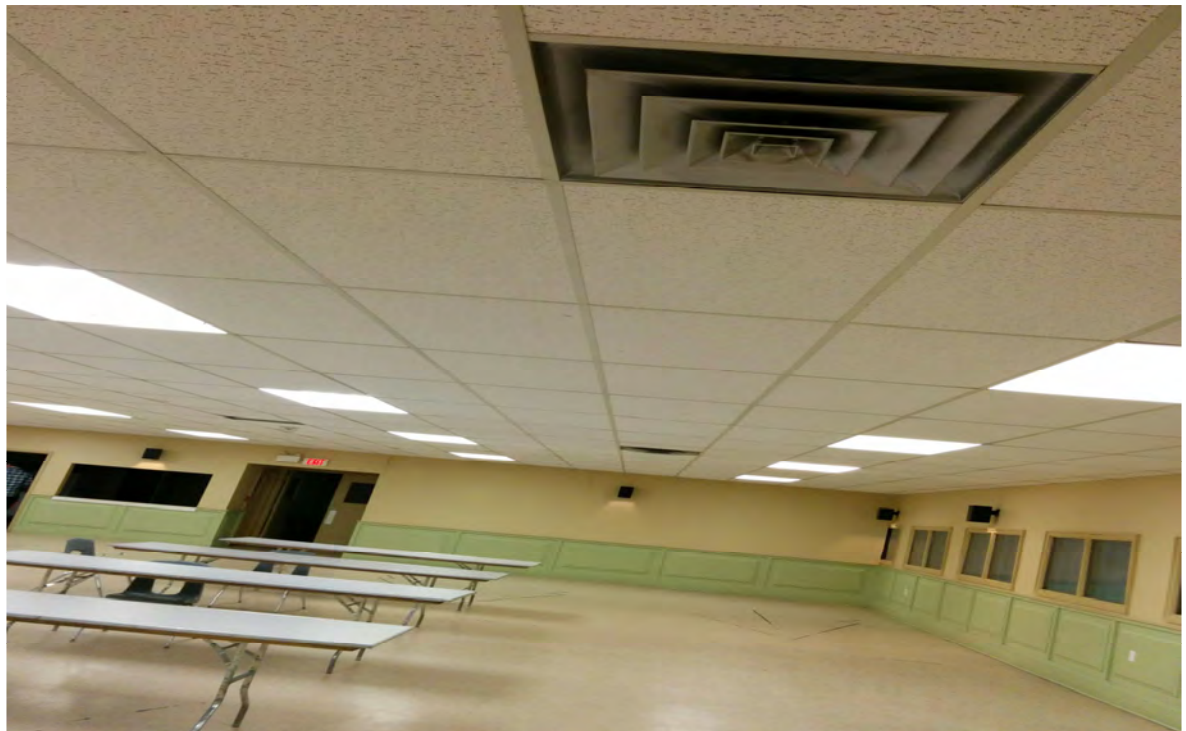
- 2.6 The ducting system had no access panels to verify if there are balancing dampers or any other dampers. The ducting was not accessible to verify how the fittings were done or if they were insulated.
- 2.7 The diffusers are in bad condition; there is very poor air and temperature distribution in the second floor. The diffusers were separated from each other by a long distance without return grills in the same space.

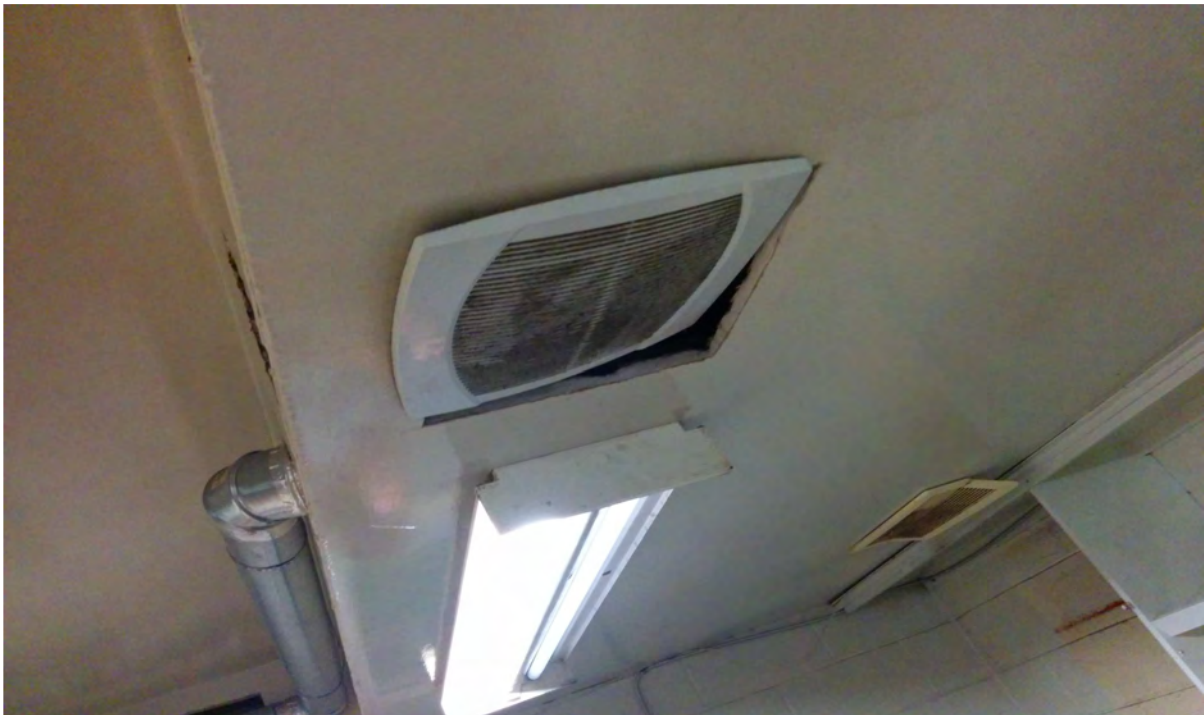
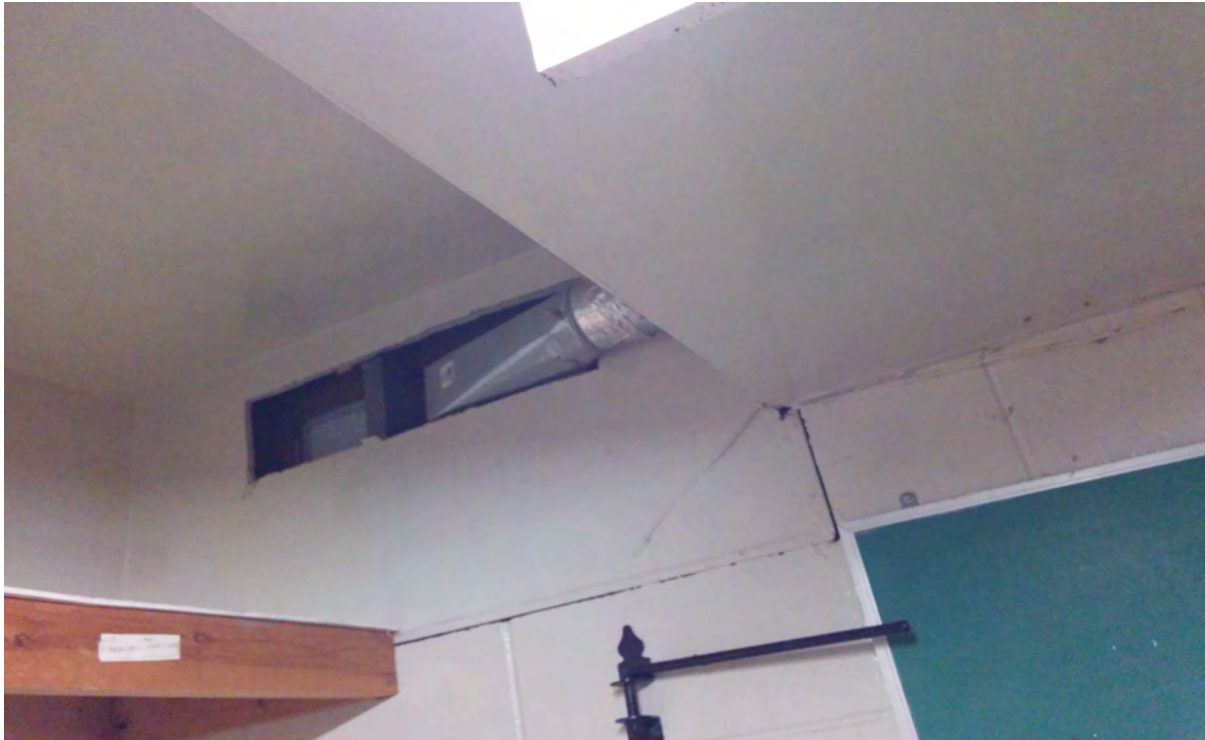
- 2.8 The supply diffusers were in a space and the return grills were in a different space.
- 2.9 Some other spaces had no supply diffusers nor return grills.
- 2.10 There is no heating, ventilation and cooling in the rink lobby as required by codes and standards. The whole corridor in the first floor had no diffusers or grills, which means no heating, cooling or ventilation.

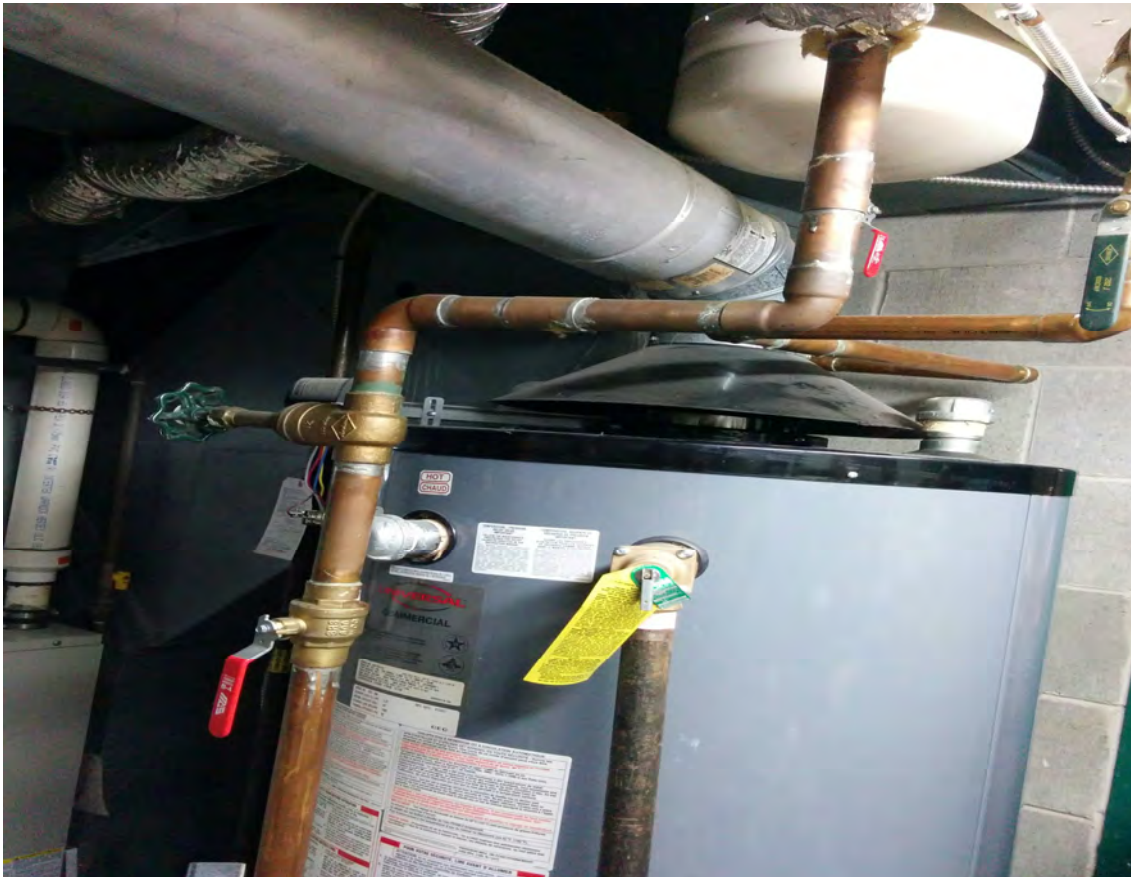
- 4.1 The fixtures are old, low efficiency and at the end of their life.
- 4.2 The pipe system could not be verified as most of it were in the ceiling space or inside walls.
- 4.3 The hot water tank is a good condition and the pipes inside the mechanical room are copper and in a good condition.
- 4.4 The incoming main domestic water pipe, valves and the meter are old, no back-flow meter was noticed.
- 4.5 No insulation on hot water pipes noticed in the whole building except some pipes in the mechanical room.
- 4.6 There was an expansion tank installed above the hot water tank.
- 4.7 No ventilation in the mechanical room and no recirculating pump.
- 4.8 No clearances around all equipment.
