## Regular Council Meeting

<b>To:</b>	Mayor and Council
<b>Date:</b>	December 16, 2024
<b>From:</b>	Chris Allison, Parks and Facilities Manager
<b>Report Number:</b>	Parks and Facilities 2024-05
<b>Subject:</b>	Mould Assessment Results and Required Remediation at Millbrook Arena

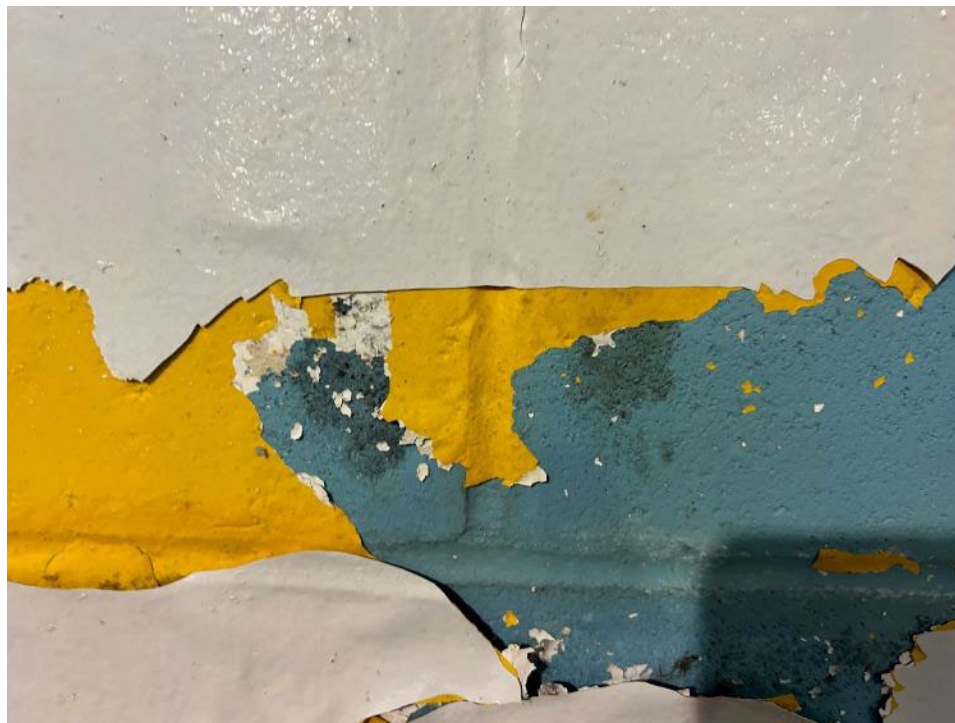
**Photo 1 Mould growth on concrete in the main arena area.**

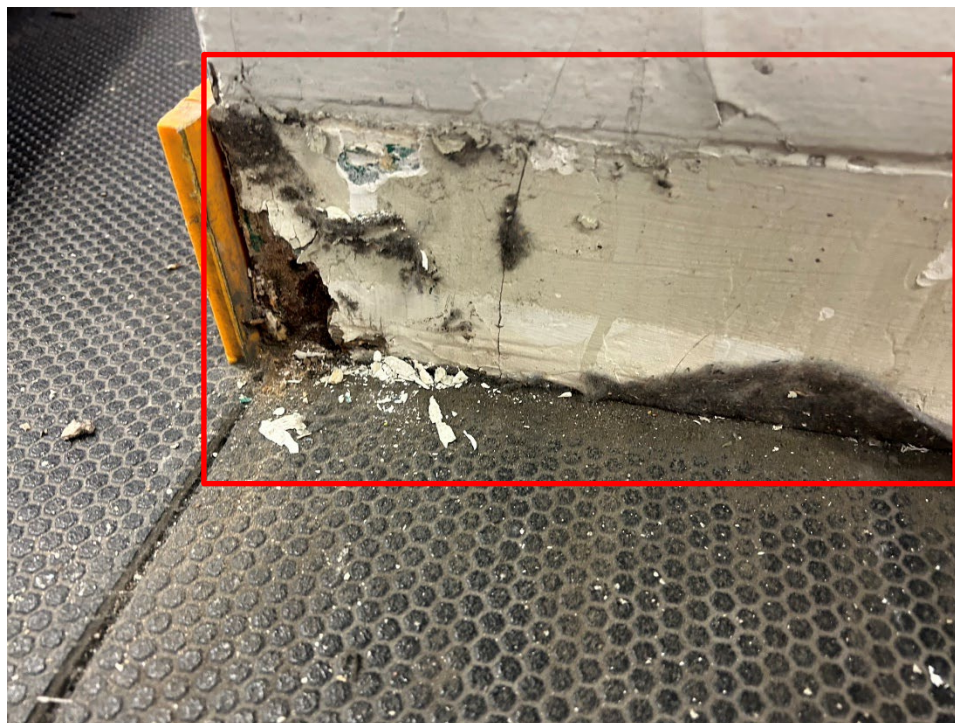
**Photo 2 Mould growth on gypsum in the lobby.**

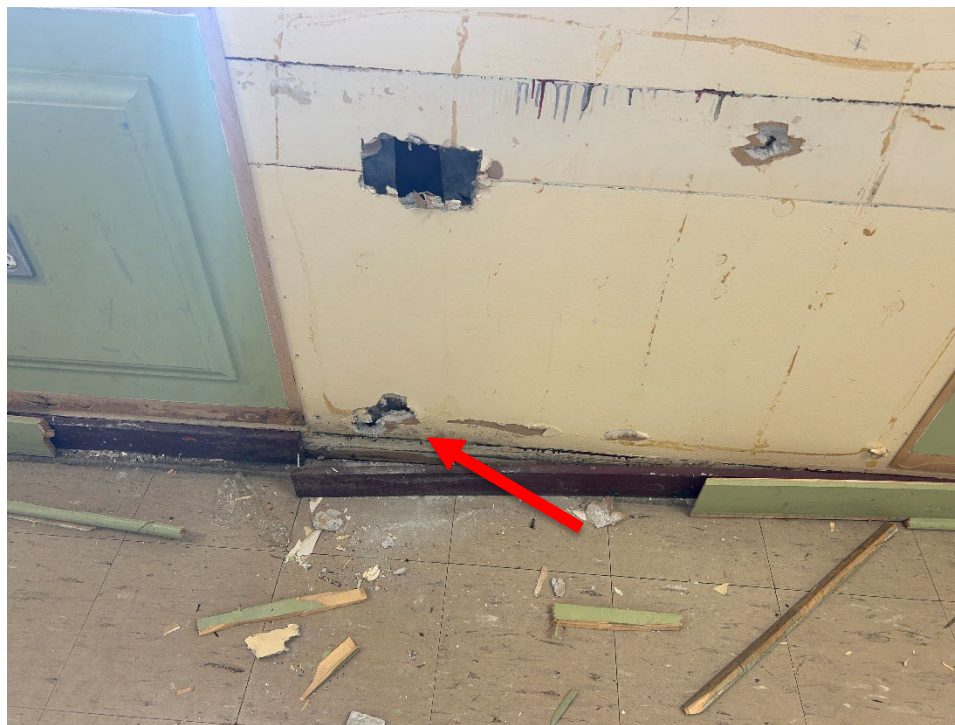
**Photo 3** Mould growth on gypsum wall and wood baseboard trim in the second floor hall.

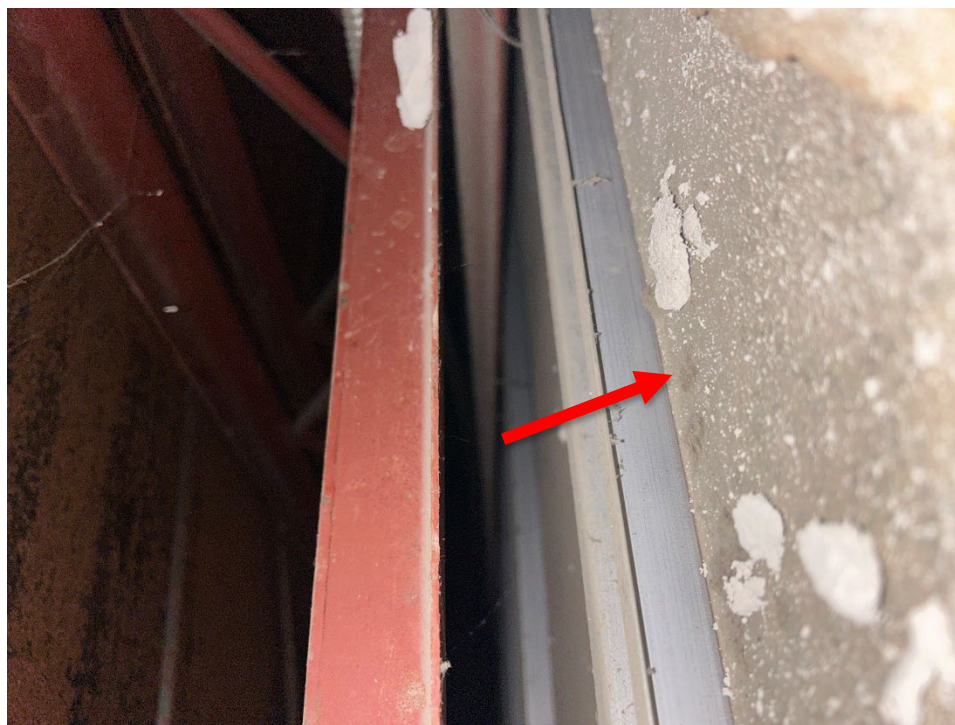
**Photo 4** Mould growth on gypsum in changeroom 3.

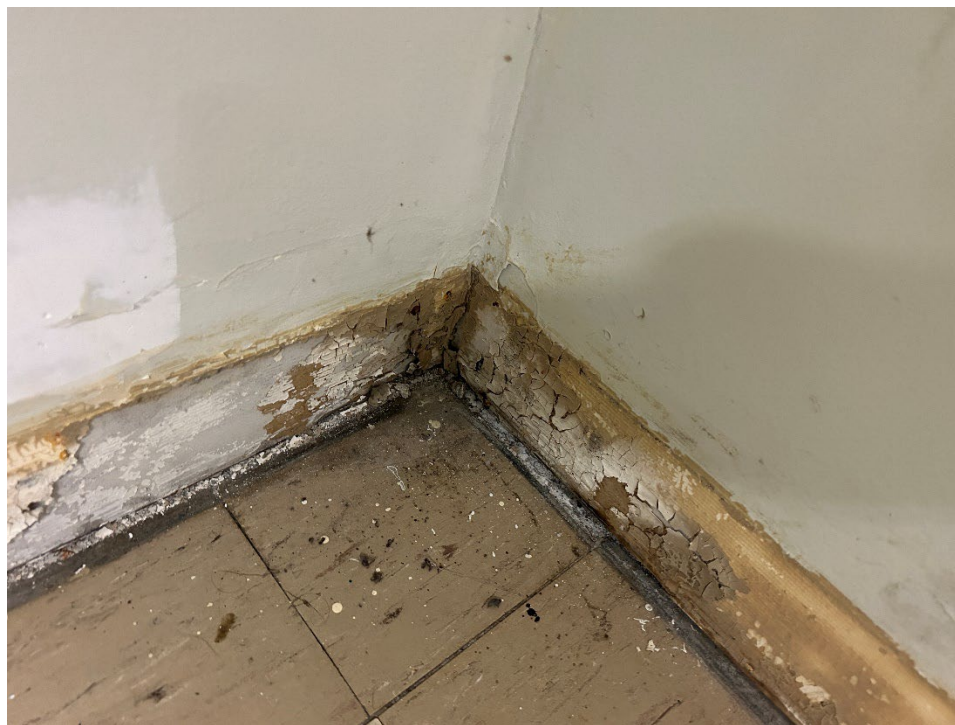
**Photo 5** Mould growth on gypsum in the second-floor woman's washroom.

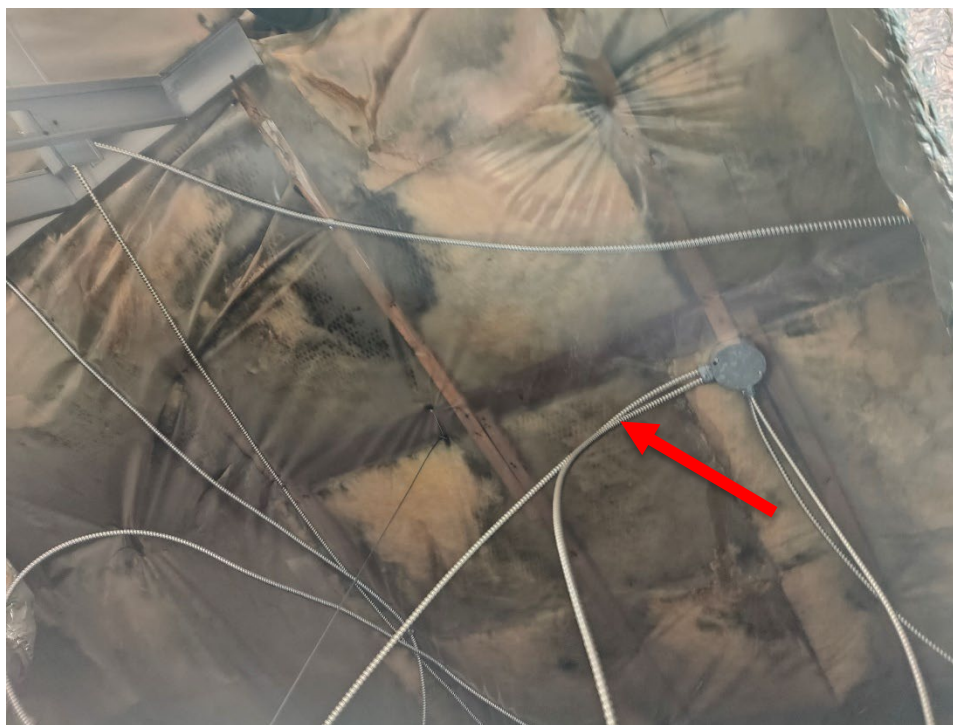
**Photo 8 Mould growth on vapour barrier and fibreglass ceiling insulation.**

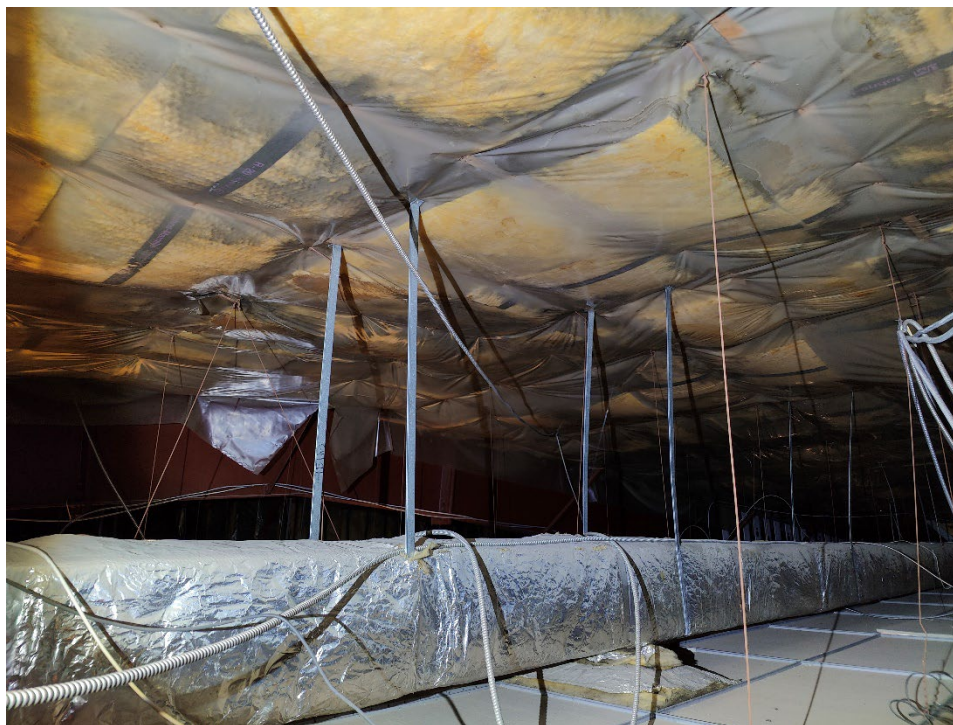
**Photo 9 Mould growth vapour barrier and fiberglass insulation.**

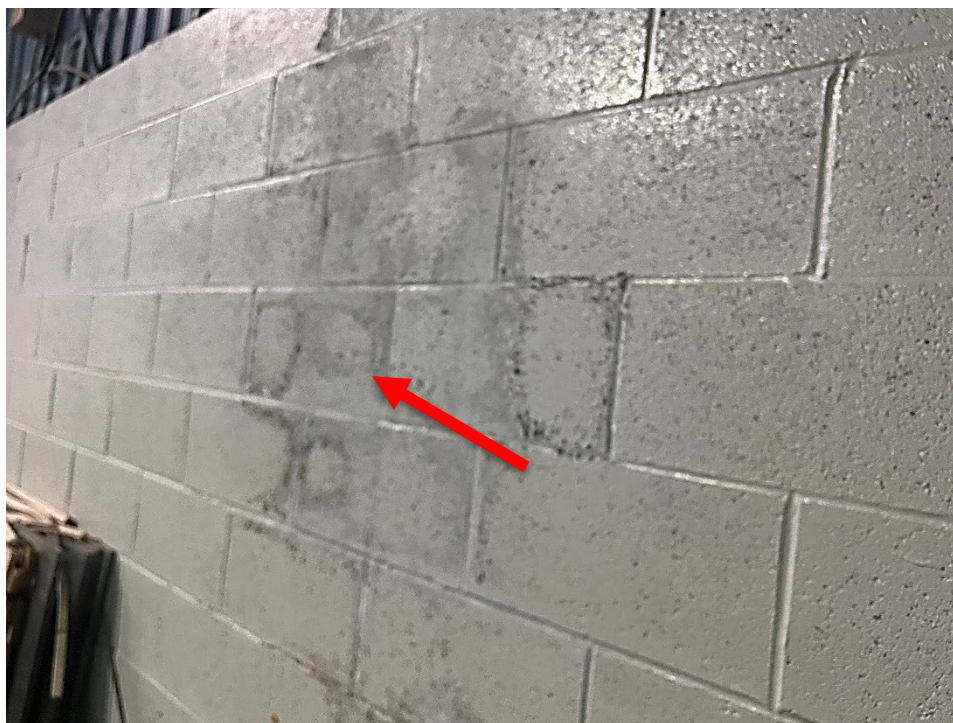
**Photo 10 Mould growth concrete block wall.**

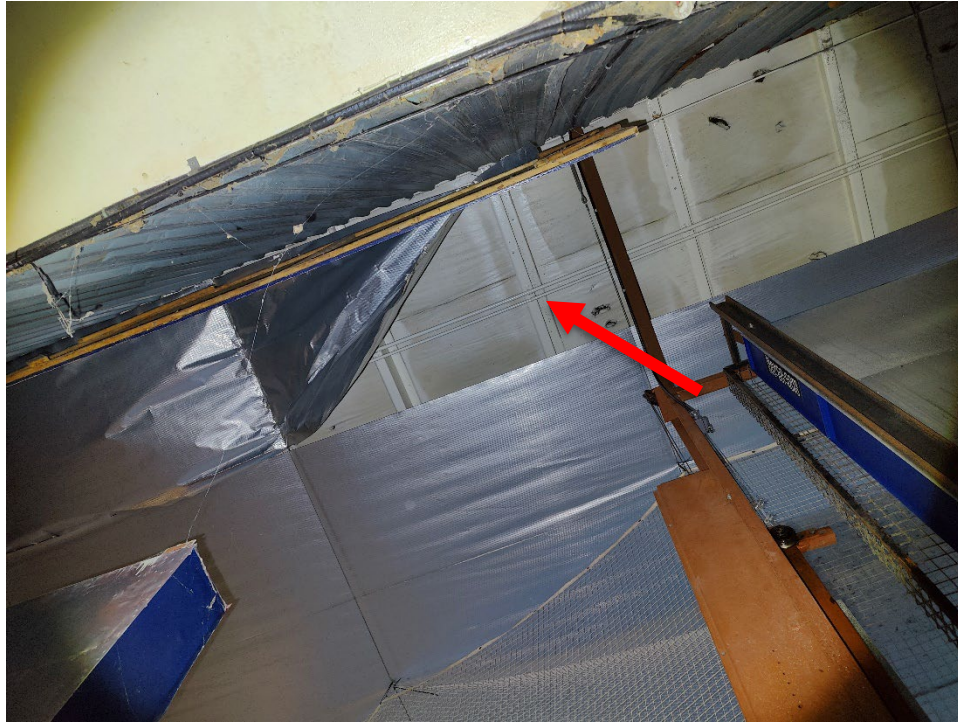
**Photo 11 Mould impacted fibreglass insulation.**

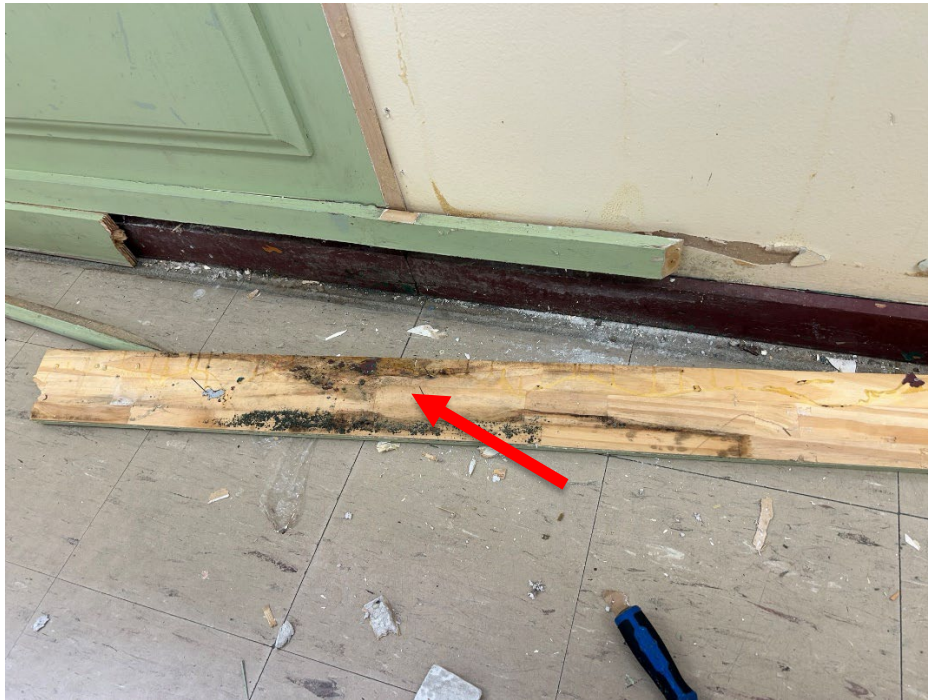
**Photo 13 Mould impacted wooden baseboard.**

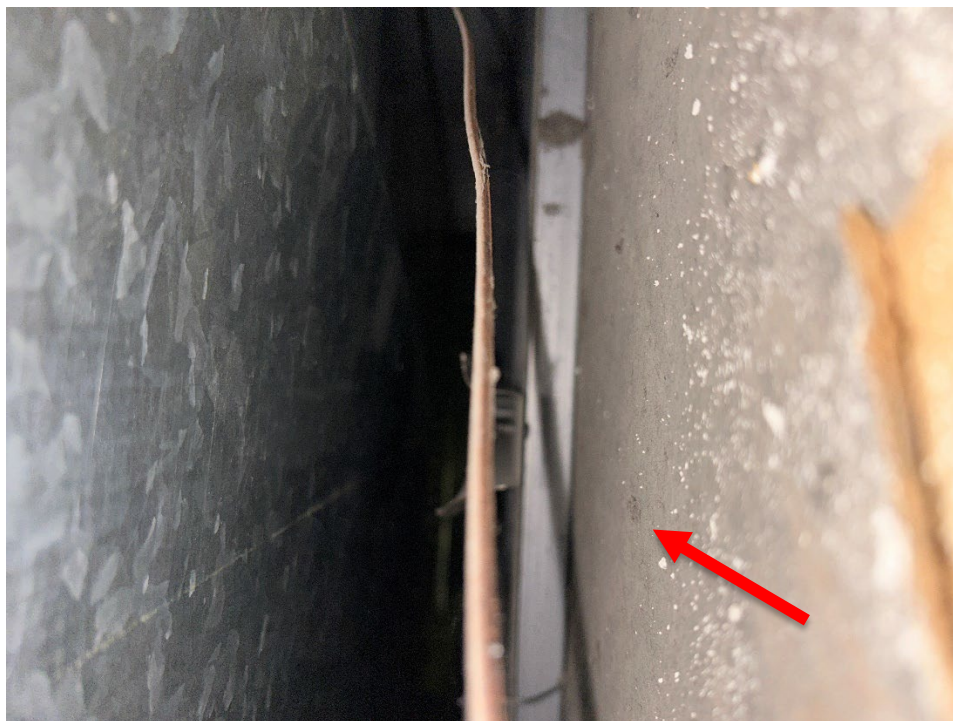
**Photo 15 Mould impacted gypsum ceiling.**

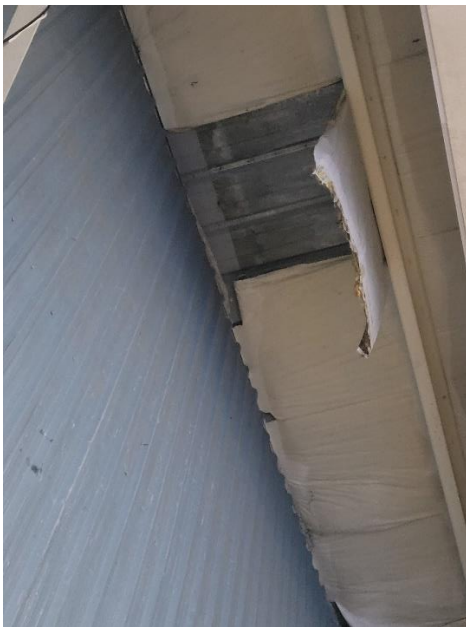
Photo 03 – Damaged Roof Insulation

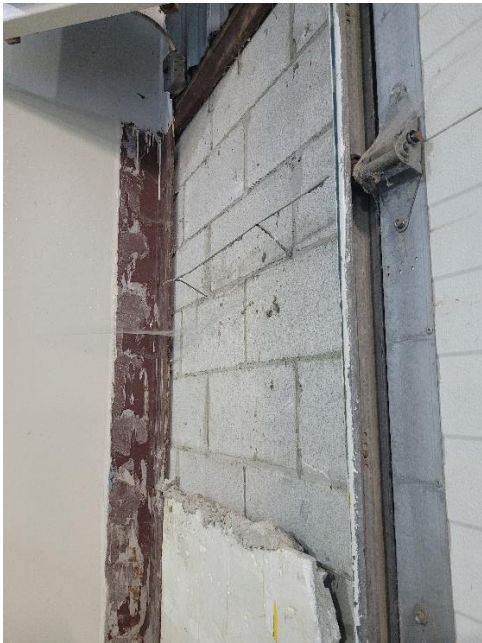
Photo 05 – Damaged Block Wall

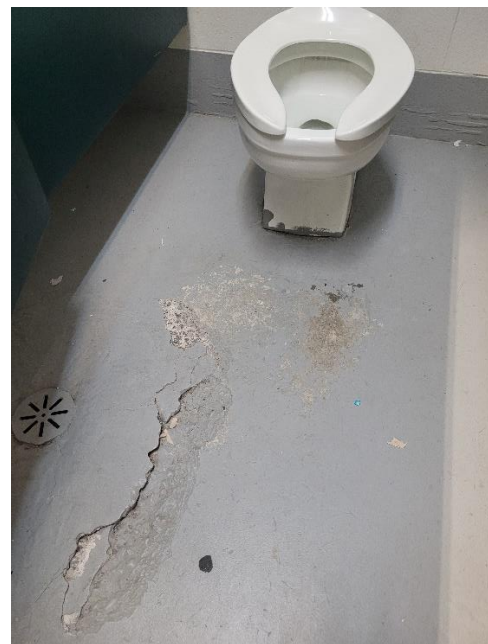
Photo 12 – Damaged Slab in Washroom

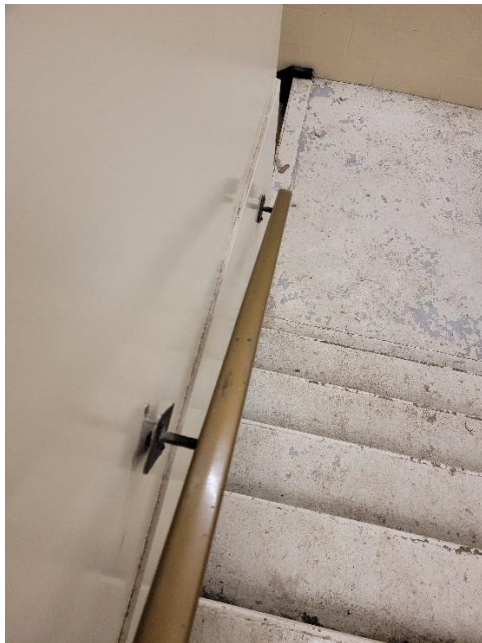
Photo 19 – Damaged Rail

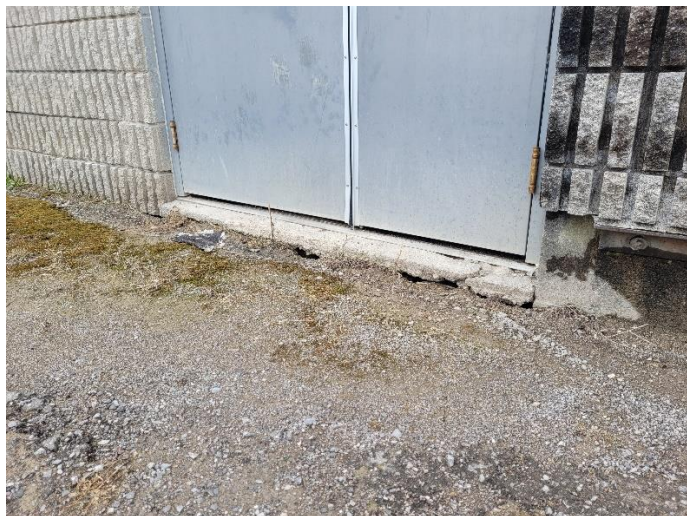
Photo 25 – Damaged Concrete Slab at Southwest Corner

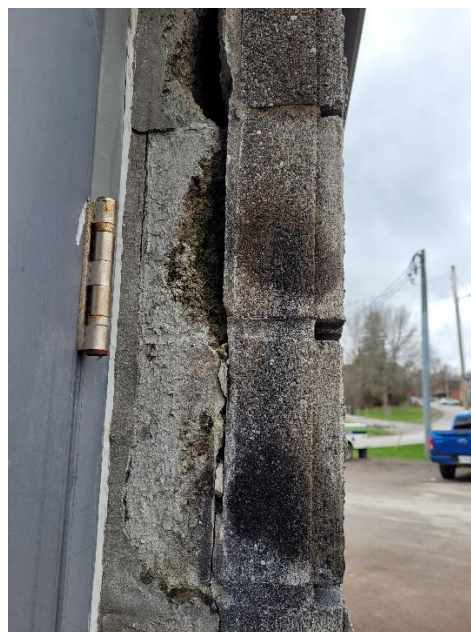
Photo 26 – Damaged Split Ribbed Block at Southwest Corner

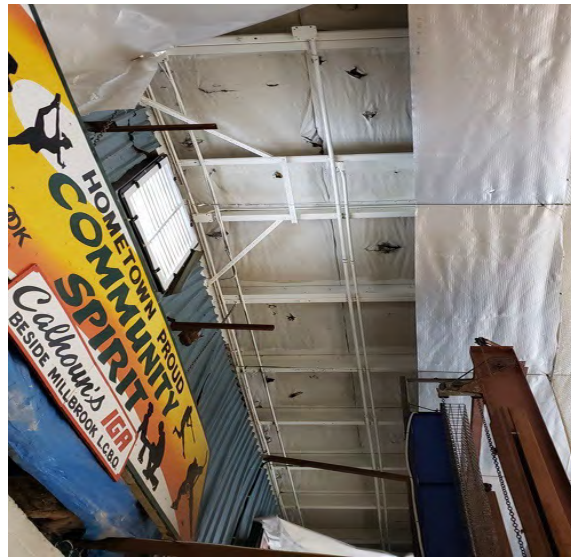
Photo 001 Hidden Roof Deck & Z-Purlins

- The roof deck generally appeared to be in fair condition with no evidence of water/moisture damage (Photo 001). However, at the area exposed behind the net, there were visible minor damage due to puck impacts. For aesthetics purposes, we recommend that the damaged areas are cleaned and painted as required to match original conditions.
- The cold formed steel z-purlins was generally observed to be in fair to good condition.

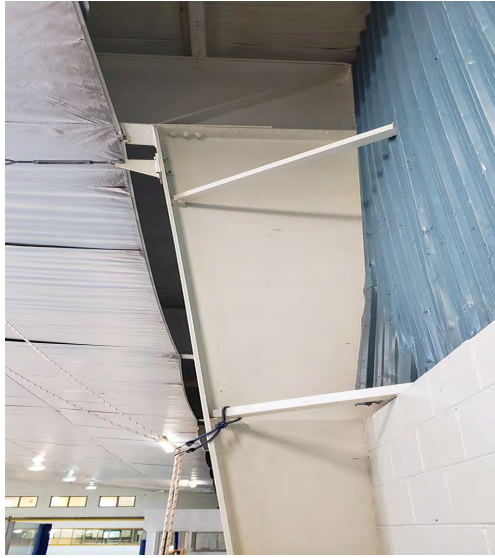
Photo 003      Pre-Engineered Frame

- Minor damage was observed at the surface of the frames resulting from repeated puck impacts (Photo 003). For aesthetics purposes, we recommend that the damaged area is cleaned and painted as required to match original conditions.

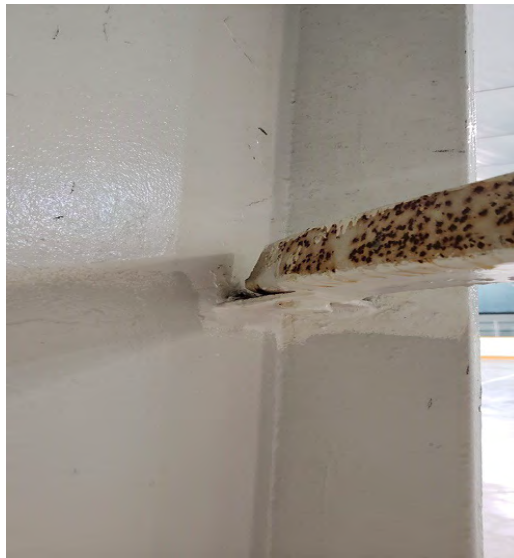
- Minor localized surface rusting was observed along several bracing members (Photo 004). This is likely due to condensation and high humidity during occupancy. We recommend for the rusted area to be wire brushed clean to bare metal and an epoxy protective coating is applied.

Photo 004      Rust on Frame Brace

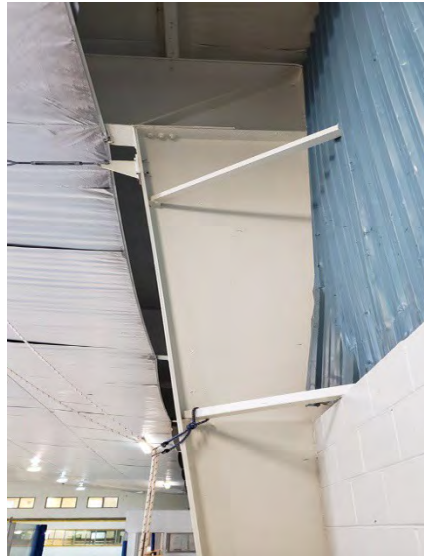
- Metal cladding appears to be separating from the wall at one of the frames along the west side of the arena (Photo 015). We recommend that the panel be re-secured to match the existing conditions.

Photo 015      Metal Cladding Along West Side

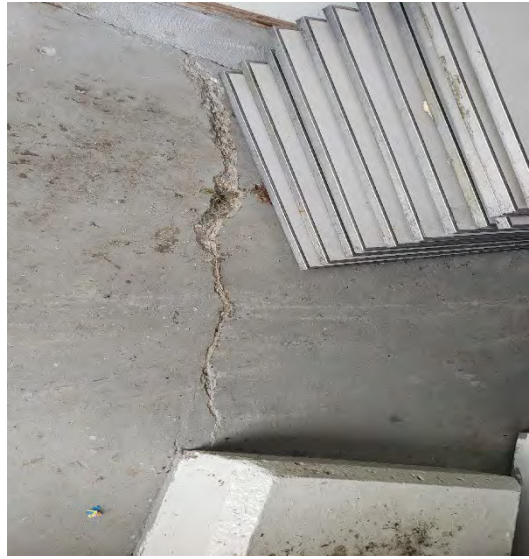
- Moderate cracking was observed near the entrance of the compressor room (Photo 017). We recommend to infill the void space with suitable mortar to match existing conditions.

Photo 017      Cracking Outside of Compressor Room

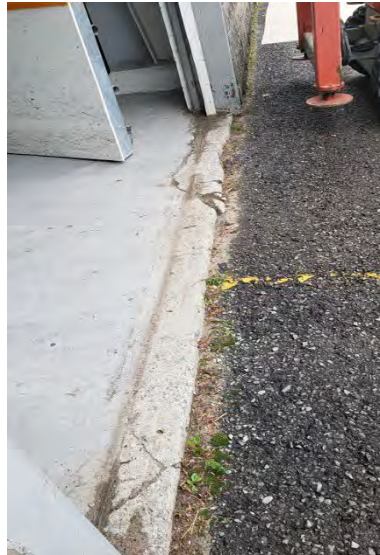
- Moderate cracking and spalling were observed underneath the exterior garage door on the East side of the building (Photo 018). We recommend for all loose and unsound concrete to be chipped out and removed and patched with a suitable repair mortar.

Photo 018      Apron Slab Under Garage Door

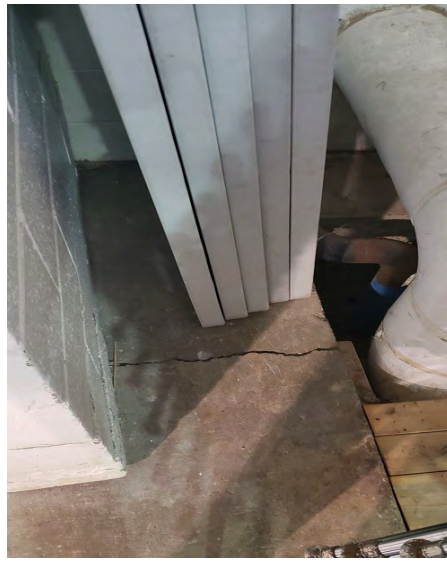
- Significant cracking was observed adjacent to the ice-surfacing room (Photo 019). This is likely due to previous differential settlement of the structure. We recommend for the slab to be repaired and patched with a suitable repair mortar to prevent further deterioration.

Photo 019      Major Crack in Apron Slab

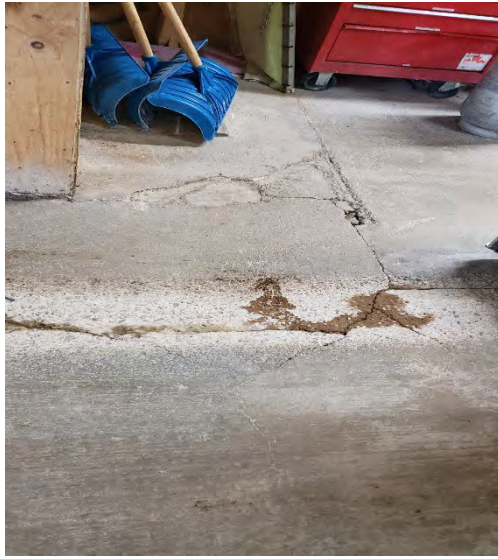
Photo 021      Cracking Starting in Resurfacing Room

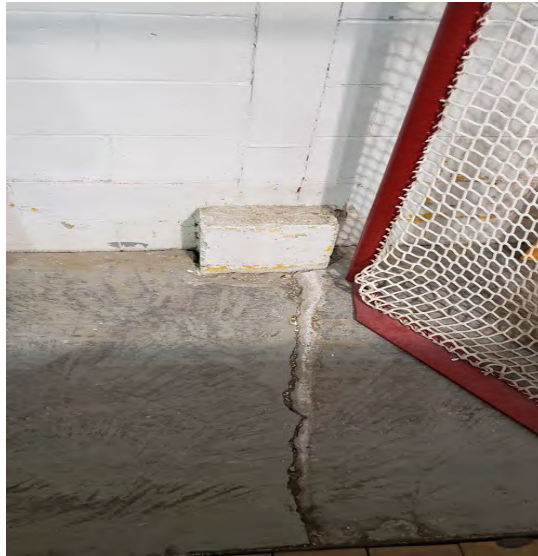
Photo 023      Cracking Under North-Side Column

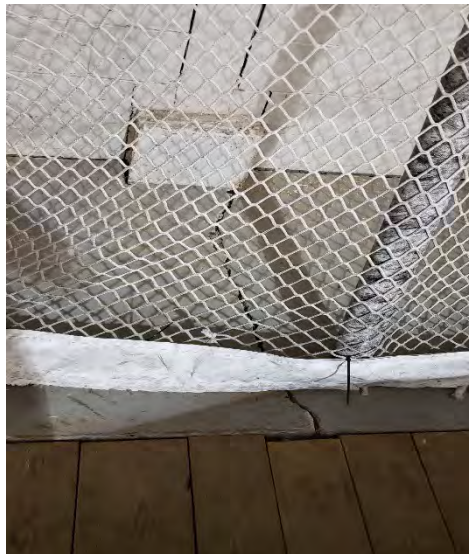
Photo 024      Cracking Under North-Side Column

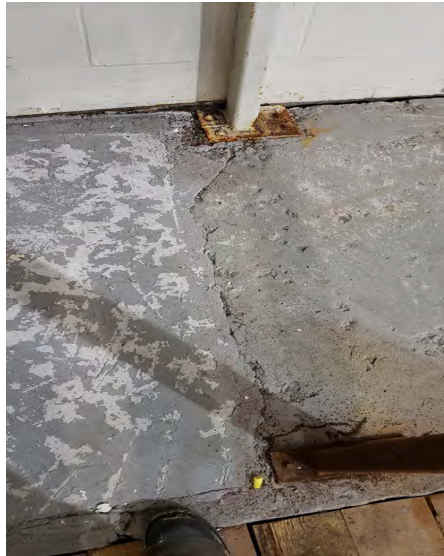
Photo 025      Crack Underneath Mechanical Equipment Stand

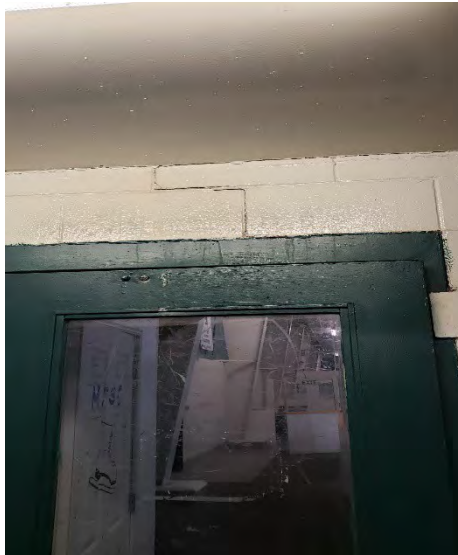
Photo 030      Step Cracking in Lobby

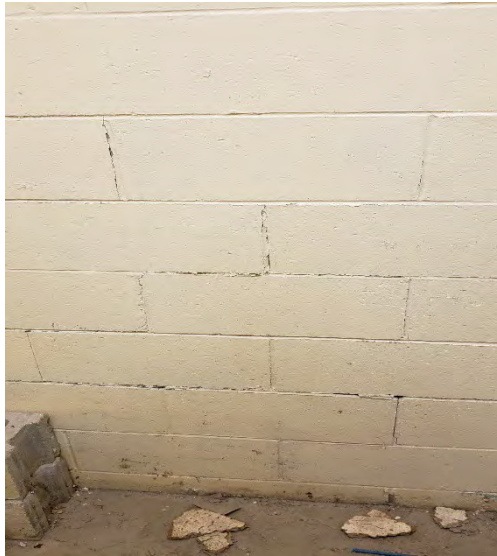
Photo 031      Minor Step Cracking in West-Side Stairwell

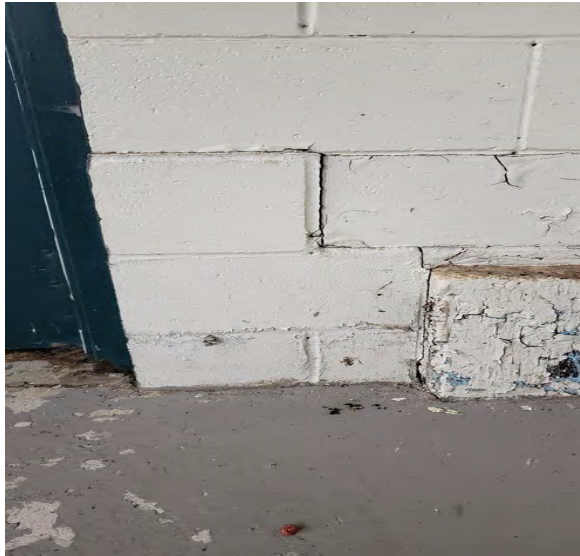
Photo 039      Step Cracking and Damage to West-Side Exit

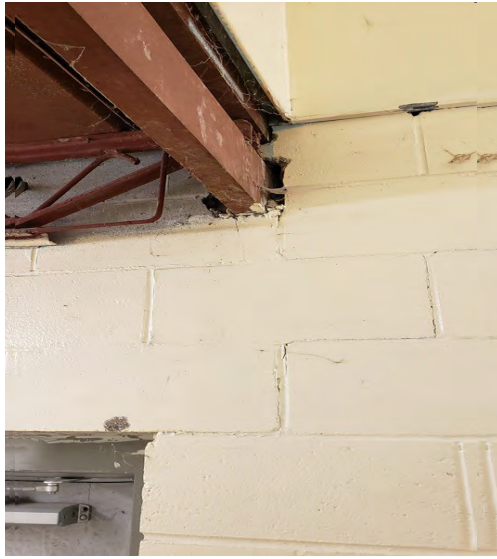
Photo 047      Localized Block Failure

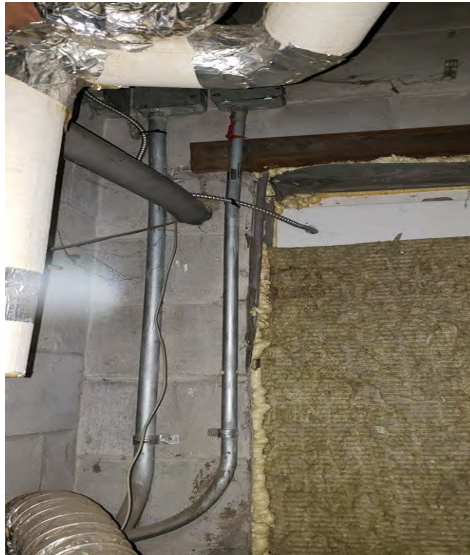
- A steel lintel in the mechanical room adjacent to changeroom 3 was observed to be bearing on a single masonry block experiencing localized cracking (Photo 048). We recommend replacing the steel lintel with a new, longer lintel with a minimum of 6" bearing on each side of the opening.

Photo 048      Localized Block Failure

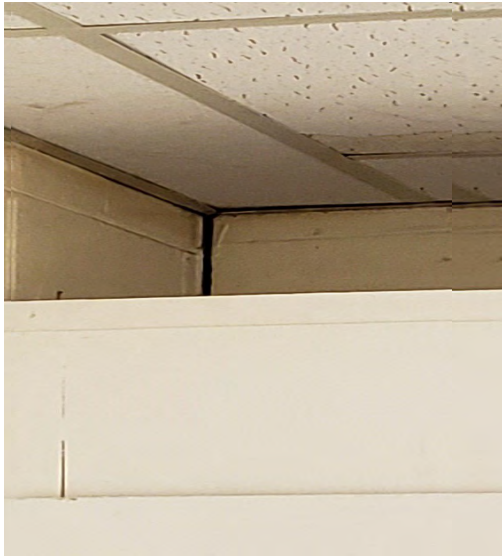
- Wall separation was observed in the storage room on the second floor (Photo 049). We recommend in filling this void space with suitable flexible mortar.
- The remainder of the south stairwell walls appeared to be in good condition (Photo 050).

Photo 049      Wall Separation in Second-Floor Storage Room

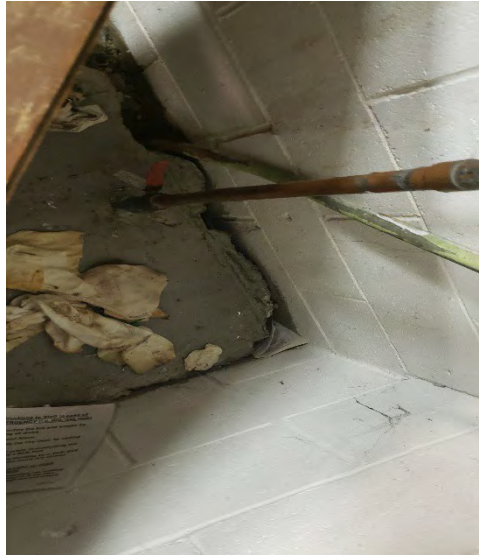
- The concrete slab within the compressor room appeared to be separated from the building structure locally at the north-east corner of the building (Photo 051). We recommend that this gap be infilled with an appropriate mortar to ensure that no moisture can accumulate at the base of the wall and cause further damage.

Photo 051      Slab-On-Grade to Wall Separation in Compressor Room

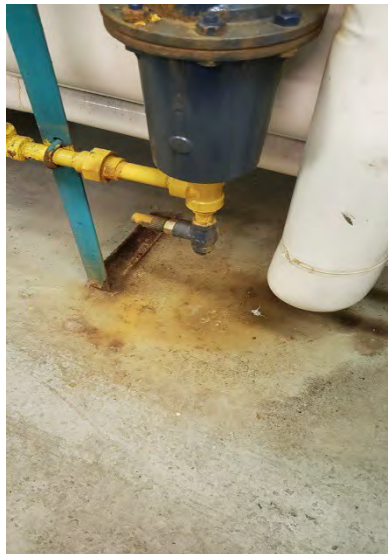
- Staining of the concrete surface was observed below the ammonia pump (Photo 052). This is not a structural concern at this time, however we recommend that the concrete surface is cleaned and an appropriate protective coating is applied to the concrete surface to prevent furthermore advanced deterioration in the future.

Photo 052      Concrete Staining in Compressor Room

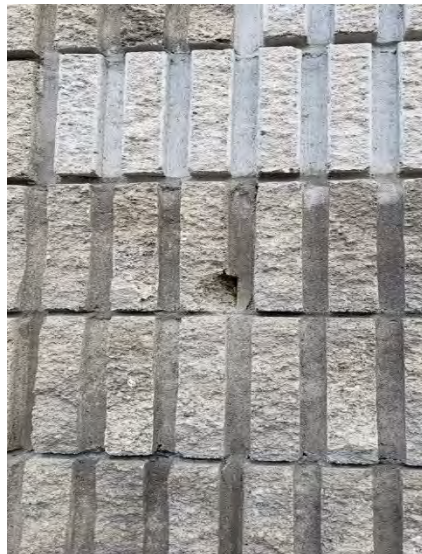
- Minor cracking of the mortar joints was observed along the architectural precast concrete wall panels at localized areas (Photo 065).
- Localized damage to single brick in the architectural precast concrete wall panels was observed (Photo 066). We recommend for the architectural precast concrete wall panels to be repaired and patched with a suitable repair mortar to prevent further deterioration of the architectural wall.

Photo 066 Localized Brick Damage

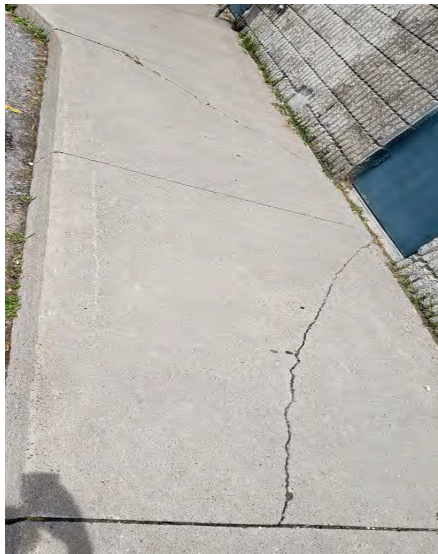
- Localized minor cracking was observed at the concrete walkway adjacent to the south elevation (Photo 070). This cracking appears to be a result of freeze and thaw cycles and heaving below the slab. This is not a structural concern.

Photo 070      Damage to Sidewalk

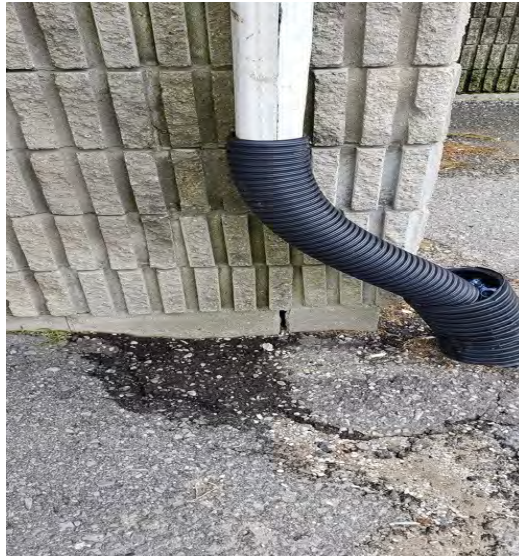
- The foundation wall near the lobby has a significant gap, and the surrounding paved area is experiences minor deterioration (Photo 071). This is likely due to the damaged eaves that is leaking water onto the wall (Photo 072). We recommend that the crack in the foundation be repointed.
- Moss was observed to be growing along the east side wall (Photo 073). This is a sign of moisture accumulation and has resulted in deterioration of the precast concrete wall panels (Photo 074). We recommend for the architectural precast concrete wall panels to be cleaned at these locations and to prevent further more advanced damage to the wall system.

Photo 071      Gap in Foundation Wall

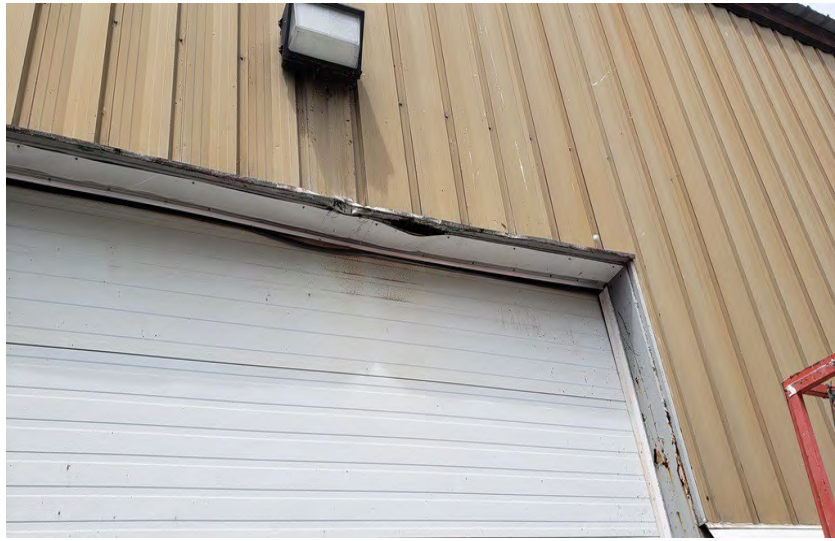
- Caulked panel joints along architectural precast concrete wall panels appear to be in good condition (Photo 075).
- Metal cladding above architectural precast concrete wall panels appears to be in good condition (Photo 076).
- Minor damage to the metal was observed above the garage door opening near the North side (Photo 077). A section of the steel lintel enclosed by the metal was visible at the damaged location and the lintel was observed to be in poor condition with significant rust accumulation and loss of cross-sectional area (Photo 078). We recommend that this lintel be exposed, removed and replaced with a new lintel to match existing conditions, and the damaged metal siding be repaired/replaced to restore to original conditions. to match the surrounding area.

Photo 077      Damage to Garage Door Opening

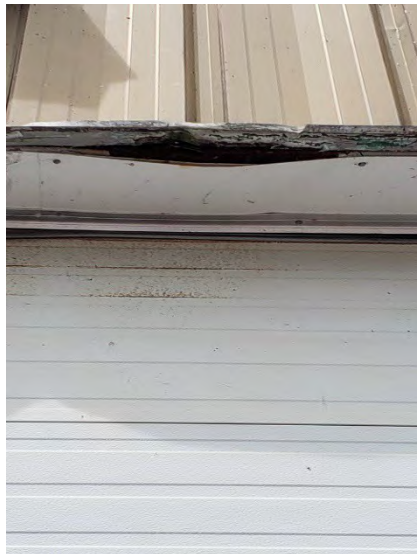
Photo 078      Close Up of Damage Garage Door

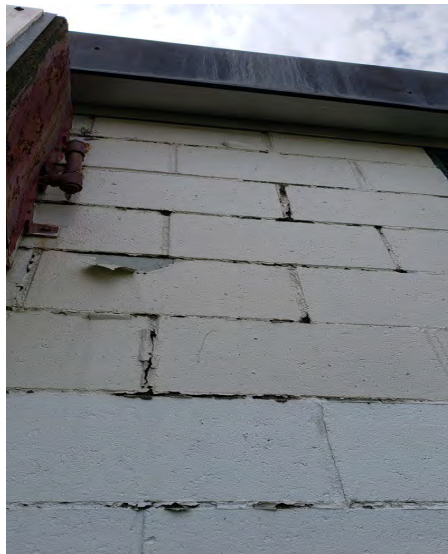
- Localized step Cracking and paint-peeling was observed along the north elevation (Photos 079, 080 and 081). We recommend for all cracked mortar joints to be routed and re-pointed to restore to original conditions. All areas of peeled paint should be cleaned, and new paint applied to match adjacent wall areas.

Photo 080      Step Cracking and Paint Peeling

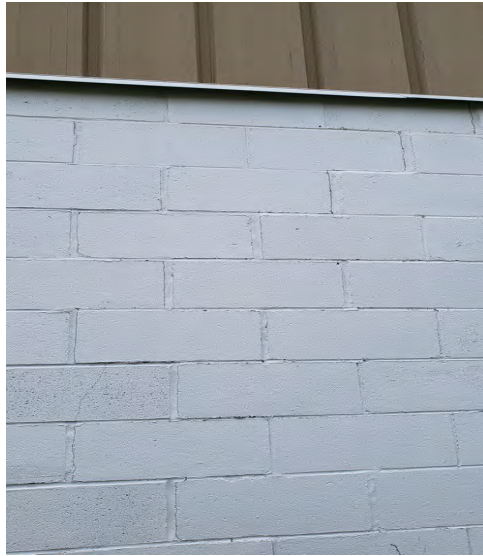
Photo 081      Step Cracking and Block Failure

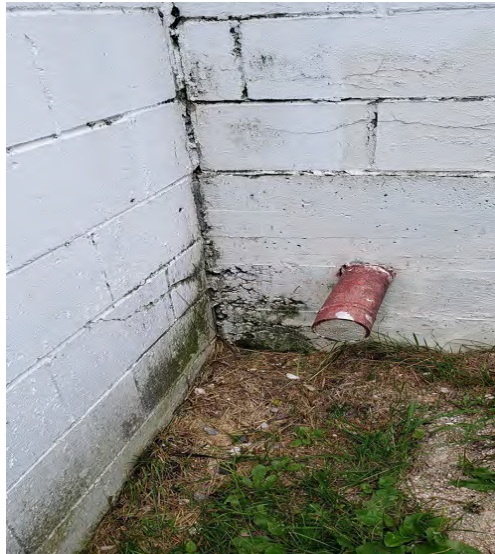
- Honeycombing at the foundation wall and mould growth was observed on the exterior of the ice-resurfacing room (Photos 082 and 083). We recommend for the block walls to be cleaned, mould accumulation to be removed at these locations. The honeycombing is likely a result from the pouring of the concrete at the time of constriction and does not pose a structural concern.

Photo 082      Honeycombing and Mould Growth

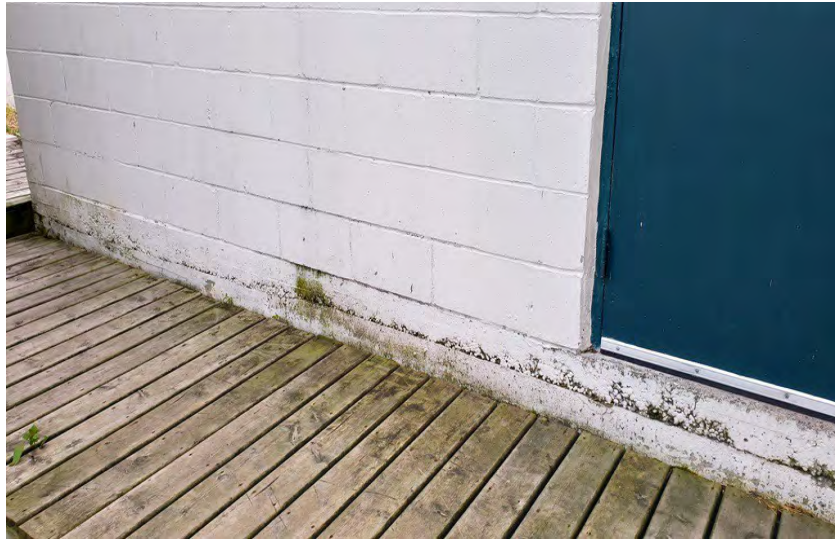
Photo 083      Honeycombing and Mould at Eastside of  
Ice-resurfacing Room

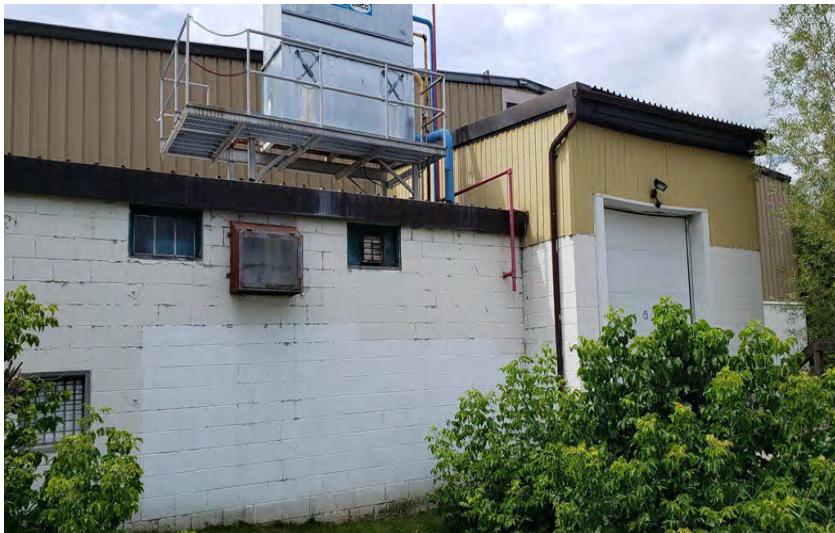
- The metal cladding was observed to be in fair to good condition (Photo 084).
- Minor damage to the base of the exterior of the garage door overhead jambs was observed (Photos 085 and 086). This is likely due to Zamboni impact while travelling in and out of the ice resurfacing room. We recommend that the enclosures are repaired to ensure more advanced damage does not occur.

Photo 084      Metal Cladding

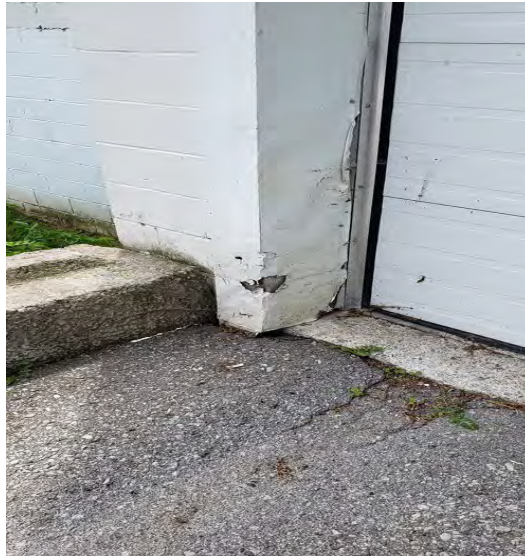
Photo 085      Damage to Garage Door Entrance

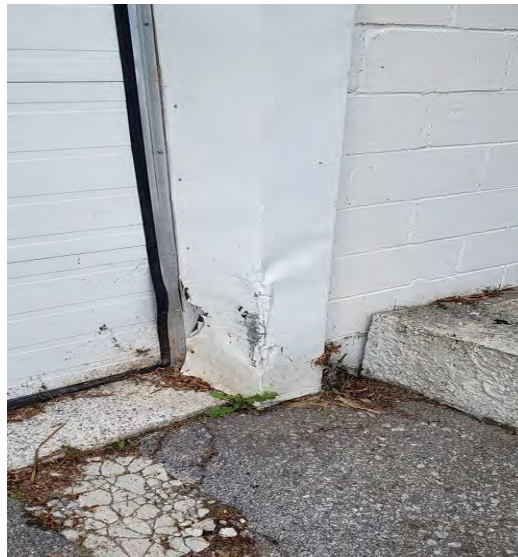
Photo 086      Damage to Garage Door Entrance

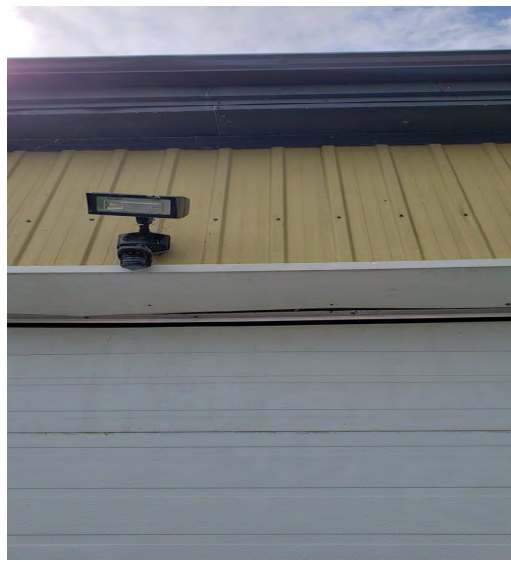
Photo 087      Damage to Garage Door Seal

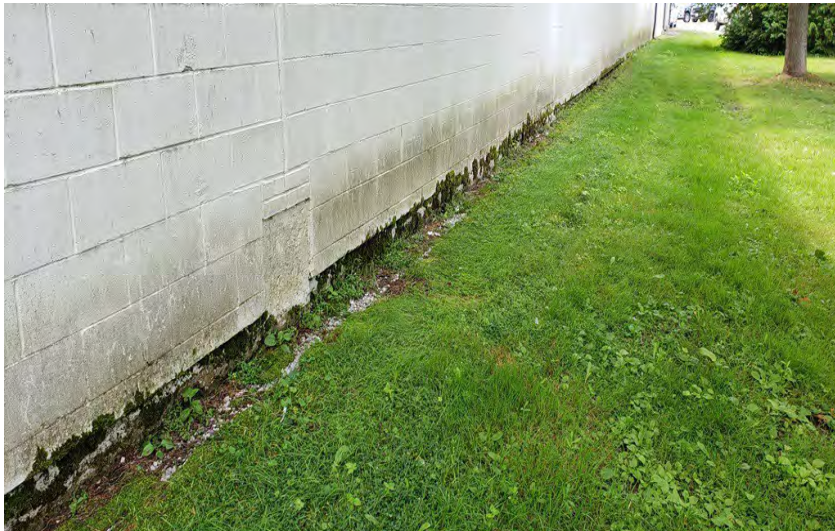
- Mould accumulation was observed at the top of the foundation wall along the entire extents of the west elevation (Photo 090). We recommend that the base of the masonry wall/top of the foundation wall be cleaned and mould to be removed at these locations to prevent future more advanced deterioration.

Photo 090      Mould Along West Side

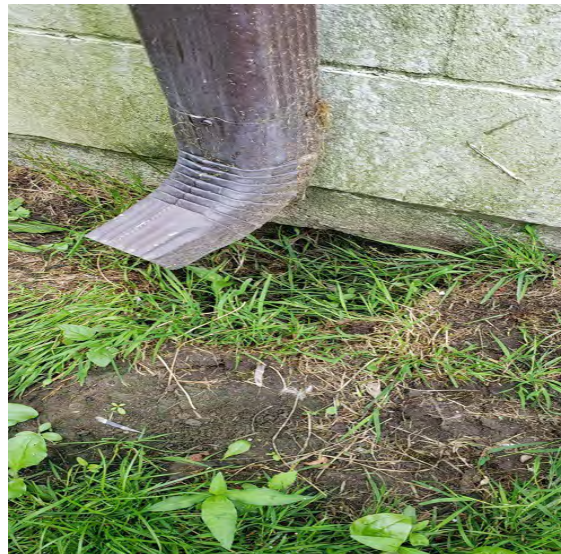
- Localized deterioration at the top of the foundation wall behind a rainwater leader location was observed (Photo 092). We recommend that this area be fixed with suitable repair mortar to ensure no further damage can be done to the structure.

Photo 092      Localized Foundation Wall Damage

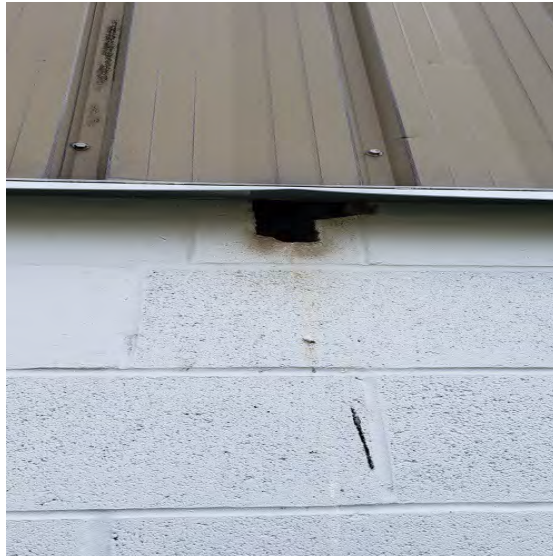
- An opening was observed at the top of the masonry block wall near the south side of the wall (Photo 093). We recommend that the damaged concrete block at this location is removed and replaced with new block to match existing condition to ensure further, more advanced deterioration does not occur to the building system.

Photo 093      Hole in Masonry Block

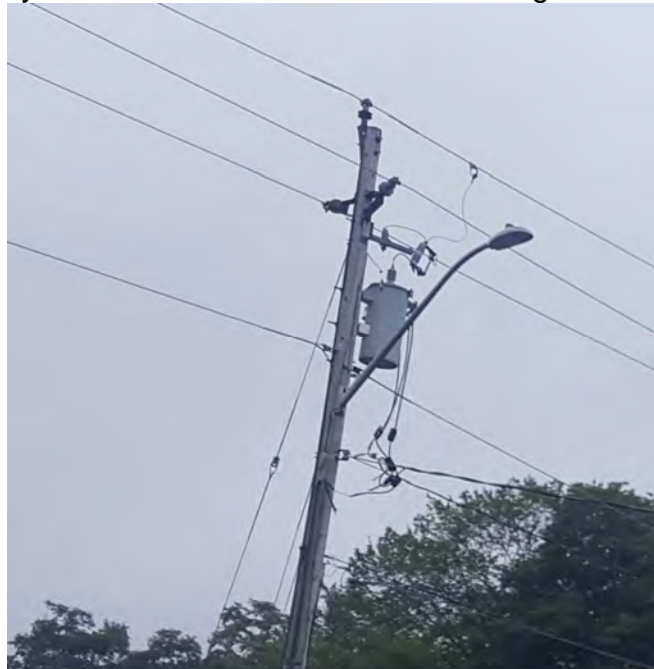
- 2.3 A single pole mounted 50kVA pole mounted transformers supply the Front Service used to supply front of the building, including hall, canteen changerooms and washrooms.
- 2.3.1 The transformer appears in good condition. The transformer also supplies the street lighting to the west.
- 2.3.2 The secondary conductors run overhead individually from the service pole to a wall mounted cable termination rack. The cables enter a raceway via a weather-head and drop to the utility meter on the exterior of the building.
