## Regular Council Meeting

<b>To:</b>	Mayor and Council
<b>Date:</b>	December 16, 2024
<b>From:</b>	Chris Allison, Parks and Facilities Manager
<b>Report Number:</b>	Parks and Facilities 2024-05
<b>Subject:</b>	Mould Assessment Results and Required Remediation at Millbrook Arena

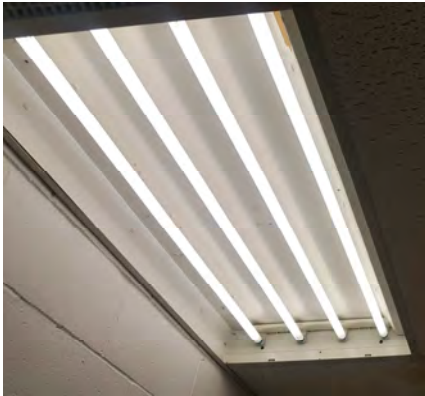
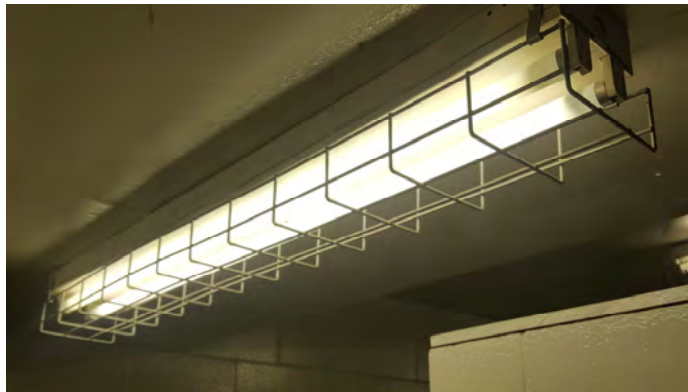
5.3 Most of the existing 120V lighting fixtures are tubular florescent fixtures. Some incandescent fixtures have been upgraded to CFL lamps.

5.4 It is recommended to replace the existing fluorescent fixtures with LED, not just replace the lamps with LED equivalents.

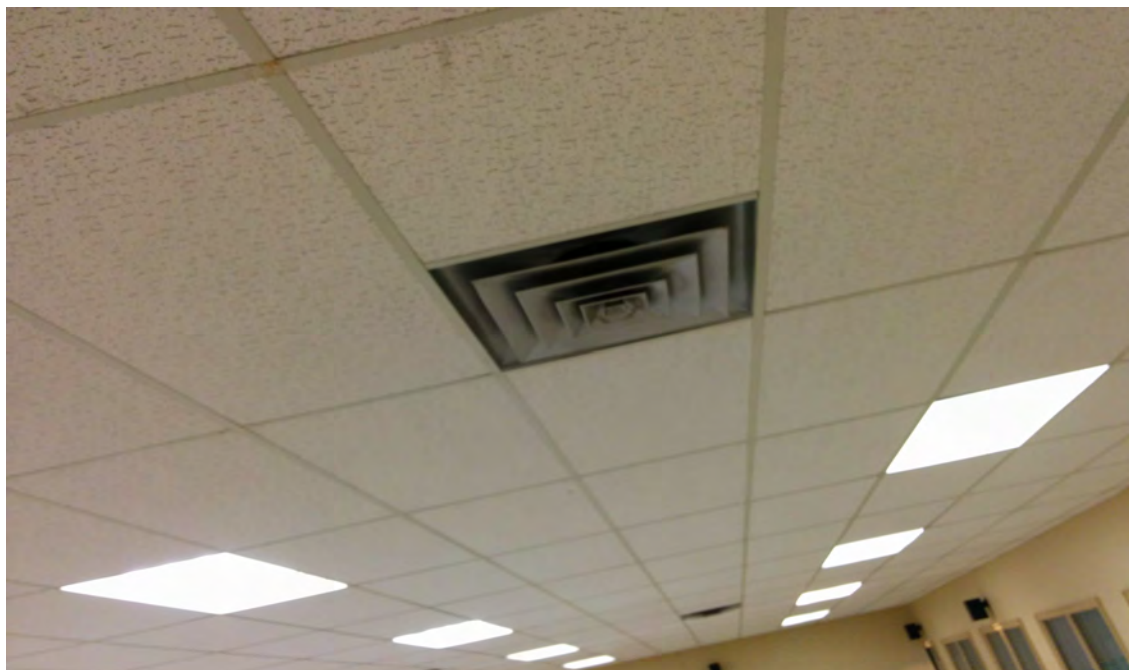
- 2.6 The ducting system had no access panels to verify if there are balancing dampers or any other dampers. The ducting was not accessible to verify how the fittings were done or if they were insulated.
- 2.7 The diffusers are in bad condition; there is very poor air and temperature distribution in the second floor. The diffusers were separated from each other by a long distance without return grills in the same space.

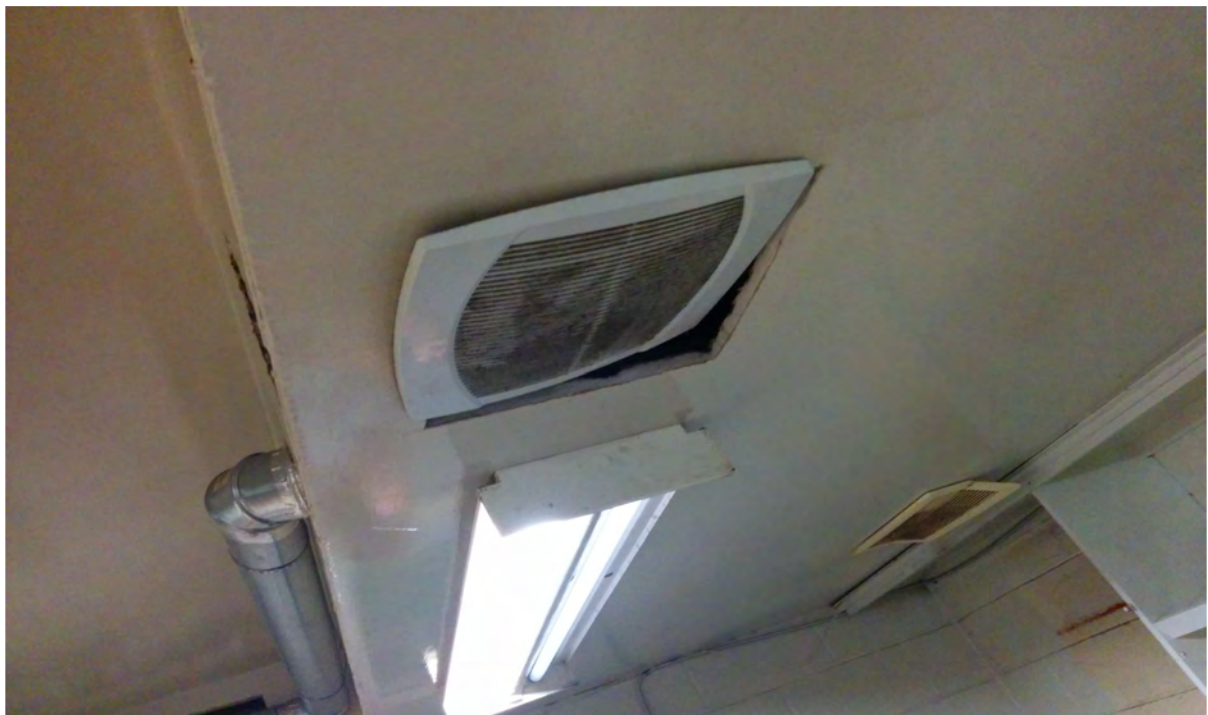
- 2.8 The supply diffusers were in a space and the return grills were in a different space.
- 2.9 Some other spaces had no supply diffusers nor return grills.
- 2.10 There is no heating, ventilation and cooling in the rink lobby as required by codes and standards. The whole corridor in the first floor had no diffusers or grills, which means no heating, cooling or ventilation.
