**BARRY BRYAN  
ASSOCIATES**

Re: **Consulting Services to Update Our Structural Investigation Report to Assess the Feasibility of Renovating the Millbrook Arena or Utilizing the Space in Other Ways**  
**4 Needlers Lane, Millbrook, Ontario**  
**BBA Project No. 22059 (REVISED)**

Barry Bryan Associates (BBA) was requested by the Township of Cavan Monaghan to provide an updated review of the Millbrook Arena located at 4 Needlers Lane in Millbrook, Ontario.

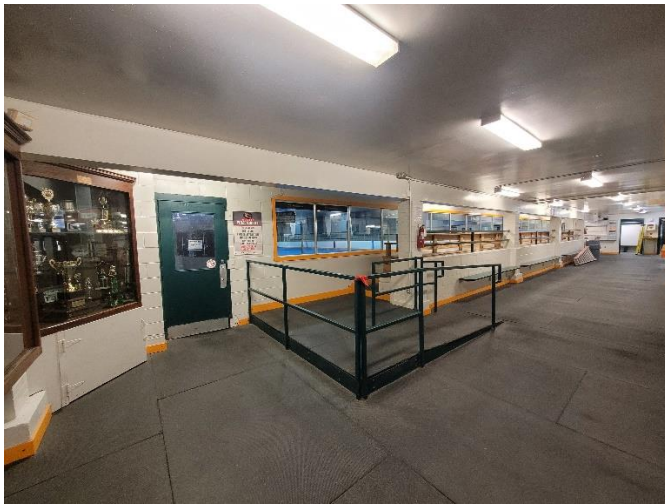
Photo 09 – Arena Viewing Area

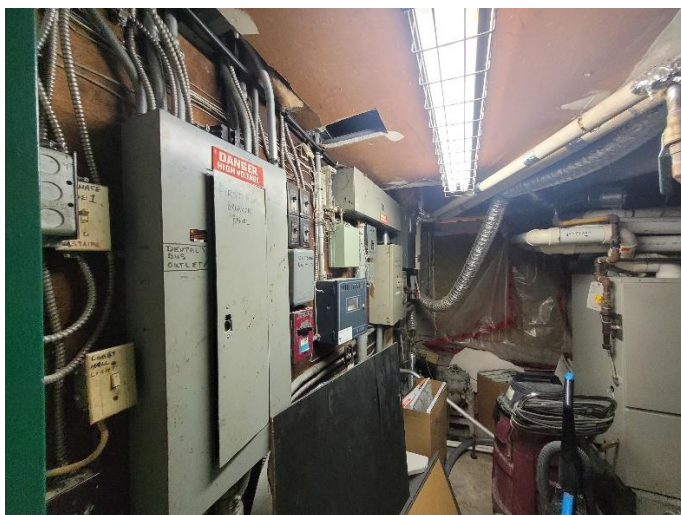
Photo 11 – Furnace/Electrical Room

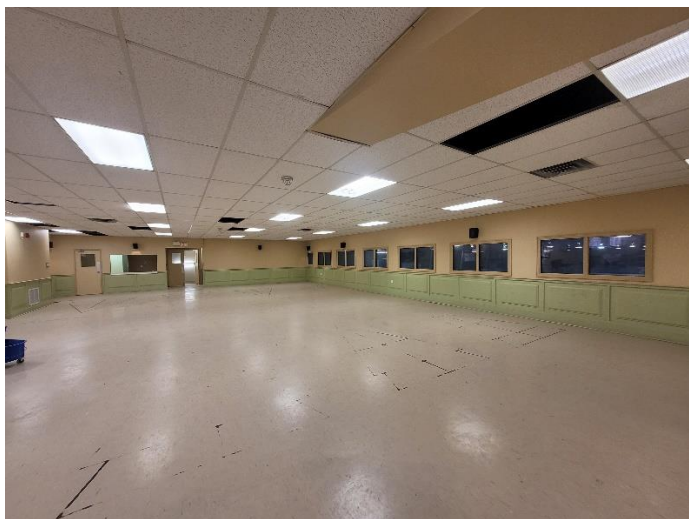
Photo 15 – Second Floor Community Area

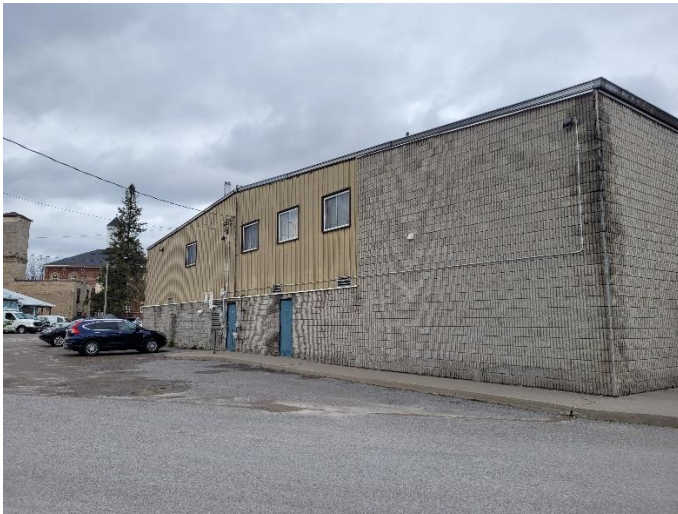
Photo 21 – South Elevation

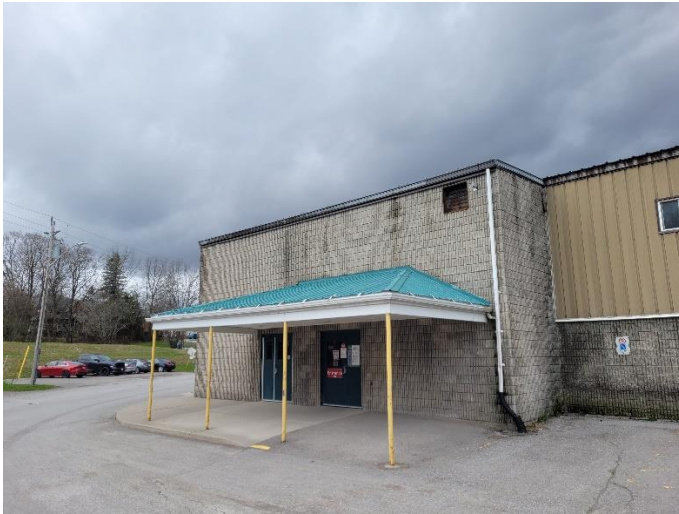
Photo 29 – Arena Entrance on East Elevation

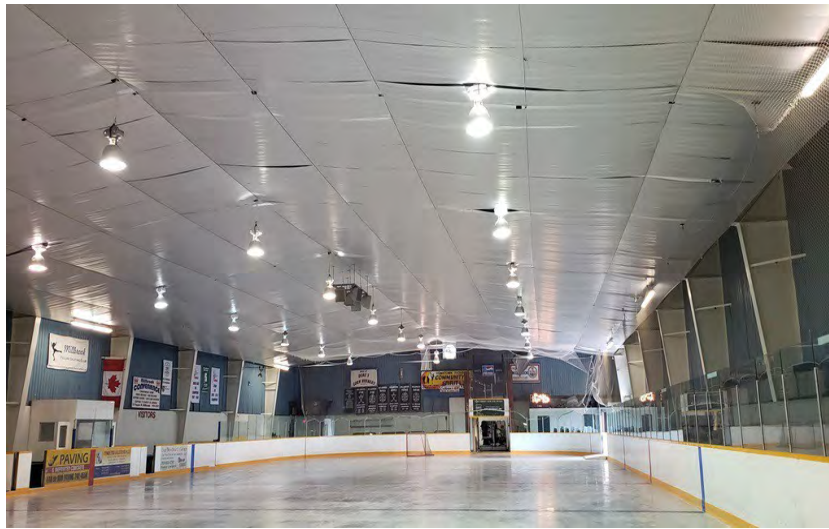
The main structure of the arena consists of a pre-engineered structural frame system with tapered steel girders supporting the steel purlins. The steel frames span approximately 90'-0" and are spaced at approximately 21'-1" centre to centre. We were unable to complete a detailed review of the entire extents of the tapered girders as this framing was enclosed by the existing insulation system (Photo 002). Our observations are as follows:

Photo 002 Roof Deck Insulation covering Pre-Engineered Frames

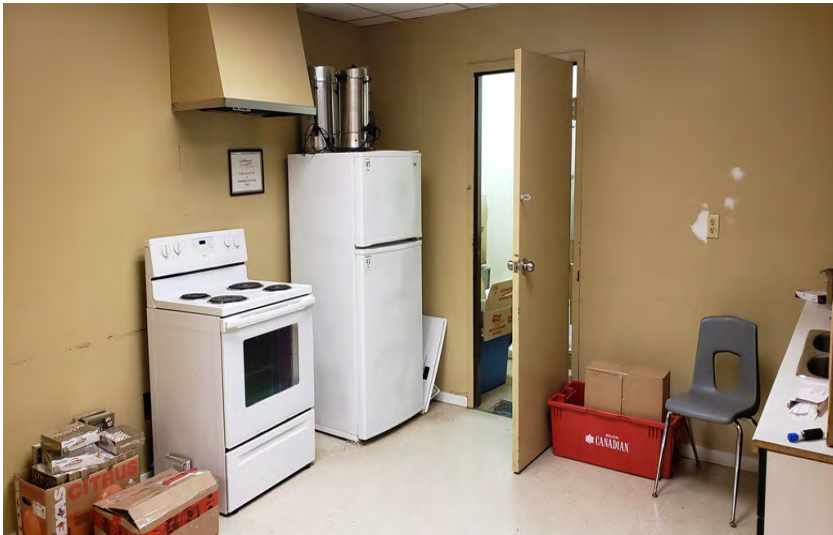
Photo 056      Second Floor Kitchen

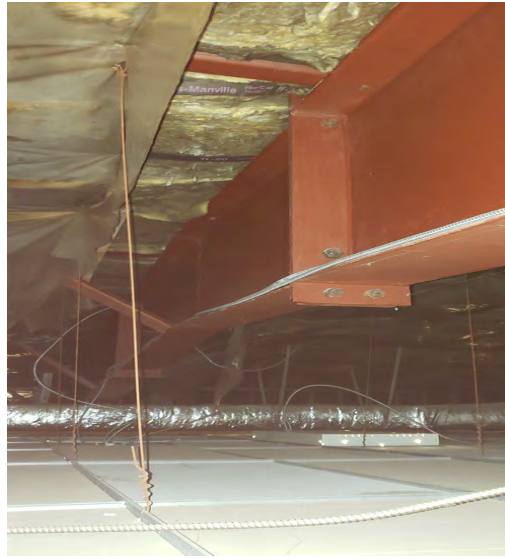
Photo 057      Partial Second-Floor Roof Framing

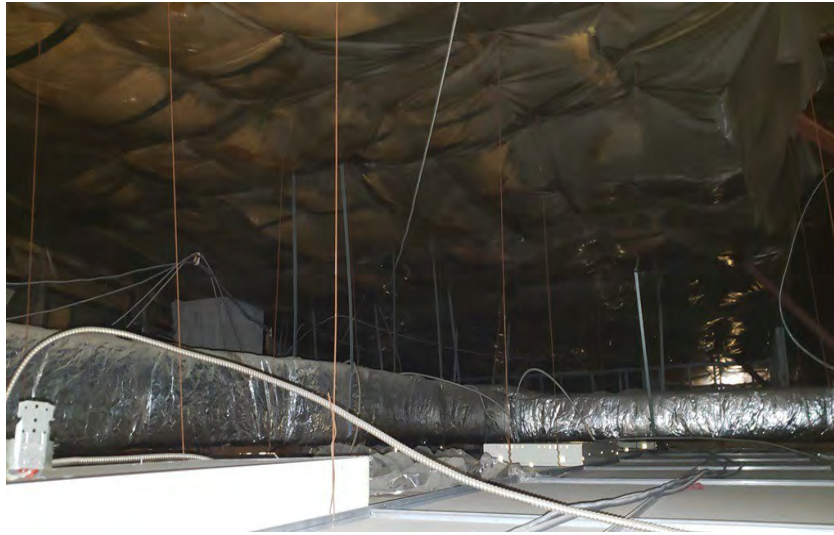
Photo 058      Insulation and Plastic Covering

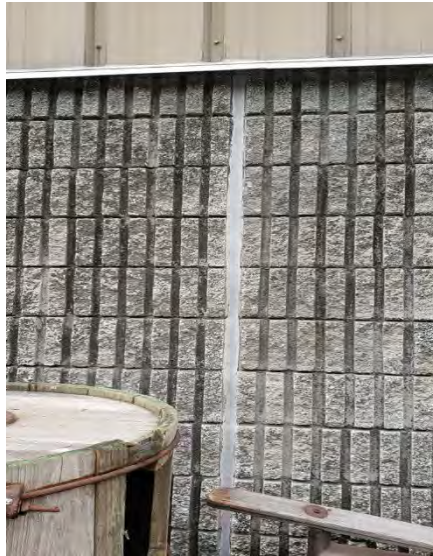
- Caulked panel joints along architectural precast concrete wall panels appear to be in good condition (Photo 075).
- Metal cladding above architectural precast concrete wall panels appears to be in good condition (Photo 076).
- Minor damage to the metal was observed above the garage door opening near the North side (Photo 077). A section of the steel lintel enclosed by the metal was visible at the damaged location and the lintel was observed to be in poor condition with significant rust accumulation and loss of cross-sectional area (Photo 078). We recommend that this lintel be exposed, removed and replaced with a new lintel to match existing conditions, and the damaged metal siding be repaired/replaced to restore to original conditions. to match the surrounding area.

Photo 075      Wall Joint

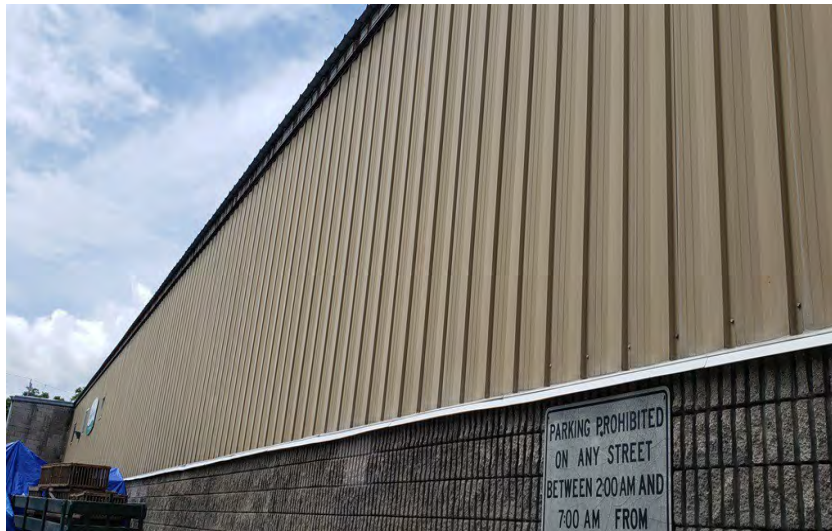
Photo 076      East Side Metal Cladding

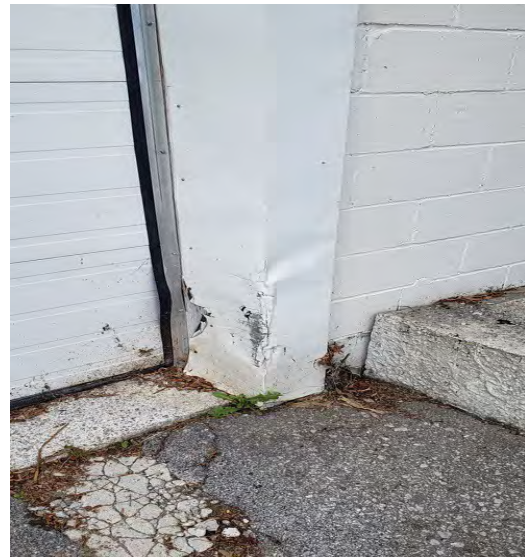
- The metal cladding was observed to be in fair to good condition (Photo 084).
- Minor damage to the base of the exterior of the garage door overhead jambs was observed (Photos 085 and 086). This is likely due to Zamboni impact while travelling in and out of the ice resurfacing room. We recommend that the enclosures are repaired to ensure more advanced damage does not occur.

Photo 086      Damage to Garage Door Entrance

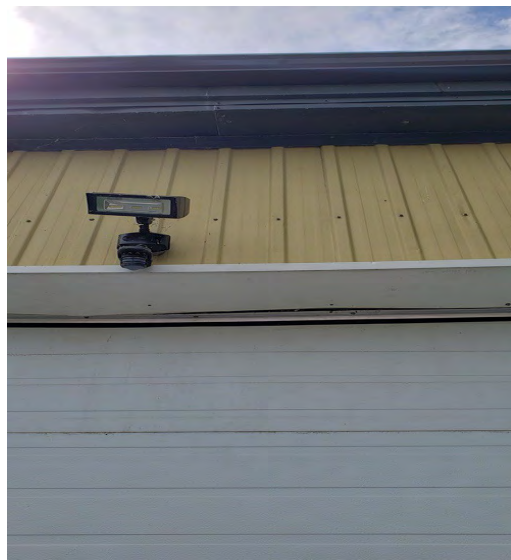
Photo 087      Damage to Garage Door Seal

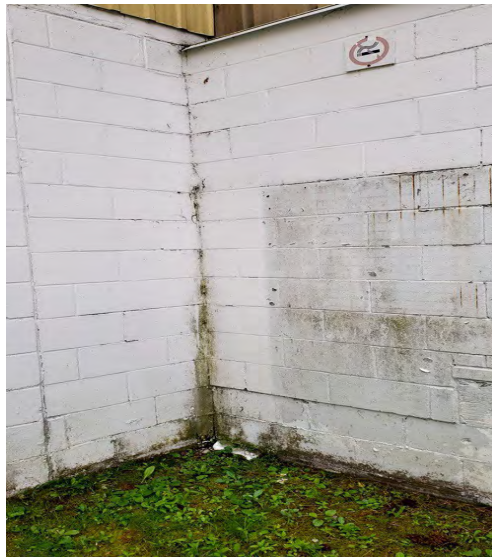
- Moisture accumulation was observed along the north elevation (Photo 088). We recommend for the block walls to be cleaned to restore the original building condition.

Photo 088      Mould and Moisture on Block Wal

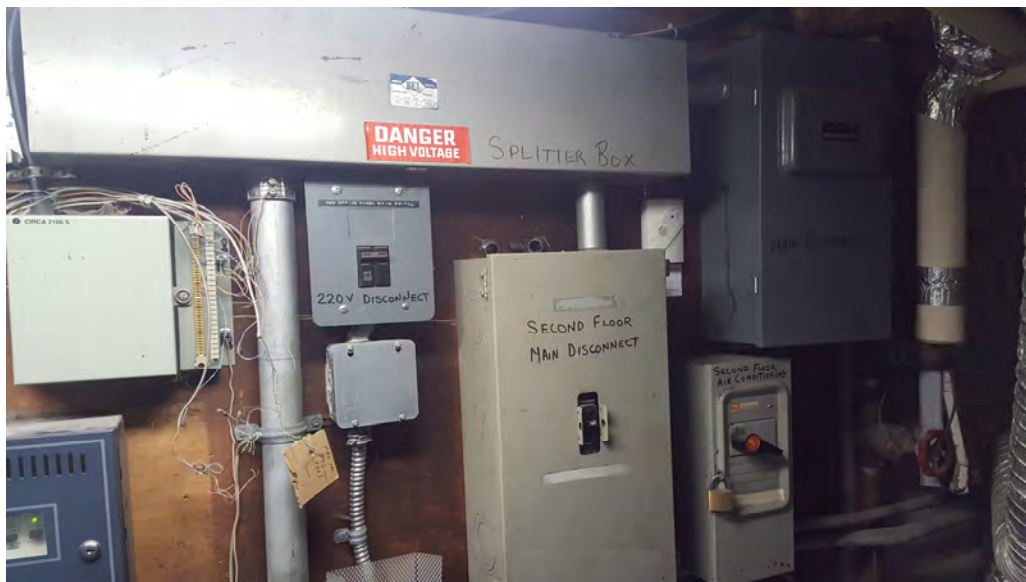
- 4.7 The canteen panel, (Square D 16 CCT) supplies the receptacles and equipment in the canteen (refrigerator, coffee makers, popcorn machine, cash register)
- 4.8 The 240V equipment appears to be all original but is in good condition.
